SECTION 19 FLOOD AND WATER MANAGEMENT ACT

FLOOD INVESTIGATION REPORT

QUEBEC ROAD, TILBURY

NOVEMBER 2013

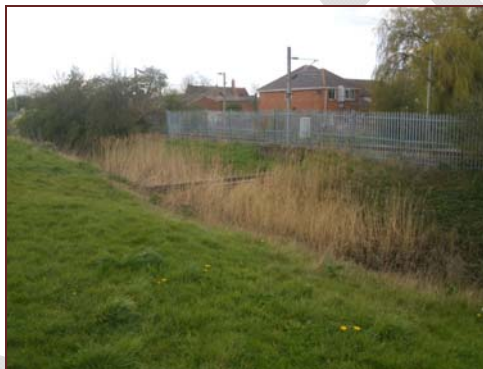
FIGURE 3: EAST DOCK SEWER, OVERGROWN VEGETATION

In December 2012 representatives from Thurrock Council Highways, the Environment Agency and PoT undertook a joint site visit regarding the condition of the Ferry Road retaining wall. At this meeting initial discussions were held regarding the wider maintenance issue of East Dock Sewer as it was apparent that it was highly vegetated (see Figure 3) and demonstrating limited flow.

Discussions with the PoT and Thurrock Highways about ownership and maintenance responsibility for the Ferry Road retaining wall ensued; vegetation clearance and desilting works hinged on responsibility for this section of the East Dock Sewer. Its condition impacted on the viability of undertaking works to the watercourse with concerns regarding its structural integrity.

<i>Recommendation 1</i>	<i>Due By: January 2014</i>
<i>Determine ownership and maintenance responsibility for Ferry Road retaining wall.</i>	
<i>Responsibility:</i>	<i>Port of Tilbury, Environment Agency, Thurrock Council Highways</i>

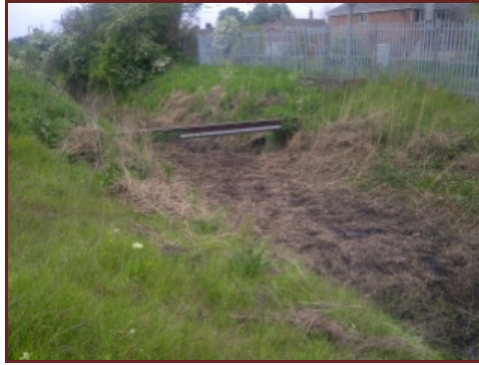
FIGURE 4: EAST DOCK SEWER AFTER VEGETATION CLEARANCE

After further flooding in February, March and April the EA resolved to undertake vegetation clearance works (see Figure 4) in an attempt to remove any blockages to flow and to also undertake a topographic survey to determine bed levels.

A meeting followed on the 19th June 2013 between the EA and AW to discuss the Quebec Road flooding. On review of the survey results it was discovered that there was a localised high silt level around the outfall of the AW sewer.

It appears that the surcharging of the sewerage system was being caused at least in part by the restricted outfall into the East Dock Sewer, resulting in water backing up into the surface water sewer and flooding properties. It was therefore proposed that localised desilting be undertaken around the outfall to enable discharge from the sewer. It was determined that the scope of these works were outside of the Ferry Road retaining wall and therefore could be undertaken without risk to that structure.

In response to the findings from the topographic survey the EA has chosen to use its permissive powers to undertake the works to remove the silt build up by the outfall structure on East Dock Sewer. In order to do this, they informed the PoT as landowners in June and sought their agreement for disposal of the arisings on their land.

Recommendation 2	Due By: COMPLETE
<i>Undertake short-term maintenance works to East Dock Sewer to remove silt build up downstream of AW sewer outfall.</i>	
Responsibility:	<i>Environment Agency, Port of Tilbury</i>
