the play inspection company

Annual Inspection

Thurrock Council

Corringham Town Park

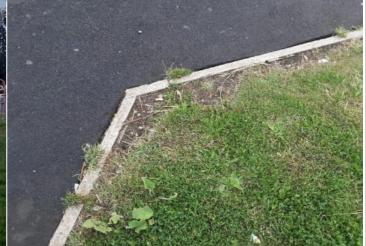
Finding: The surface is lifting at the edges and creating trip Action: Repair perimeter of surfacing to remove trip points points

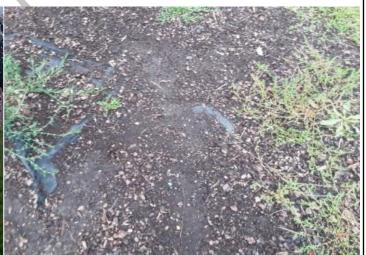
Finding: The bark safety surface is low and the membrane is exposed creating trip points

Action: Remove or resecure the exposed membrane and top up the surface to the correct level

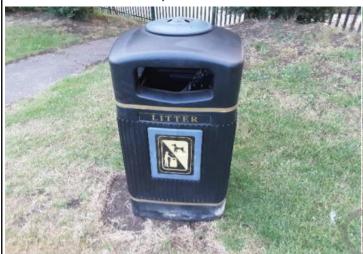
Finding: The bin is not securely fixed to the surface and there is some possibility of the item tipping or rolling over

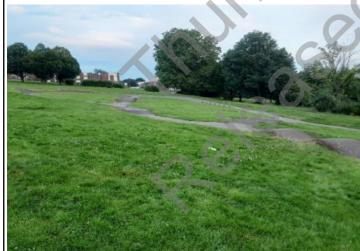
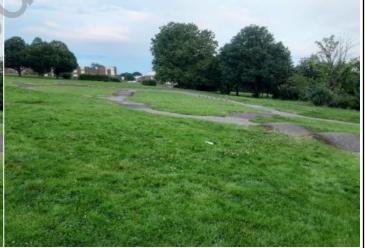
Finding: BMX tracks are not currently covered by any British or European Standard; comments made in the report are based on the application of our knowledge and understanding of the Wheeled Sports Standard (BS EN 14974) and their maintenance and the area has been risk assessed accordingly

Action: Monitor use and review risk assessment regularly

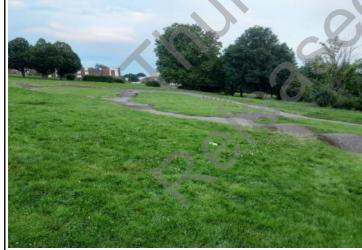
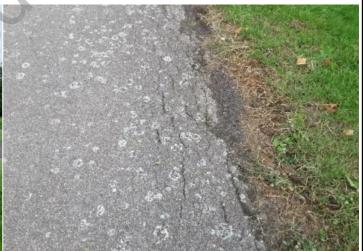
Finding: There are minor stress fractures in the tarmac surface

Action: Monitor and repair if required

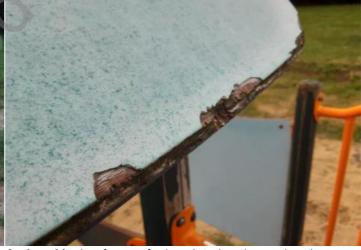
Finding: There is some evidence of rot in the timber

Action: Monitor for any further deterioration and replace as required

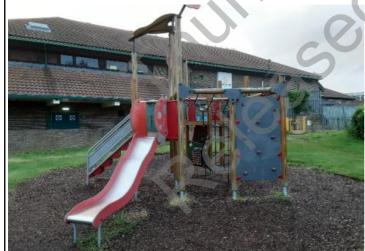
Finding: Parts of the timber are rough or splintered

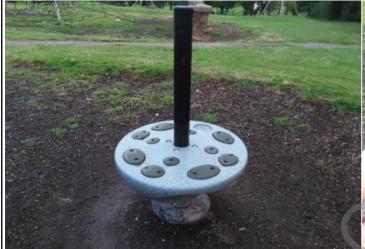
Finding: There is/are missing components creating finger Action: Replace the missing components entrapment/s in the redundant bolt holes and the item fails to meet the requirements of BS EN 1176 Part 1 4.2.7.6

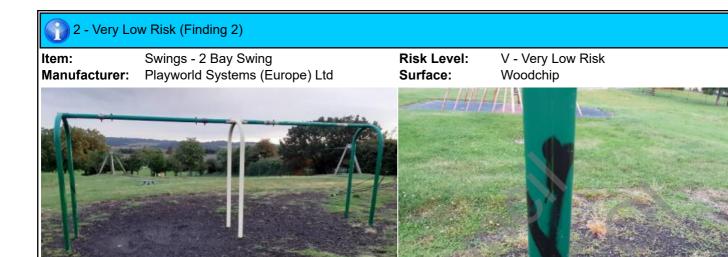
Finding: There is some graffiti present Action: Remove the graffiti

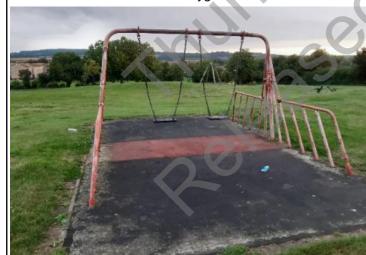
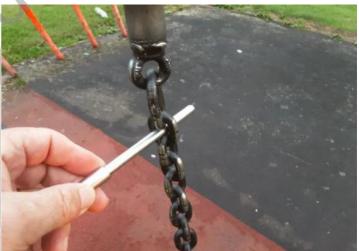
Finding: The chain openings are in excess of the 8.6mm as Action: Monitor - No remedial work recommended recommended by BS EN 1176

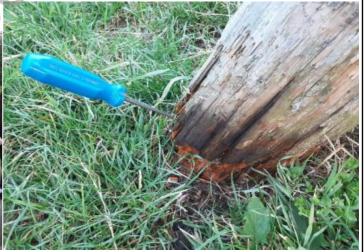
Finding: There are areas or parts of the timber on the structure that have rotted

Action: Replace all affected timbers

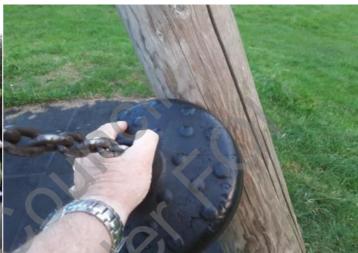
Finding: The seat is less than 2.0 metres from the post Action: Adjust the cable stop position to ensure the when extended at 45 degrees at the end of the area of travel minimum distance is maintained and does not meet the requirements of BS EN 1176 Part 4

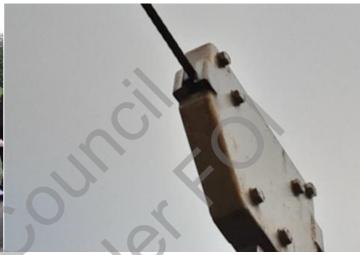
Finding: The nylon inserts are worn or missing at the point Action: Replace worn or missing inserts as required the cable enters the traveller

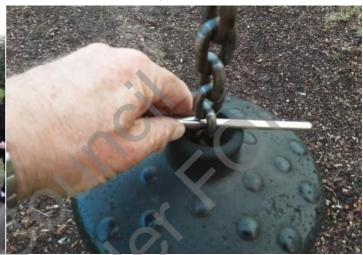
Finding: The chain openings are in excess of the 8.6mm as **Action:** Monitor - No remedial work recommended recommended by BS EN 1176

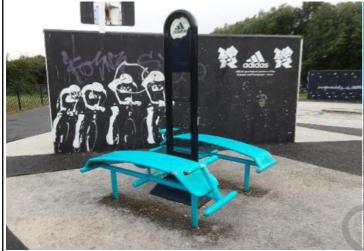
Finding: The paintwork on this item has been damaged or worn exposing the metal underneath which is rusting

Action: Treat any rusting components and repaint

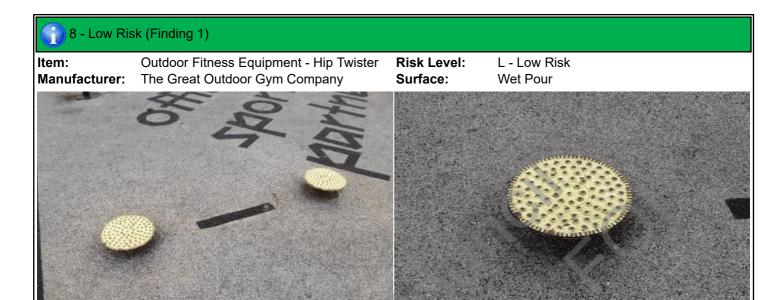
Finding: The deflection of the rotating user station exceeds Action: Monitor - No remedial work recommended the maximum 105 degrees required by BS EN 16630

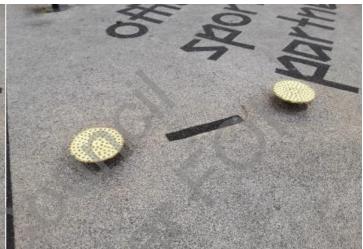
Finding: The central support is missing

Action: Replace the missing support or remove the item completely

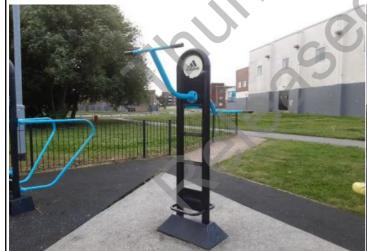
Finding: The paintwork on this item has been damaged or worn exposing the metal underneath which is rusting

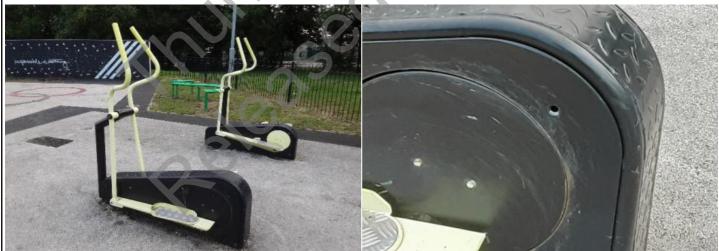
Finding: There is or are fixings missing on the item

Action: Replace all missing fixings

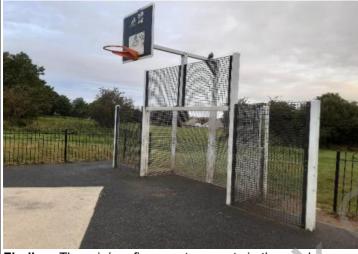
Finding: There is/are finger entrapments in the mesh openings and the item fails to meet the requirements of BS EN 15312 Clause 4.4.2.2 Entrapment of fingers

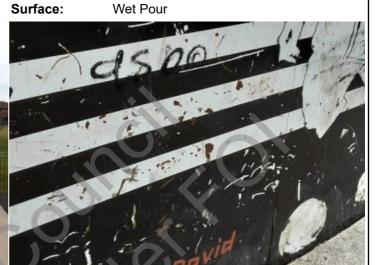
Finding: The paintwork on this item has been damaged or worn exposing the metal underneath which is rusting
