## Annual Inspection

Thurrock Council

Corringham Town Park

Springhouse Road, Corringham, Essex, SS17 7NB

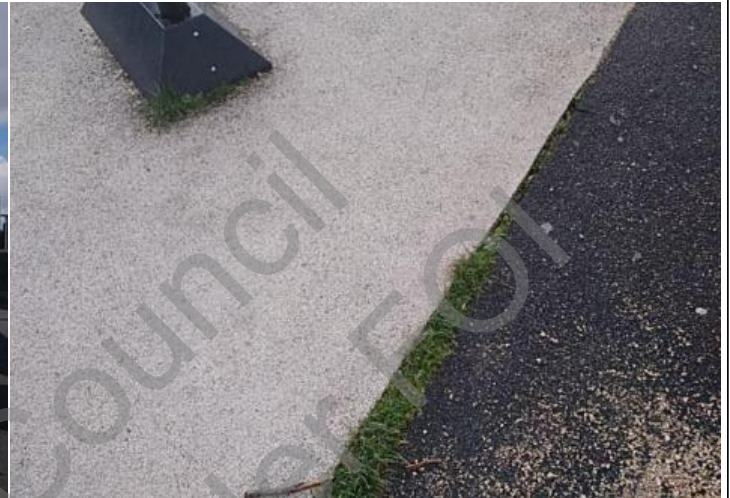
**Risk Level:** L - Low Risk  
**Surface:** N/A

**Finding:** There are significant gaps (over 30mm) between the surface and the edging or between the joints in the surface; these are large enough for a small foot to enter

**Action:** Repair surfacing

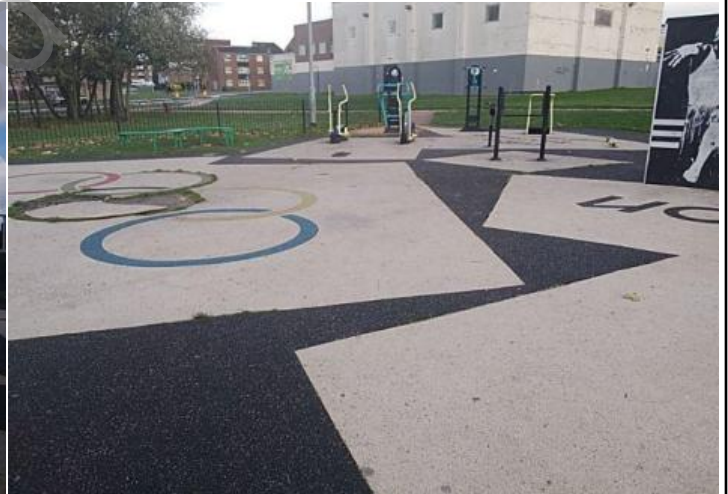
**Risk Level:** L - Low Risk  
**Surface:** N/A

**Finding:** The wetpour is crumbling in areas

**Action:** Monitor for any further deterioration and repair as required

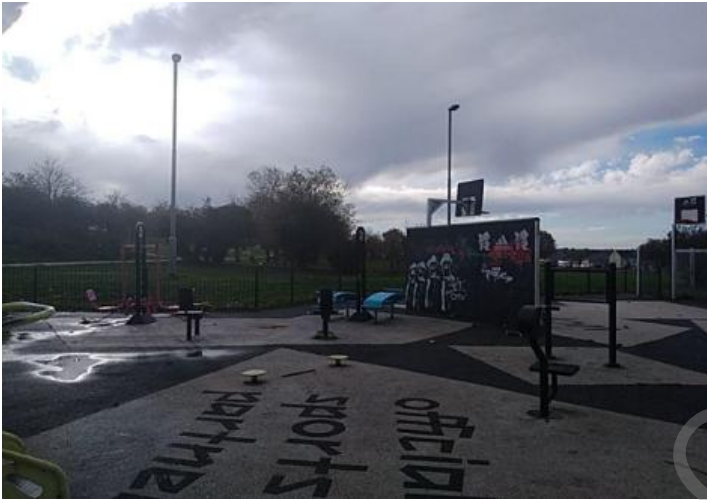
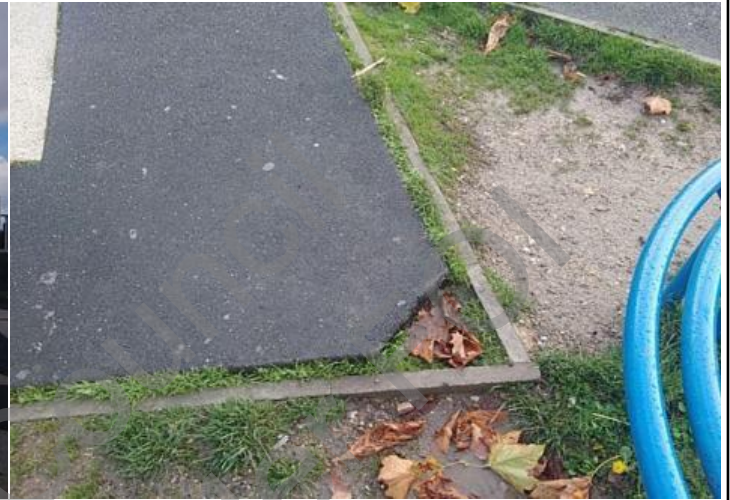
**Risk Level:** L - Low Risk  
**Surface:** N/A

**Finding:** The surface is damaged and is lifting at the edges and creating trip points  
**Action:** Repair perimeter of surfacing to remove trip points

**i** 8 - Low Risk (Finding 7)

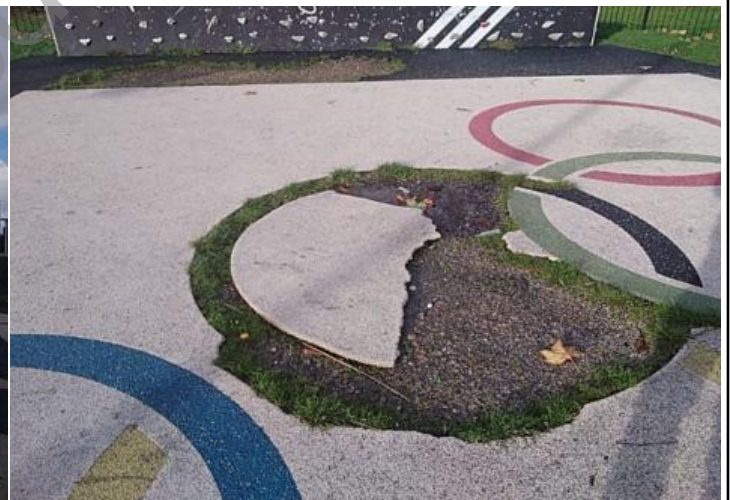
**Risk Level:** L - Low Risk  
**Surface:** N/A

**Finding:** The surfacing in the fitness area is damaged  
**Action:** Repair the damaged areas of surfacing

**i** 8 - Low Risk (Finding 8)

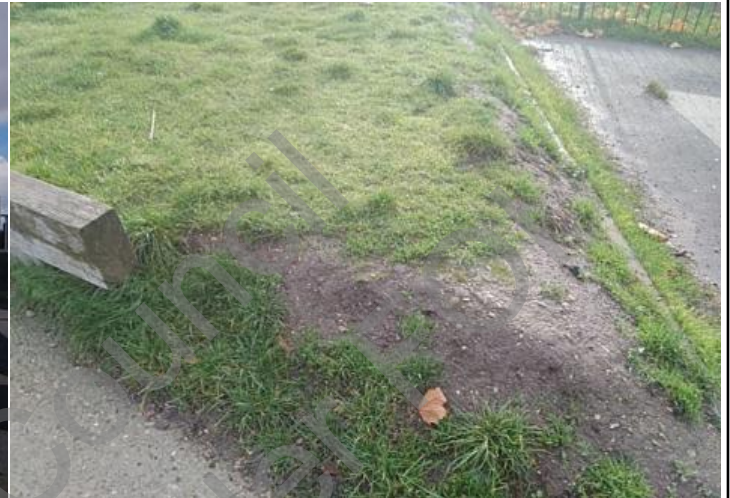
**Risk Level:** L - Low Risk  
**Surface:** N/A

**Finding:** There are sleepers missing from the timber retaining wall

**Action:** Replace the missing sleepers

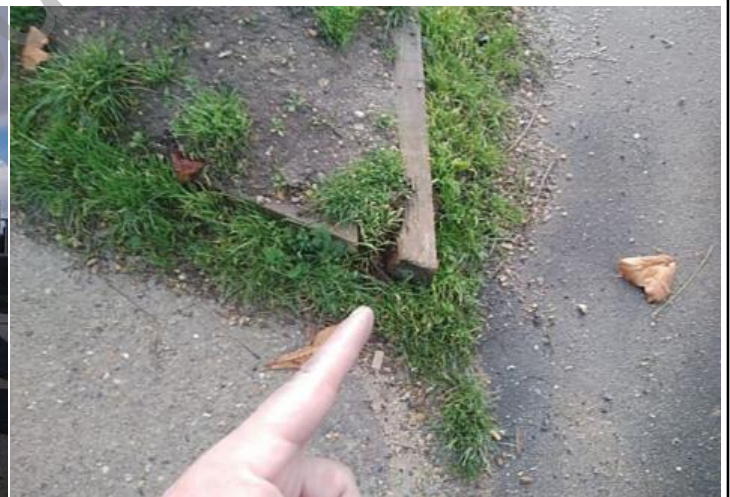
**Risk Level:** L - Low Risk  
**Surface:** N/A

**Finding:** There are areas or parts of the timber edgings that have rotted or are missing

**Action:** Replace all affected timbers

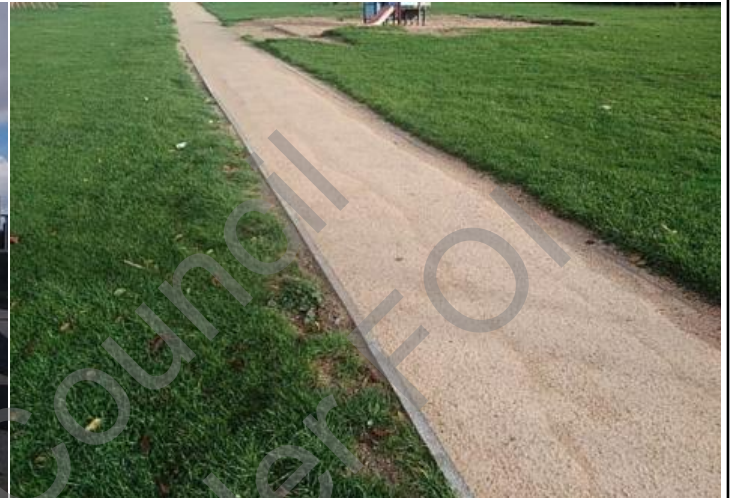
**Risk Level:** L - Low Risk  
**Surface:** N/A

**Finding:** There are trip hazards at the edges of the surface **Action:** Reinstate surrounding surface levels to remove the trip points

**i** 5 - Very Low Risk (Finding 1)

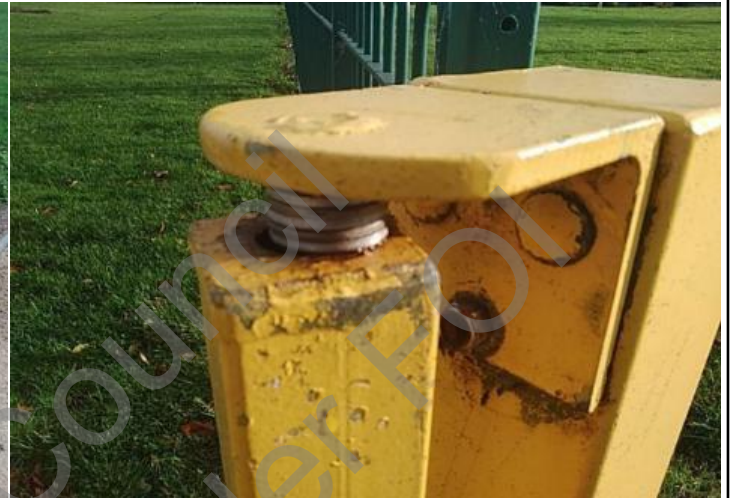
**Risk Level:** L - Low Risk  
**Surface:** Grass

**Finding:** The weld(s) on this item have failed

**Action:** Repair item

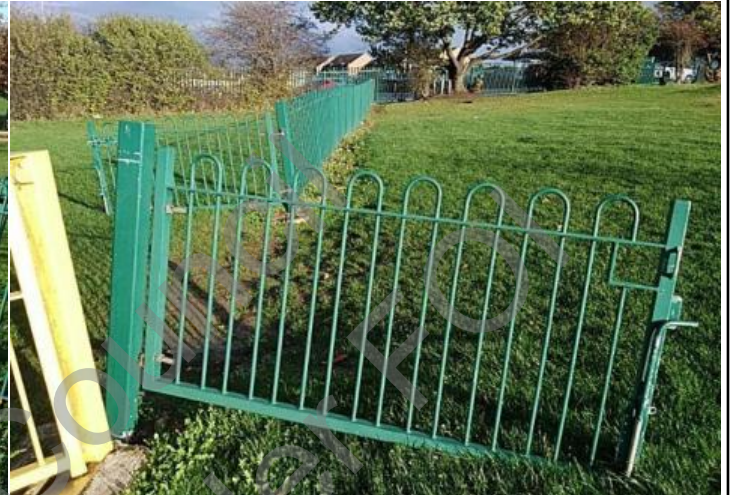
**Risk Level:** M - Moderate Risk  
**Surface:** Grass

**Finding:** The item is loose in its foundations

**Action:** Reinstall item to secure

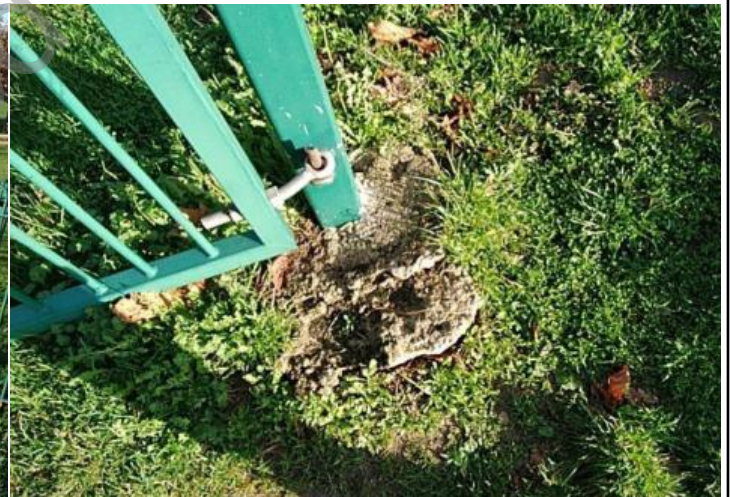
**Risk Level:** L - Low Risk  
**Surface:** Grass

**Finding:** The surface has eroded and the foundations are exposed

**Action:** Reinstall surrounding surfaces to cover the foundations

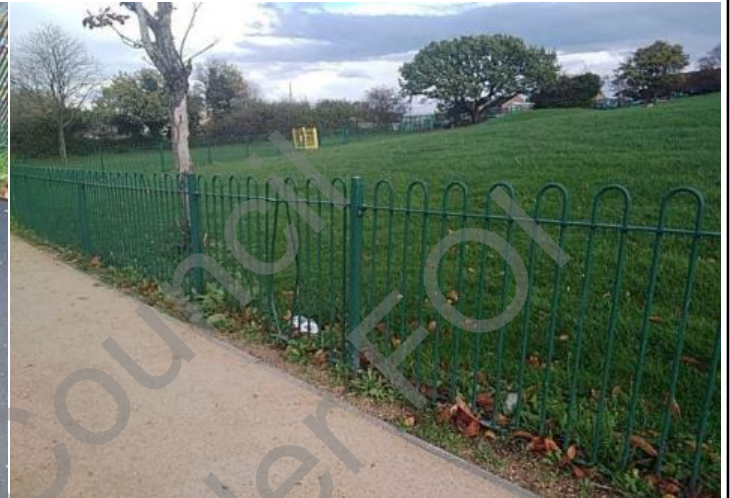
**Risk Level:** L - Low Risk  
**Surface:** Grass

**Finding:** There is some damage to the fence sections

**Action:** Monitor for any further deterioration and repair as required

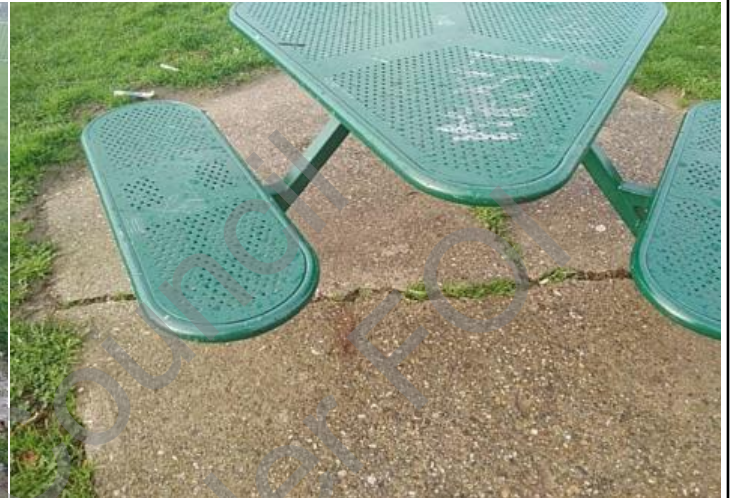
**Risk Level:** L - Low Risk  
**Surface:** Concrete

**Finding:** There is moderate damage to the surface

**Action:** Repair the damaged areas of surfacing

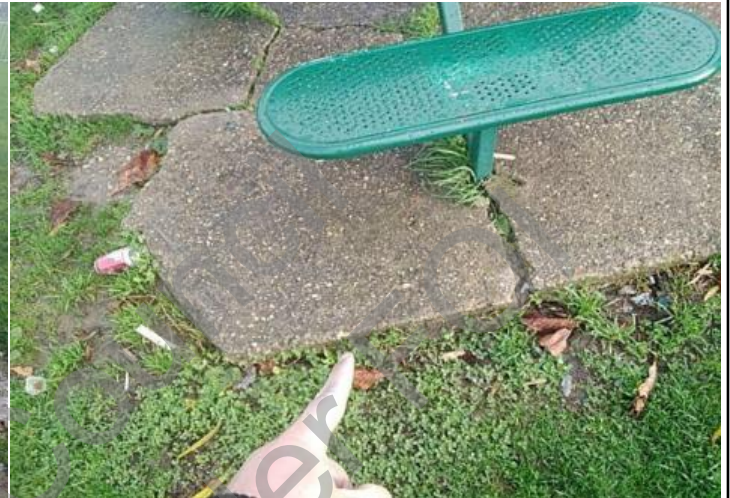
**Risk Level:** L - Low Risk  
**Surface:** Concrete

**Finding:** There are trip hazards at the edges of the surface

**Action:** Reinststate surrounding surface levels to remove the trip points

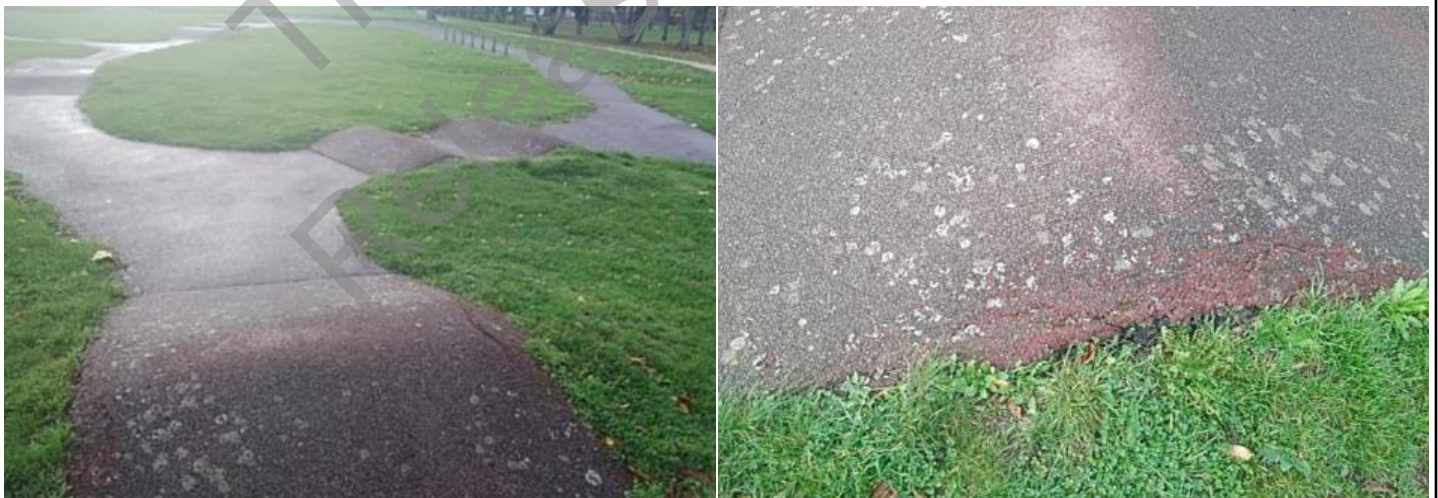
**Risk Level:** L - Low Risk  
**Surface:** Tarmac

**Finding:** The edges of the tarmac jump ramps has subsided **Action:** Repair the damaged ramps

**i** 6 - Low Risk (Finding 3)

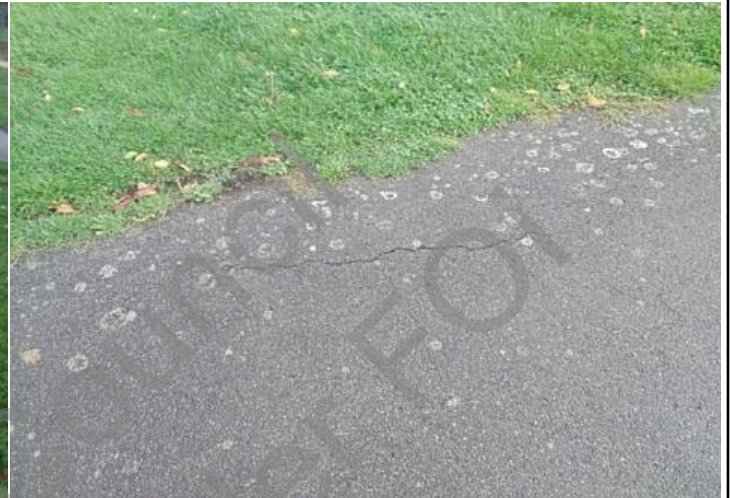
**Risk Level:** L - Low Risk  
**Surface:** Tarmac

**Finding:** There are minor stress fractures in the tarmac surface

**Action:** Monitor and repair if required

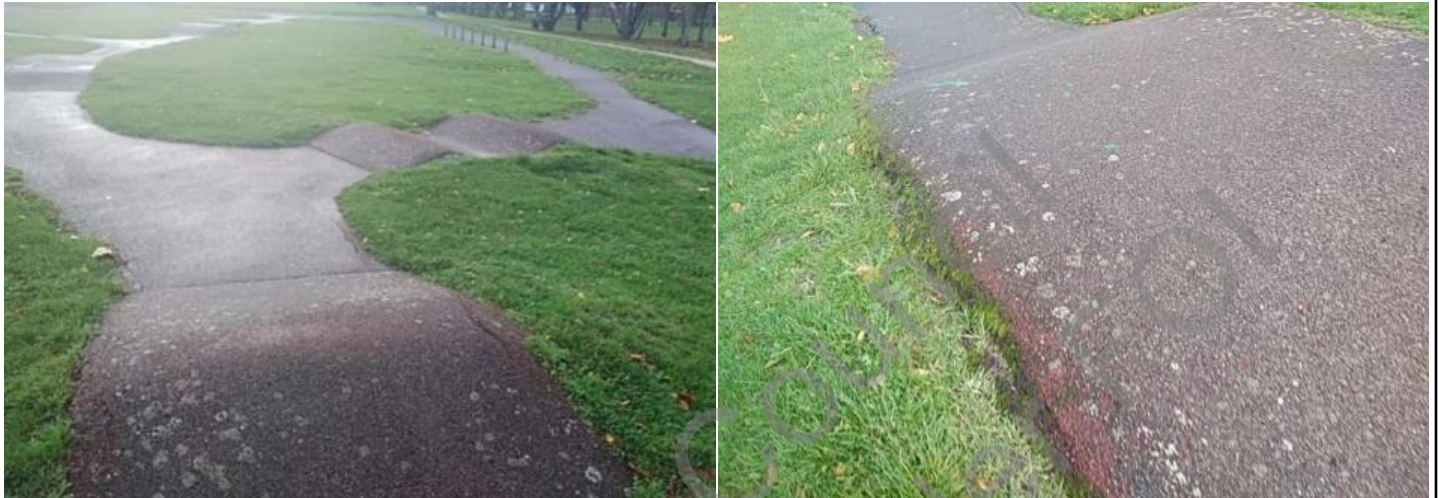
**Risk Level:** L - Low Risk  
**Surface:** Tarmac

**Finding:** There is algae, silt or moss growth on the surface resulting in slippery conditions

**Action:** Clean and treat appropriately

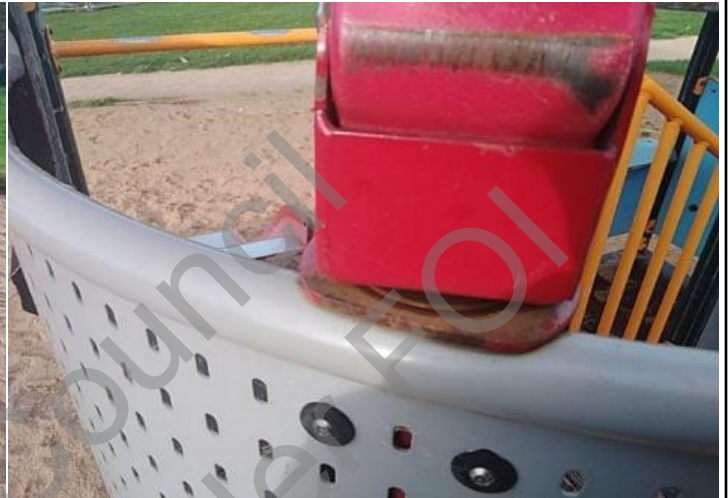
**Risk Level:** L - Low Risk  
**Surface:** Sand

**Finding:** The paintwork on this item has been damaged or worn exposing the metal underneath which is rusting

**Action:** Treat any rusting components and repaint

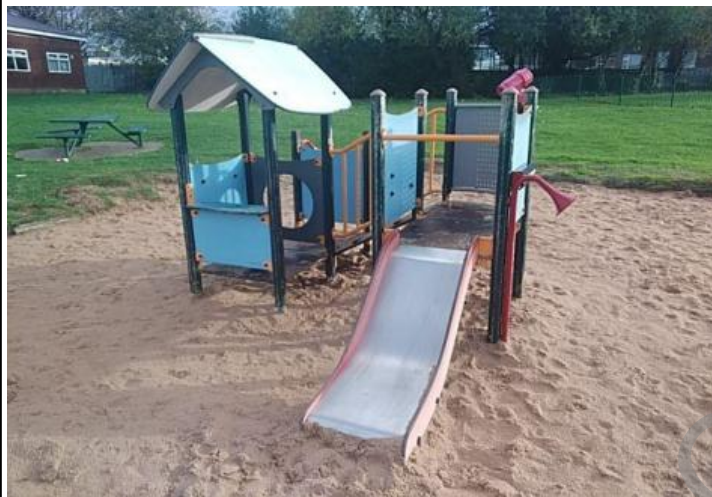
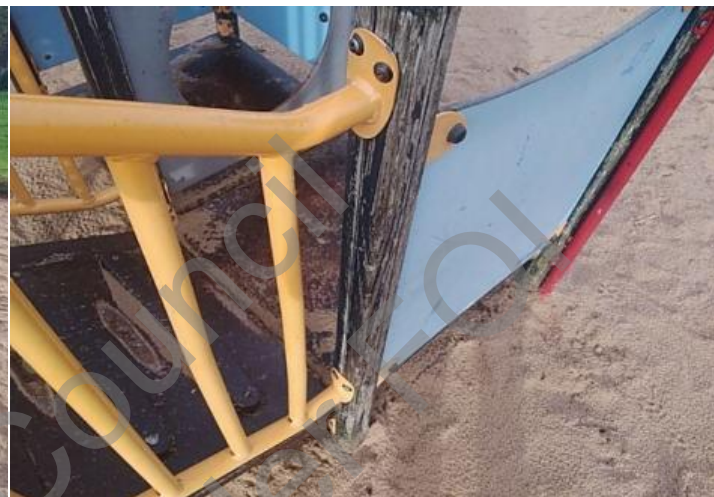
**Risk Level:** L - Low Risk  
**Surface:** Sand

**Finding:** The timber stain is in poor condition

**Action:** Prepare all affected parts and re-stain with an appropriate preservative

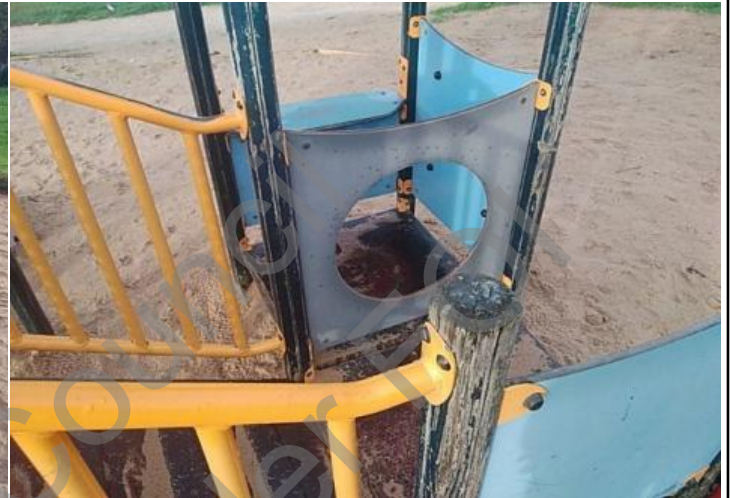
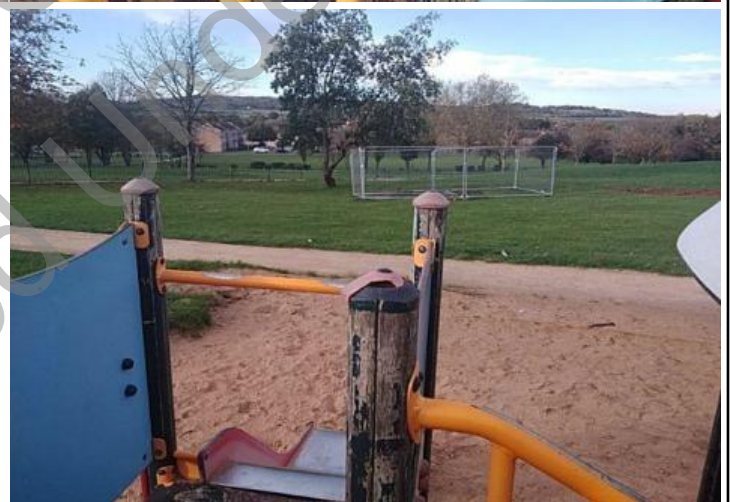
**Risk Level:** L - Low Risk  
**Surface:** Sand

**Finding:** There are post / end caps missing from the item

**Action:** Replace missing post caps

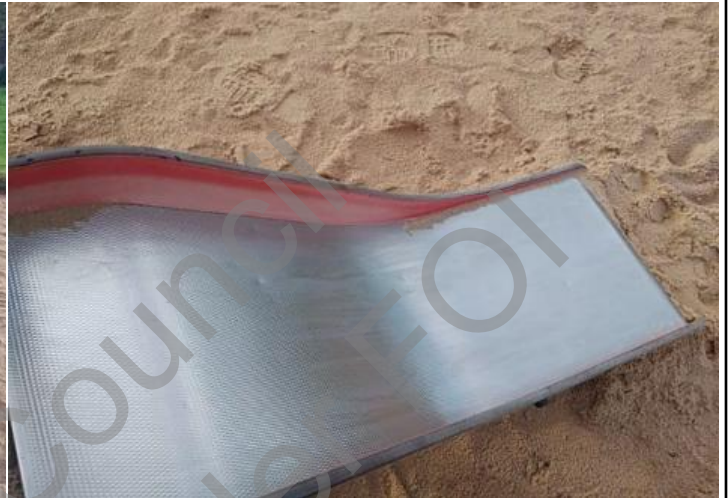
**Risk Level:** V - Very Low Risk  
**Surface:** Sand

**Finding:** There are a number of dents in the slide surface

**Action:** Monitor for any further deterioration and repair as required

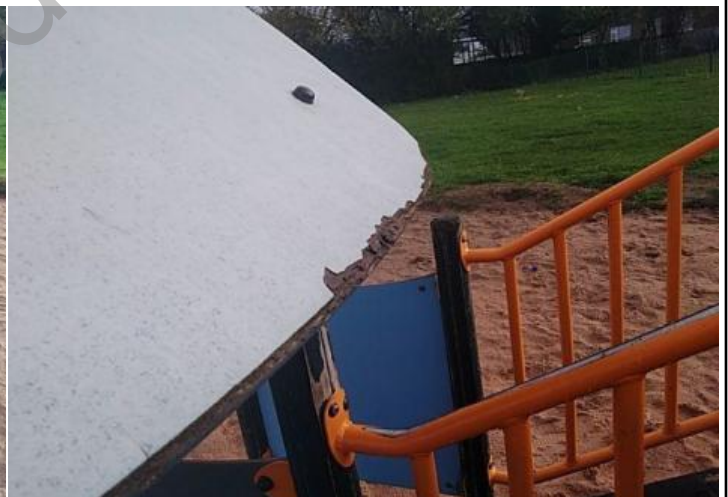
**Risk Level:** L - Low Risk  
**Surface:** Sand

**Finding:** There is some evidence of rot in the timber

**Action:** Monitor for any further deterioration and replace as required

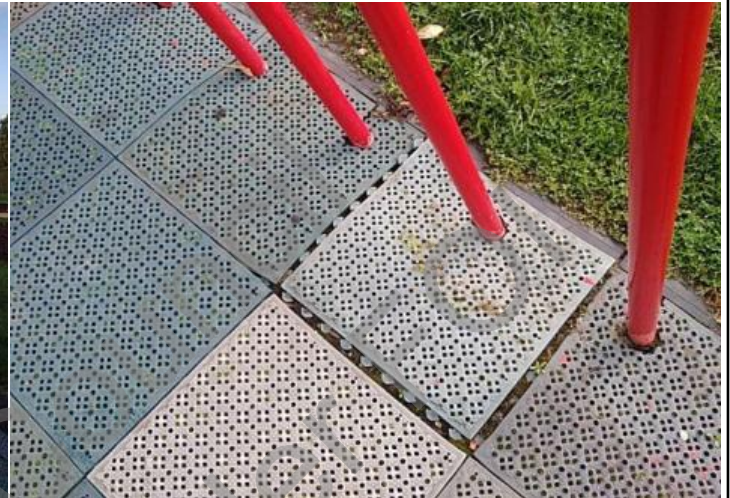
**Risk Level:** L - Low Risk  
**Surface:** Matta

**Finding:** There are gaps opening in between the tiles

**Action:** Monitor for any further deterioration and repair as required

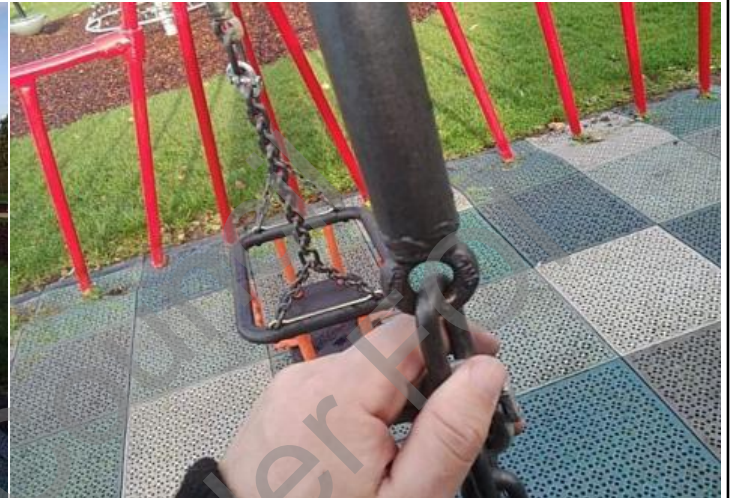
**Risk Level:** L - Low Risk  
**Surface:** Matta

**Finding:** The connecting lugs are showing signs of wear

**Action:** Monitor for any further deterioration and repair as required

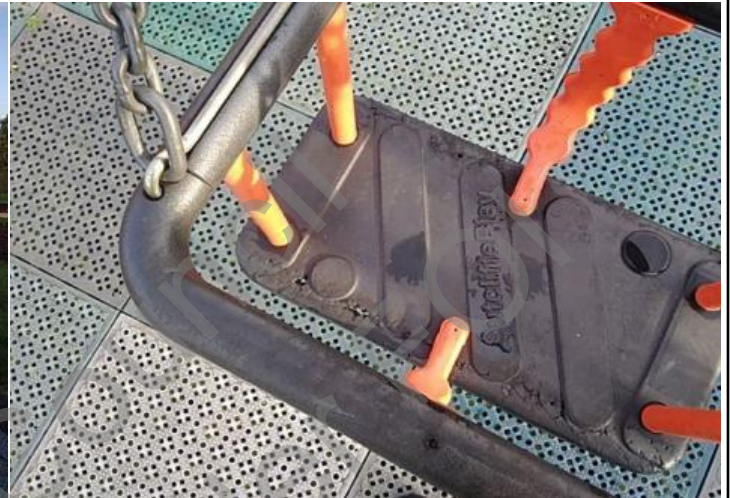
**Risk Level:** L - Low Risk  
**Surface:** Matta

**Finding:** The seat has minor damage or wear

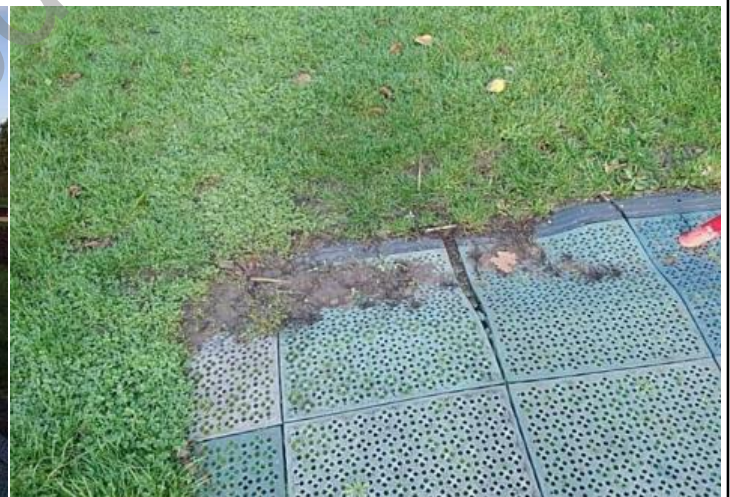
**Risk Level:** L - Low Risk  
**Surface:** Matta

**Finding:** The surface has subsided in some areas

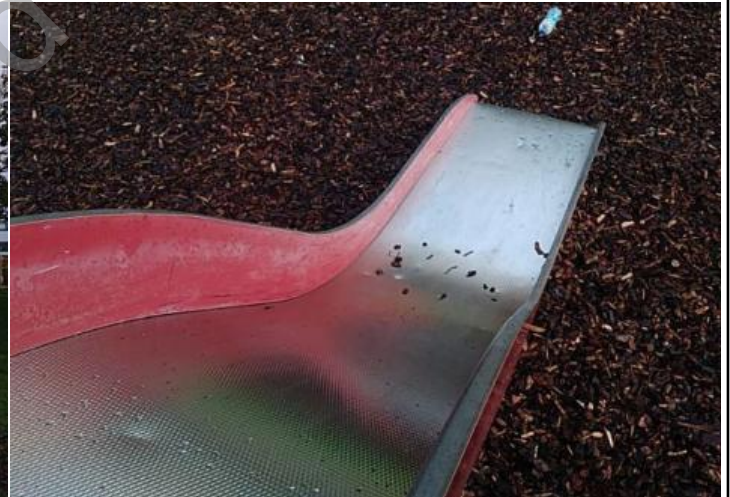
**Risk Level:** V - Very Low Risk  
**Surface:** Woodchip

**Finding:** There are a number of dents in the slide surface

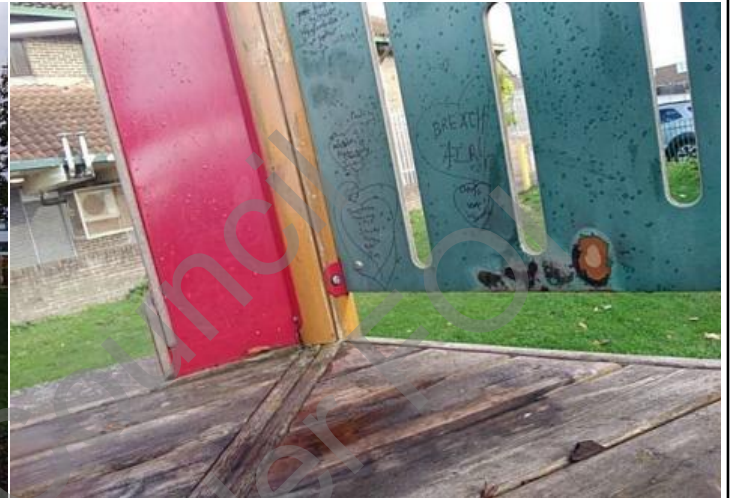
**Risk Level:** L - Low Risk  
**Surface:** Woodchip

**Finding:** There is some evidence of fire damage to the item **Action:** Monitor for any further deterioration and repair as required

**i** 6 - Low Risk (Finding 4)

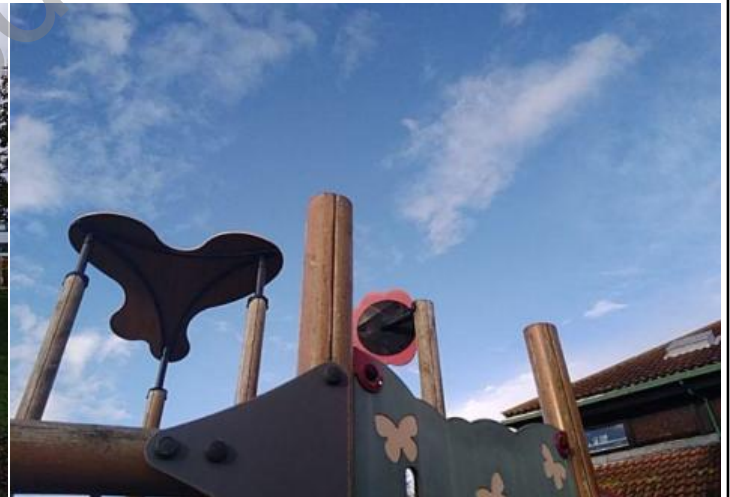
**Risk Level:** L - Low Risk  
**Surface:** Woodchip

**Finding:** There are post / end caps missing from the item **Action:** Replace missing post caps

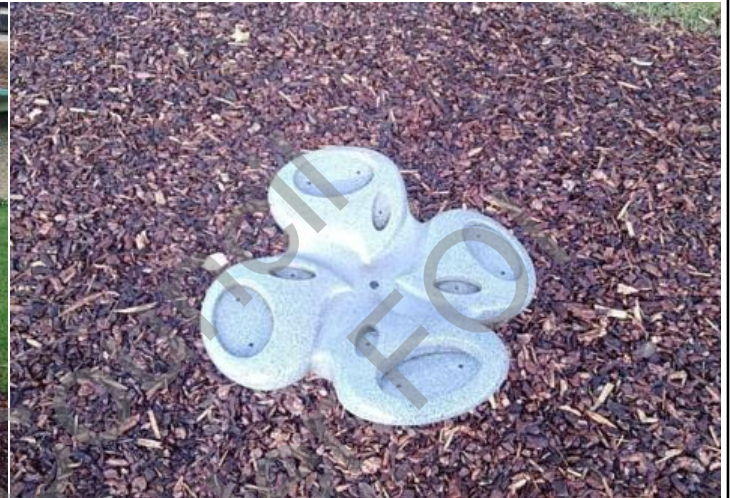
**Risk Level:** L - Low Risk  
**Surface:** Woodchip

**Finding:** The item has missing component(s)

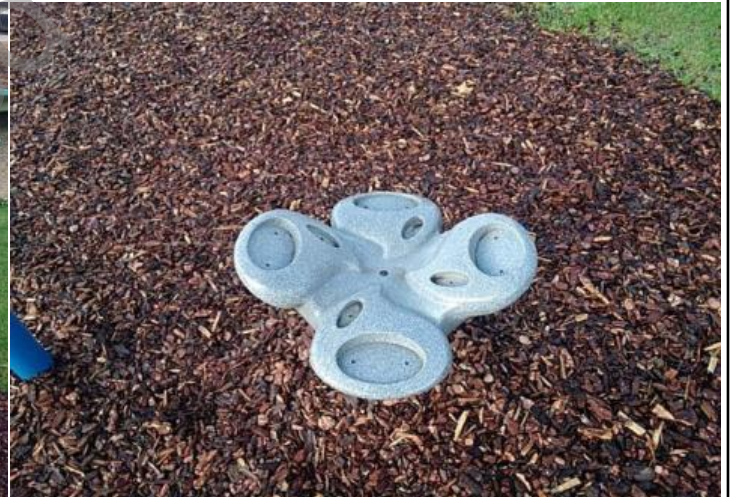
**Risk Level:** L - Low Risk  
**Surface:** Woodchip

**Finding:** The bearing is not operating correctly

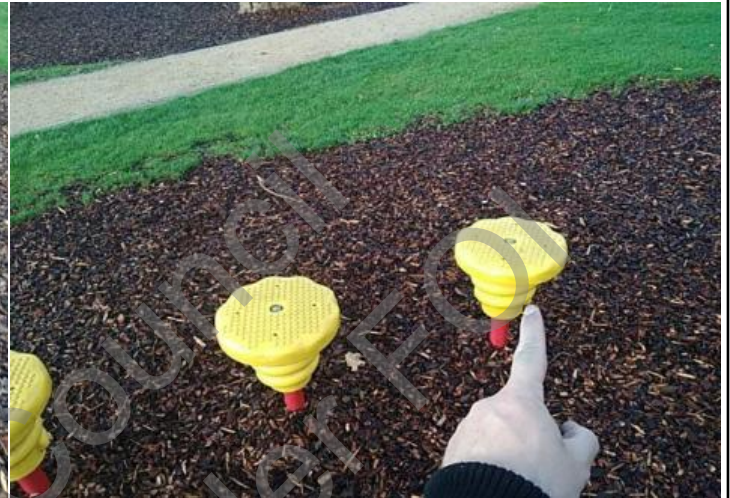
**Risk Level:** L - Low Risk  
**Surface:** Woodchip

**Finding:** The item has been damaged

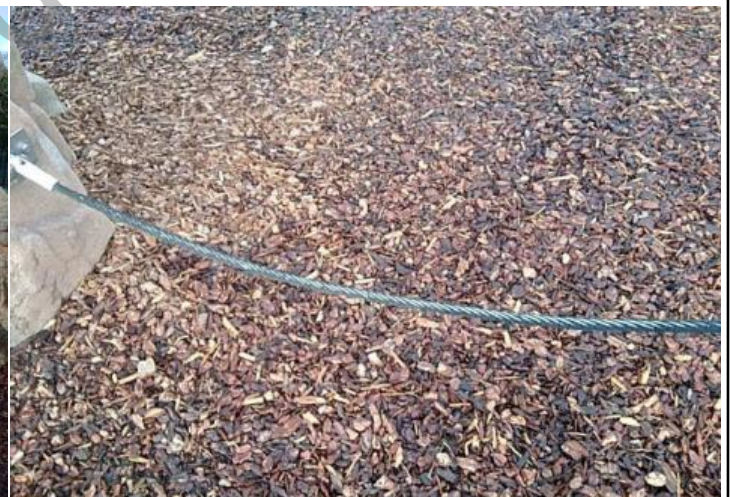
**Risk Level:** L - Low Risk  
**Surface:** Woodchip

**Finding:** The rope has worn and wire strands are exposed

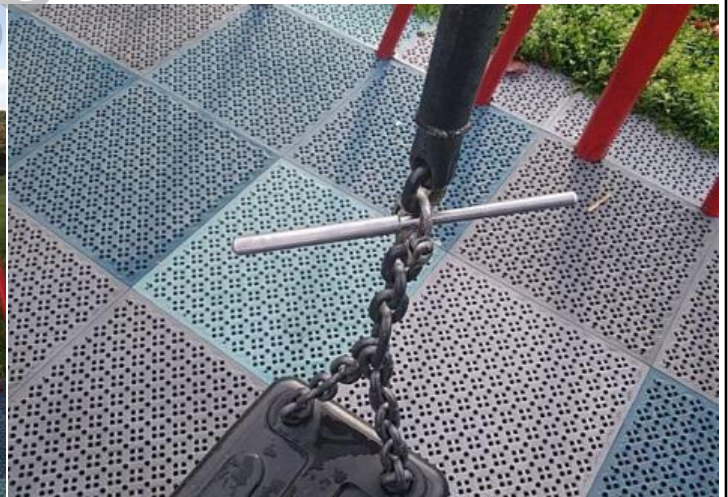
**Risk Level:** V - Very Low Risk  
**Surface:** Wet Pour

**Finding:** The connecting links are in excess of 8.6mm and less than 12mm and fail the requirements of BS EN 1176 Part 1; clause 4.2.13, Chains

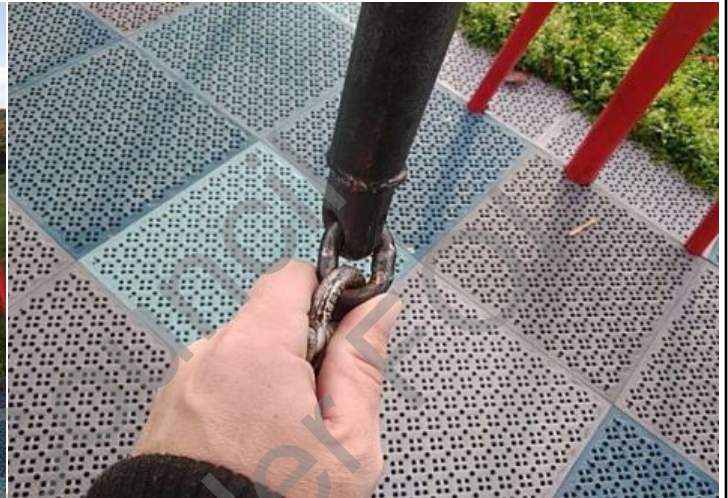
**Risk Level:** L - Low Risk  
**Surface:** Wet Pour

**Finding:** There is some notable evidence of chain wear

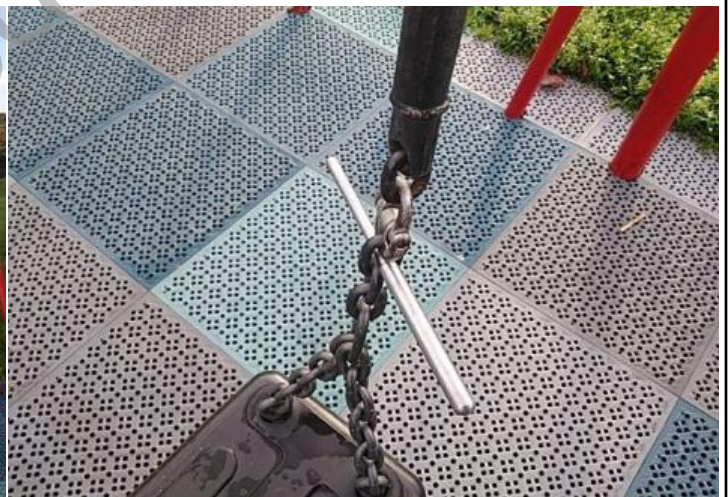
**Risk Level:** V - Very Low Risk  
**Surface:** Wet Pour

**Finding:** The chain openings are in excess of the 8.6mm as recommended by BS EN 1176

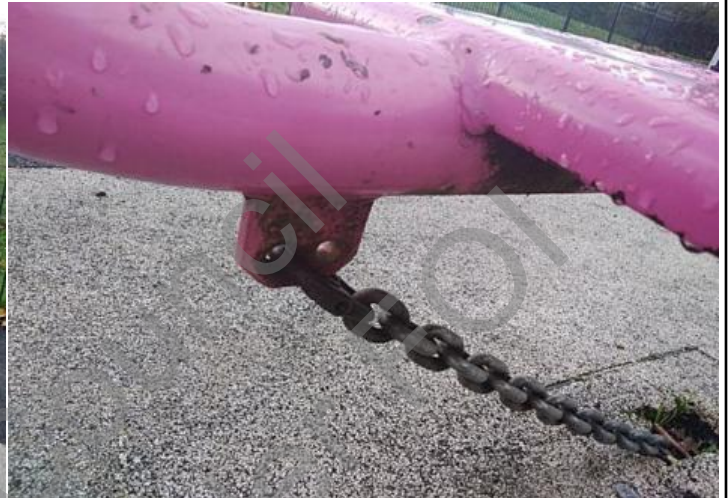
**Risk Level:** L - Low Risk  
**Surface:** Wet Pour

**Finding:** The connecting lugs are showing signs of wear

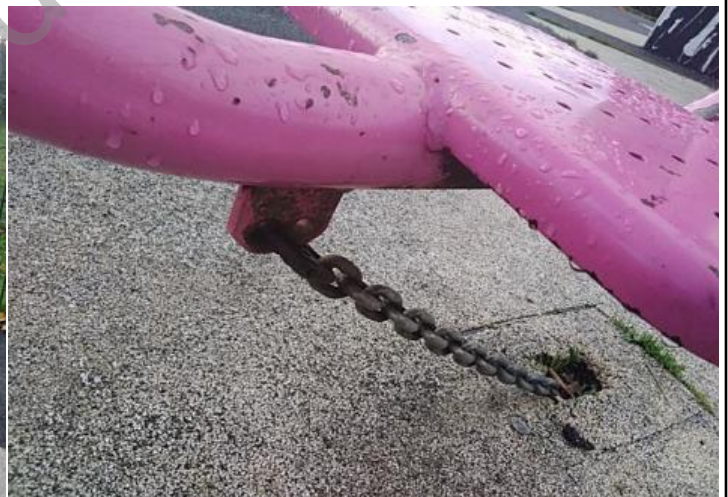
**Risk Level:** L - Low Risk  
**Surface:** Wet Pour

**Finding:** There is some wear to the shackles

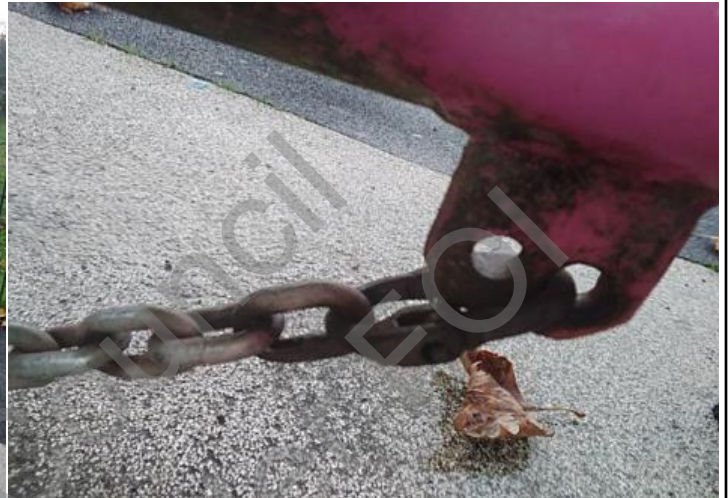
**Risk Level:** L - Low Risk  
**Surface:** Wet Pour

**Finding:** There is some notable evidence of chain wear

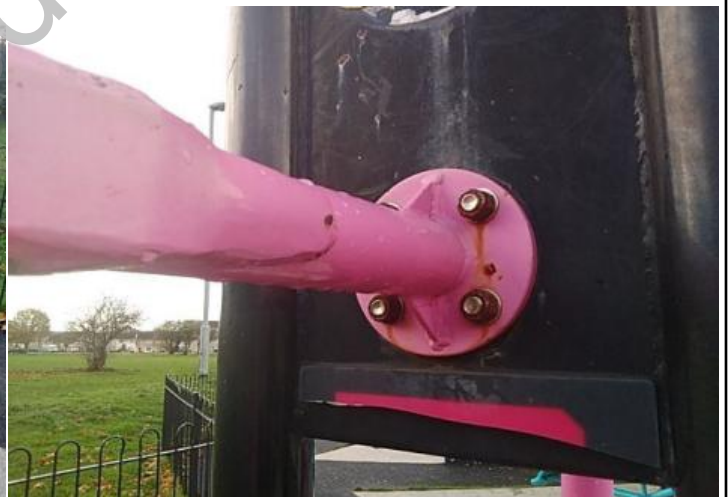
**Risk Level:** V - Very Low Risk  
**Surface:** Wet Pour

**Finding:** There is/are bolt cap covers missing or damaged on the item

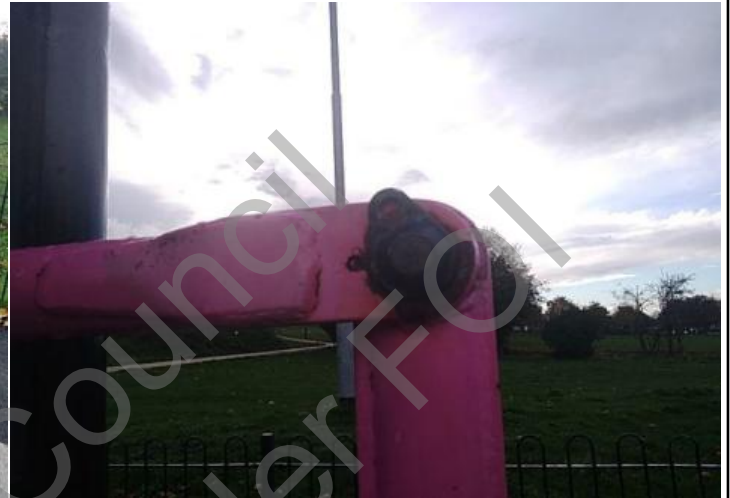
**Risk Level:** L - Low Risk  
**Surface:** Wet Pour

**Finding:** There is or are fixings missing on the item

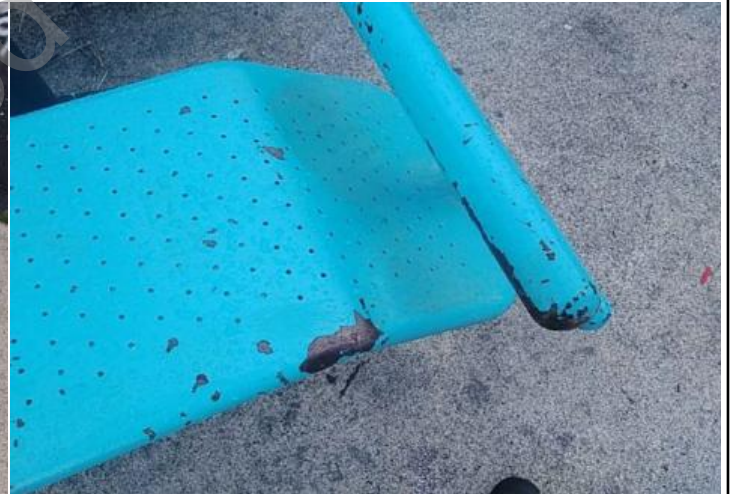
**Risk Level:** L - Low Risk  
**Surface:** Wet Pour

**Finding:** The paintwork on this item has been damaged or worn exposing the metal underneath which is rusting

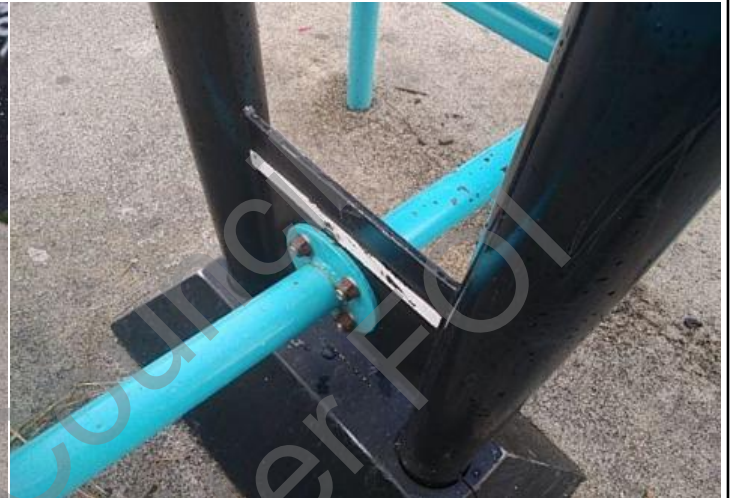
**Risk Level:** V - Very Low Risk  
**Surface:** Wet Pour

**Finding:** There is/are bolt cap covers missing or damaged on the item

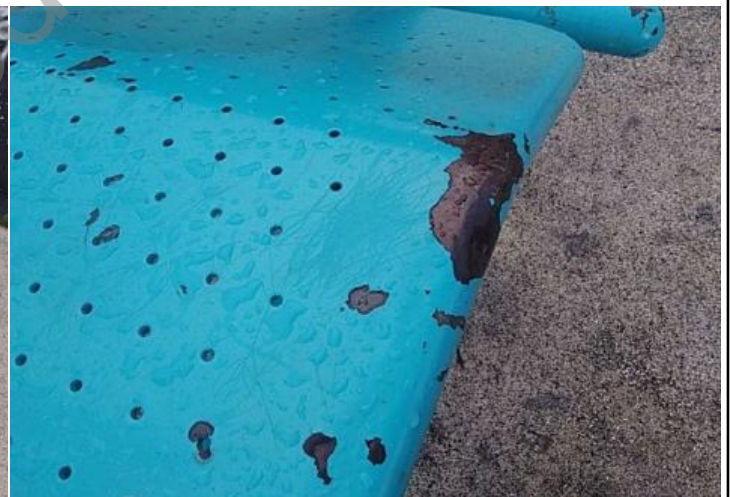
**Risk Level:** L - Low Risk  
**Surface:** Wet Pour

**Finding:** There is minor distortion damage to the bench

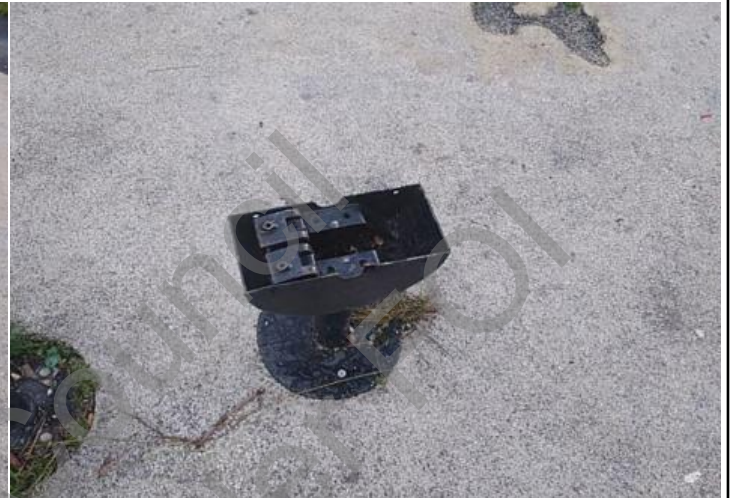
**Risk Level:** L - Low Risk  
**Surface:** Wet Pour

**Finding:** The mechanism has been removed from one item **Action:** Replace the missing components or remove the item completely

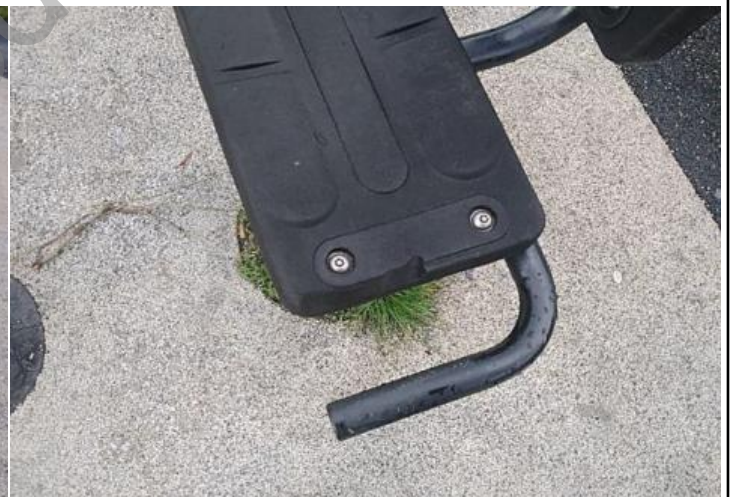
**Risk Level:** L - Low Risk  
**Surface:** Wet Pour

**Finding:** There is minor damage to the seat **Action:** Monitor and replace if required

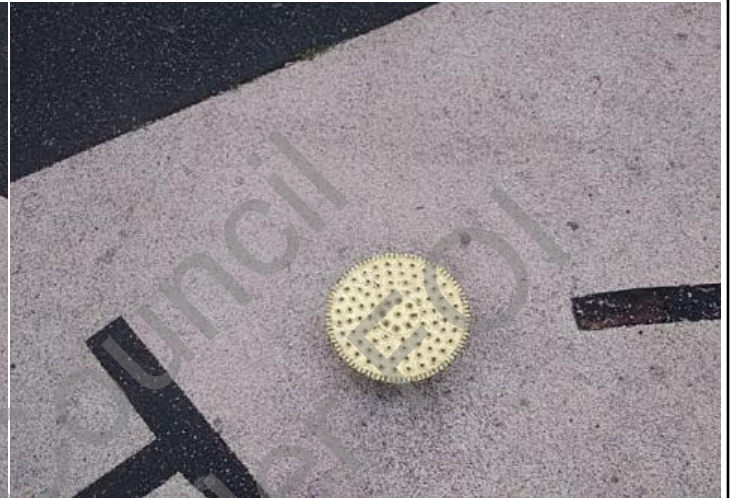
**Risk Level:** L - Low Risk  
**Surface:** Wet Pour

**Finding:** The deflection of the rotating user station exceeds the maximum 105 degrees required by BS EN 16630

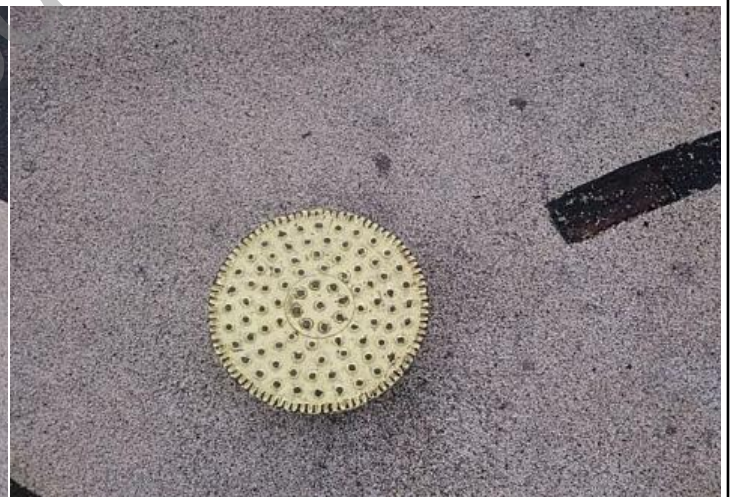
**Risk Level:** L - Low Risk  
**Surface:** Wet Pour

**Finding:** The rotating user station is not appropriately marked with a guideline of user direction and/or the original position as required by BS EN 16630

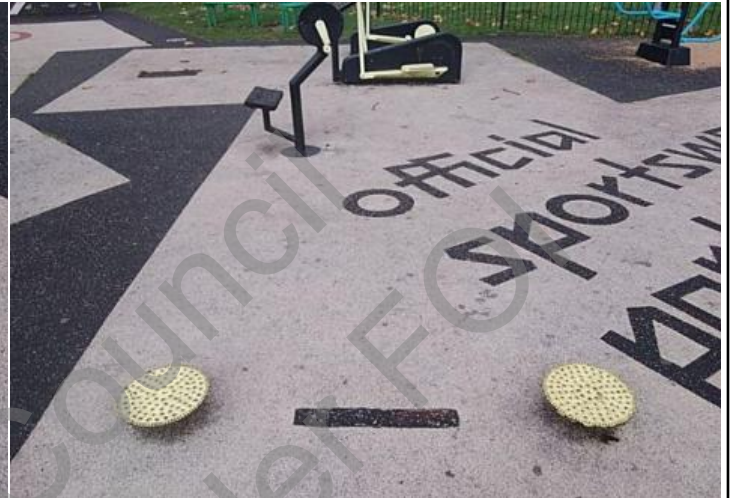
**Risk Level:** L - Low Risk  
**Surface:** Wet Pour

**Finding:** The frame has been removed

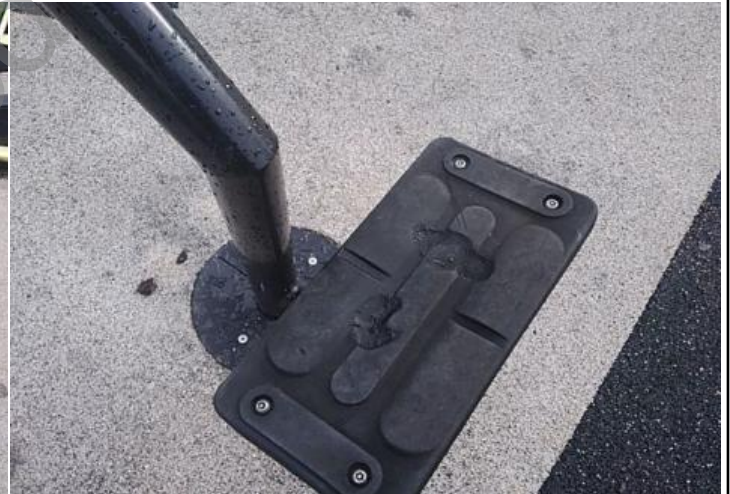
**Risk Level:** L - Low Risk  
**Surface:** Wet Pour

**Finding:** There is some evidence of fire damage to the item

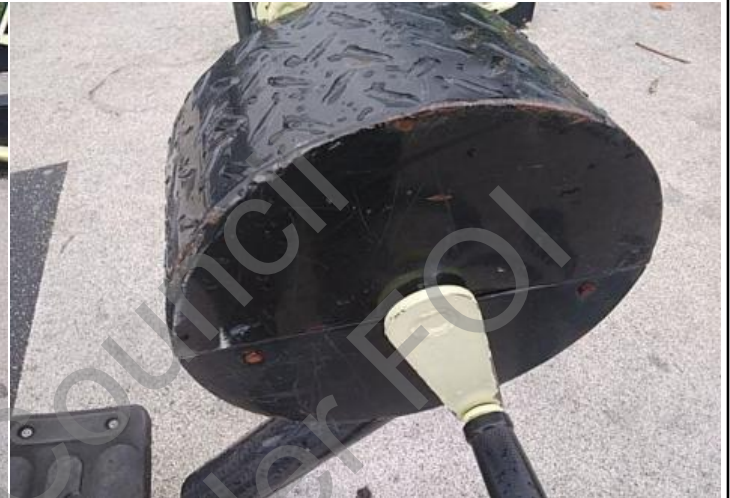
**Risk Level:** L - Low Risk  
**Surface:** Wet Pour

**Finding:** The paintwork on this item has been damaged or worn exposing the metal underneath which is rusting

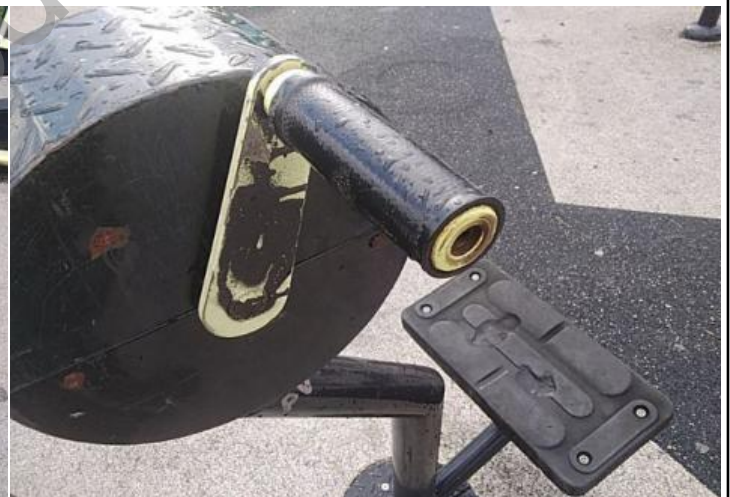
**Risk Level:** L - Low Risk  
**Surface:** Wet Pour

**Finding:** One or more handgrip(s) are damaged or missing.

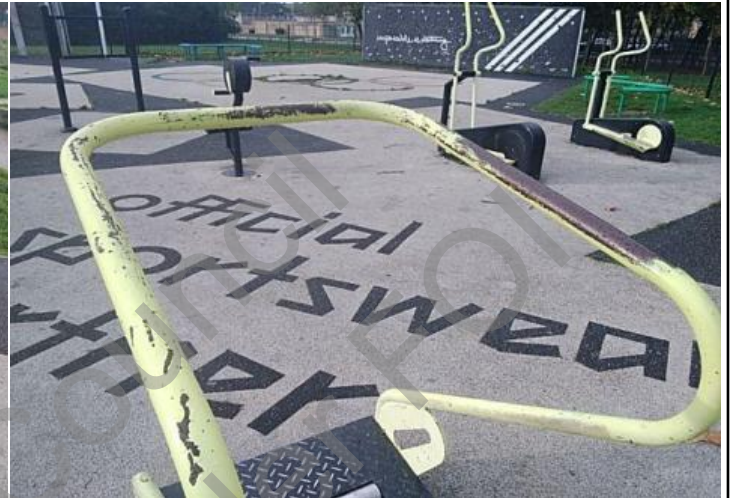
**Risk Level:** L - Low Risk  
**Surface:** Wet Pour

**Finding:** The paintwork on this item has been damaged or worn exposing the metal underneath which is rusting
