## Annual Inspection

Thurrock Council

Corringham Town Park

Springhouse Road, Corringham, Essex, SS17 7NB

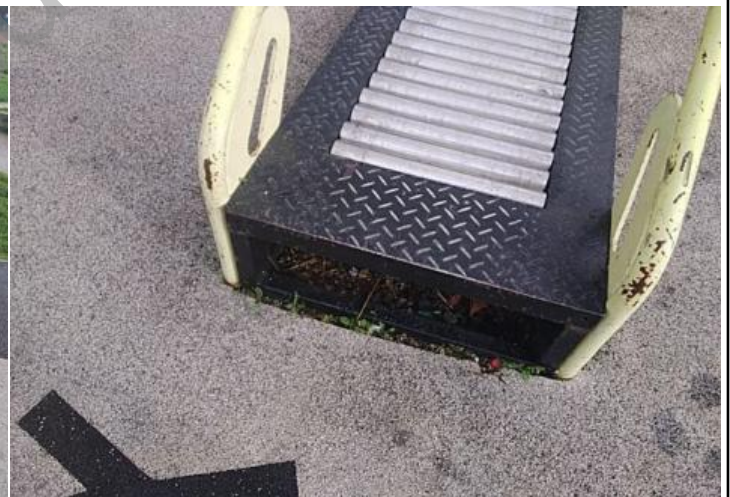
**Risk Level:** L - Low Risk  
**Surface:** Wet Pour

**Finding:** The inspection plate has been removed

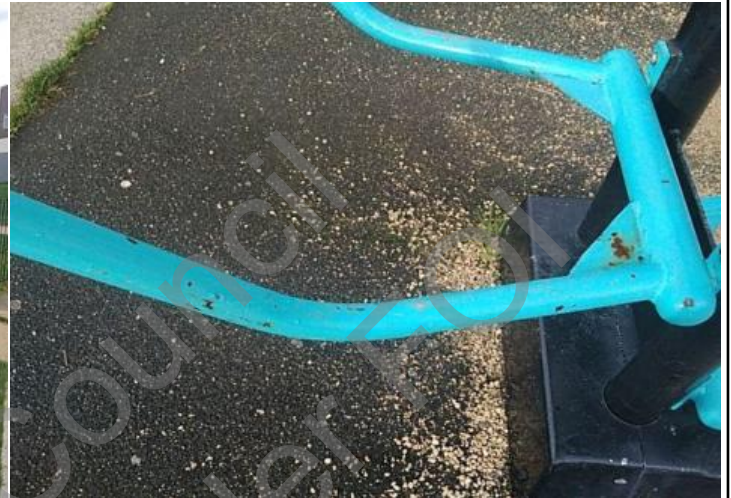
**Risk Level:** L - Low Risk  
**Surface:** Wet Pour

**Finding:** The paintwork on this item has been damaged or worn exposing the metal underneath which is rusting

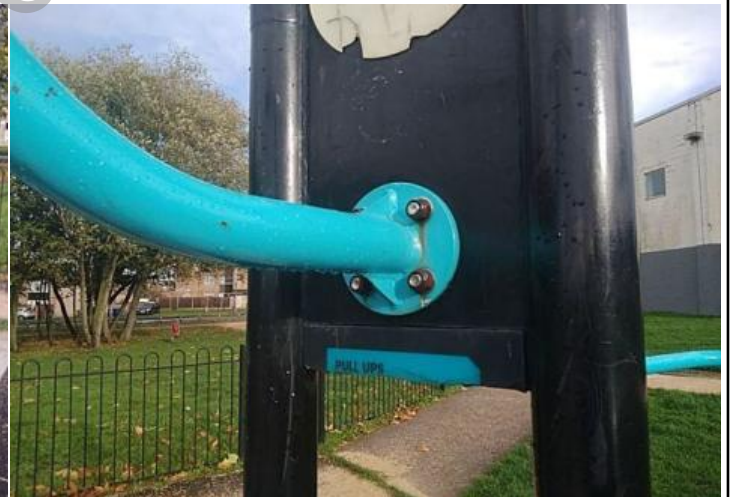
**Risk Level:** V - Very Low Risk  
**Surface:** Wet Pour

**Finding:** There is/are bolt cap covers missing or damaged on the item

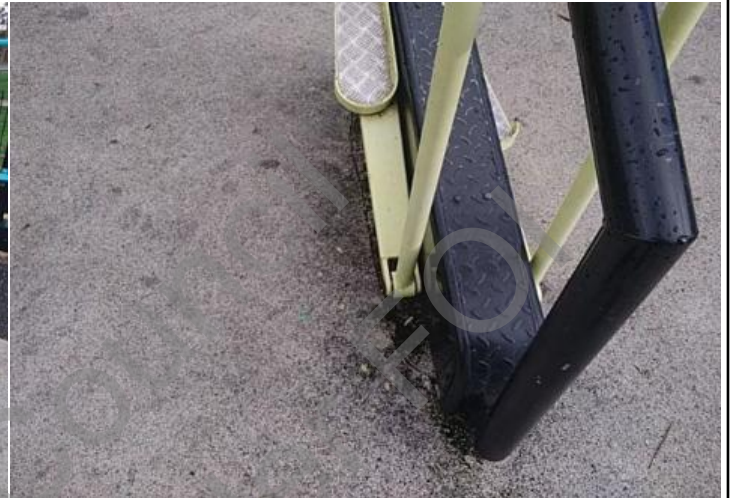
**Item:** Outdoor Fitness Equipment - Cross Trainer **Risk Level:** L - Low Risk  
**Manufacturer:** The Great Outdoor Gym Company **Surface:** Wet Pour

**Finding:** The bushes are worn or missing

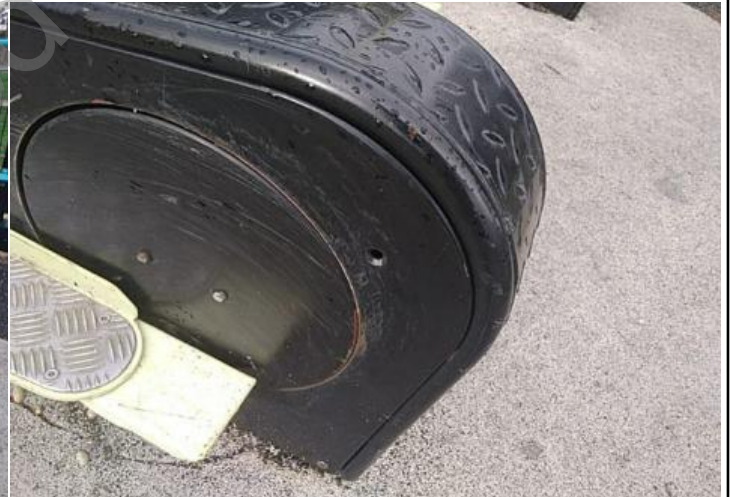
**Item:** Outdoor Fitness Equipment - Cross Trainer **Risk Level:** L - Low Risk  
**Manufacturer:** The Great Outdoor Gym Company **Surface:** Wet Pour

**Finding:** There is or are fixings missing on the item

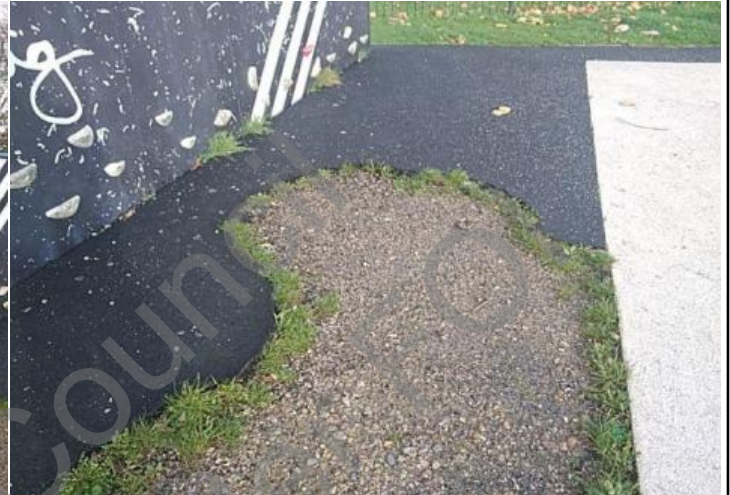
**Risk Level:** M - Moderate Risk  
**Surface:** Wet Pour

**Finding:** The surfacing is severely damaged

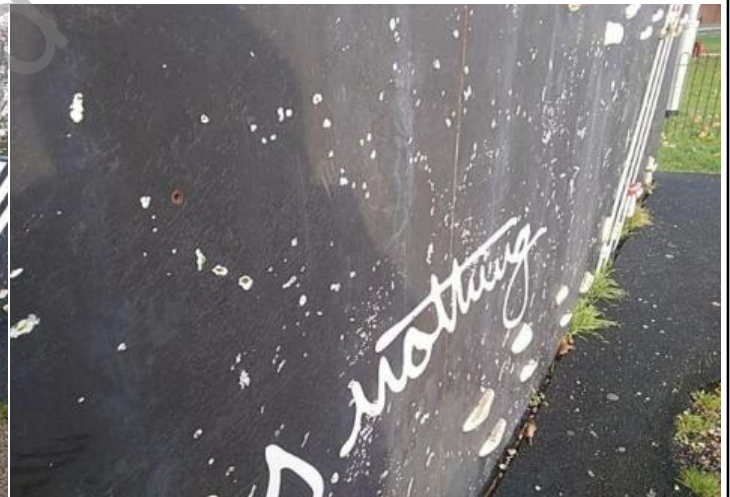
**Risk Level:** L - Low Risk  
**Surface:** Wet Pour

**Finding:** The item has been damaged

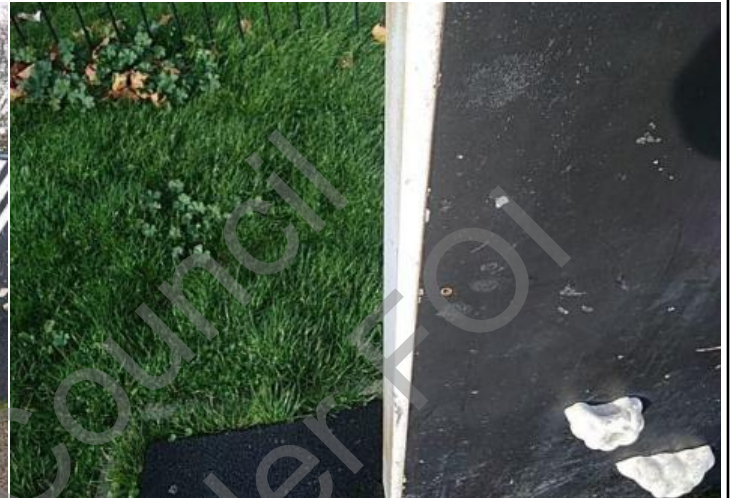
**Risk Level:** L - Low Risk  
**Surface:** Wet Pour

**Finding:** There is or are fixings missing on the item

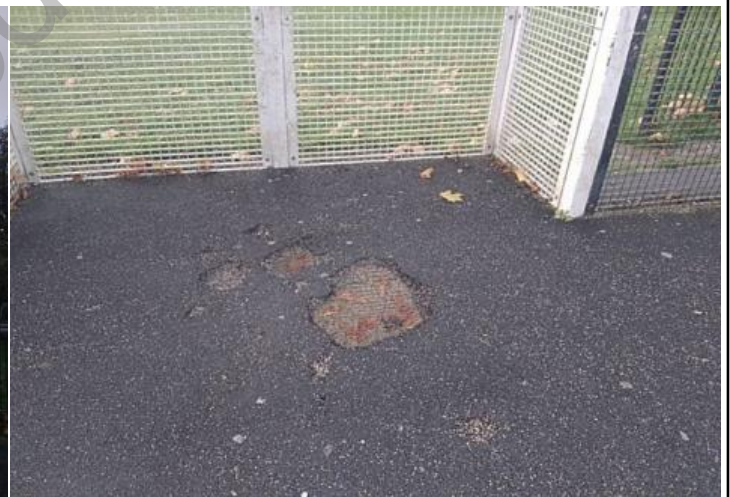
**Risk Level:** L - Low Risk  
**Surface:** Wet Pour

**Finding:** There is moderate damage to the surface

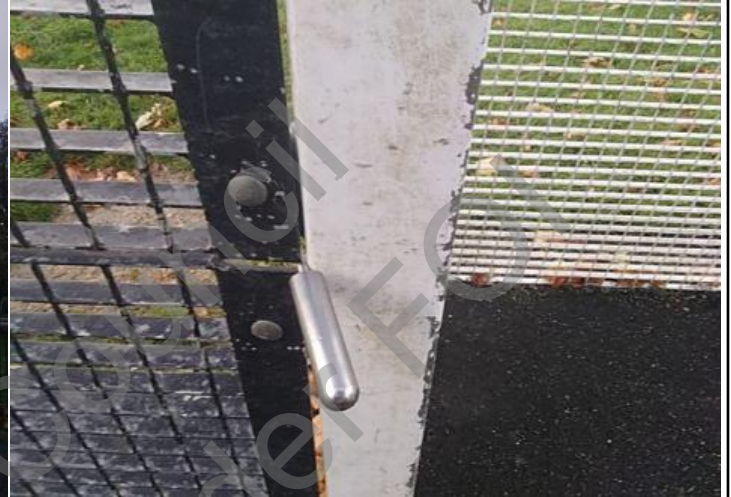
**Risk Level:** V - Very Low Risk  
**Surface:** Wet Pour

**Finding:** There is/are finger entrapments in the framework and the item fails to meet the requirements of BS EN 15312 Clause 4.4.2.2 Entrapment of fingers

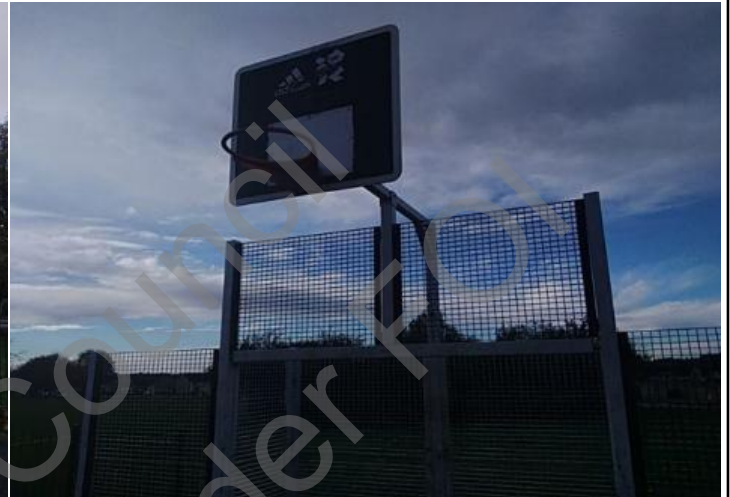
**Risk Level:** V - Very Low Risk  
**Surface:** Wet Pour

**Finding:** A clearly visible facility sign should be provided in a prominent position with the wording as detailed BS EN 15312- the equipment is not intended for children less than 3 years old- the warning - Do not climb on the framework or nets- the warning - Do not hang on the ring (if provided)- the warning - Do not wear rings or other jewellery- name and telephone number of the administrator- number to call in case of accident

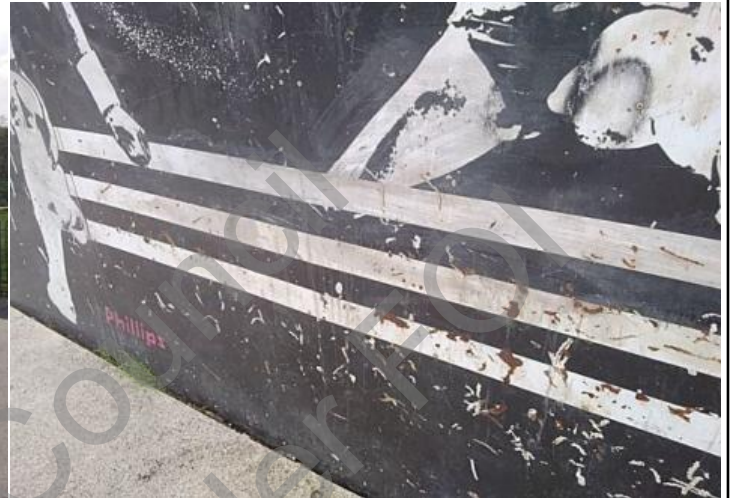
**Risk Level:** L - Low Risk  
**Surface:** Wet Pour

**Finding:** The paintwork on this item has been damaged or worn exposing the metal underneath which is rusting

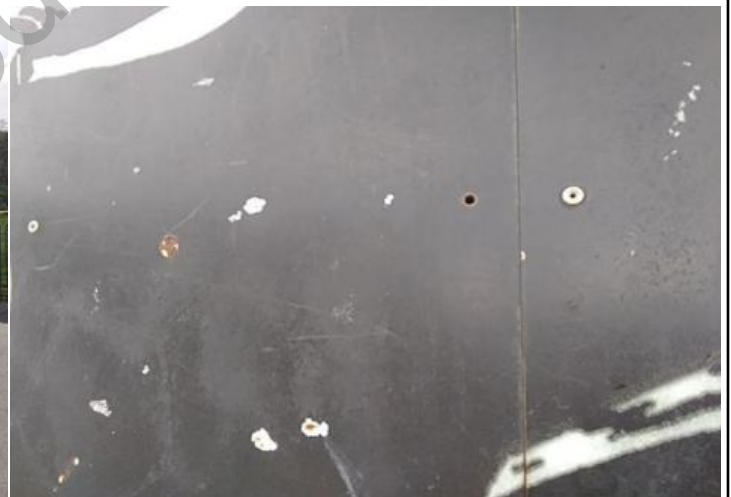
**Risk Level:** L - Low Risk  
**Surface:** Wet Pour

**Finding:** There is or are fixings missing on the item

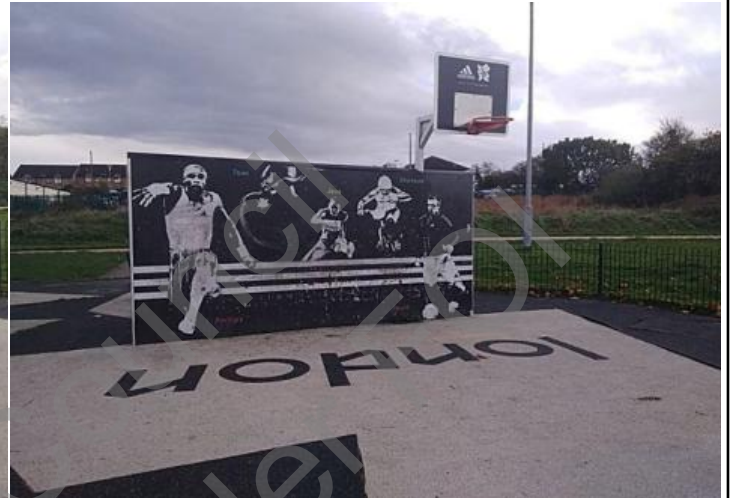
**Risk Level:** V - Very Low Risk  
**Surface:** Wet Pour

**Finding:** A clearly visible facility sign should be provided in a prominent position with the wording as detailed BS EN 15312- the equipment is not intended for children less than 3 years old- the warning - Do not climb on the framework or nets- the warning - Do not hang on the ring (if provided)- the warning - Do not wear rings or other jewellery- name and telephone number of the administrator- number to call in case of accident
