Annual Inspection

Thurrock Council

Corringham Town Park

Springhouse Road, Corringham, Essex, SS17 7NB

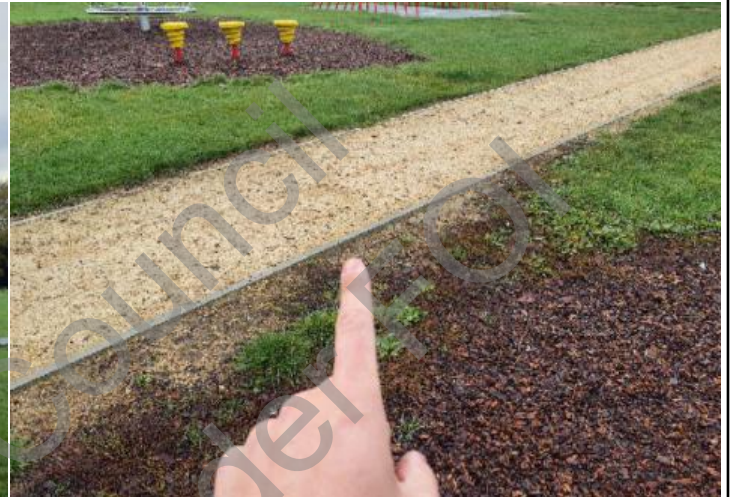
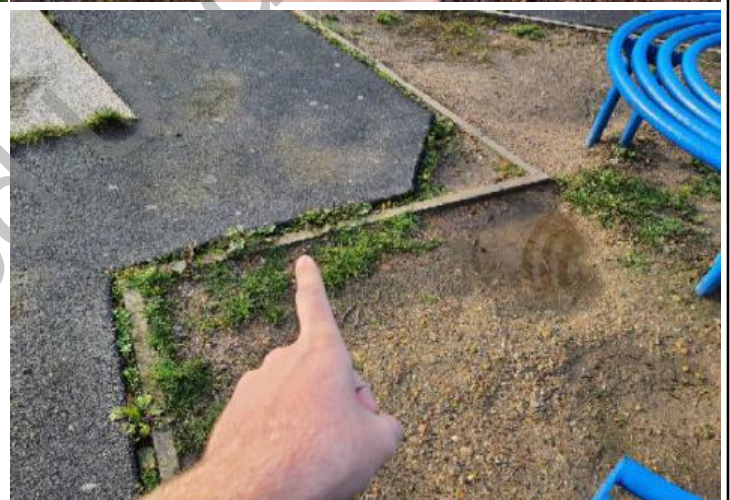
Finding: There are trip hazards at the edges of the surface

Action: Reinstate surrounding surface levels to remove the trip points

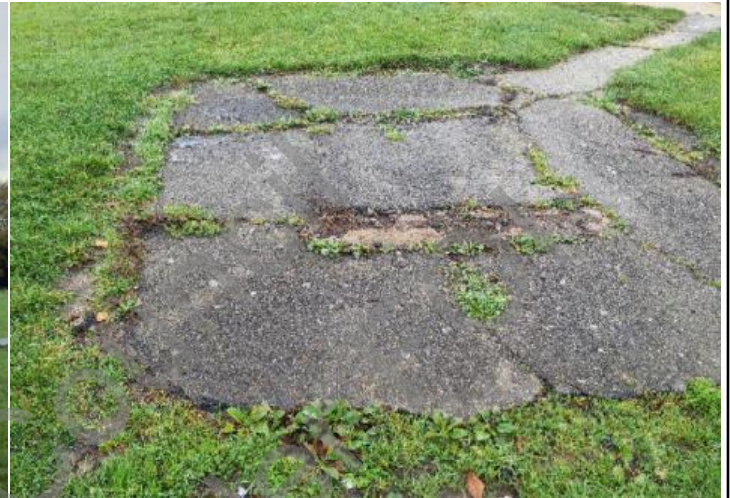
Finding: There is moderate damage to the surface

Action: Repair the damaged areas of surfacing

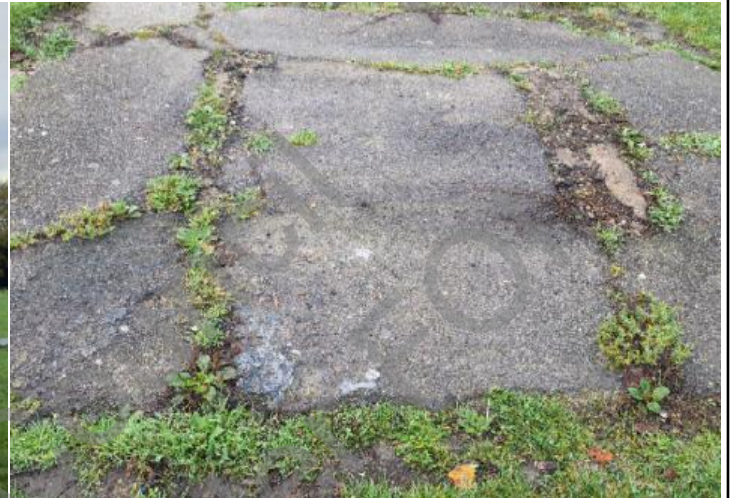
Finding: There is broken glass present on site

Action: Remove the broken glass and maintain the area

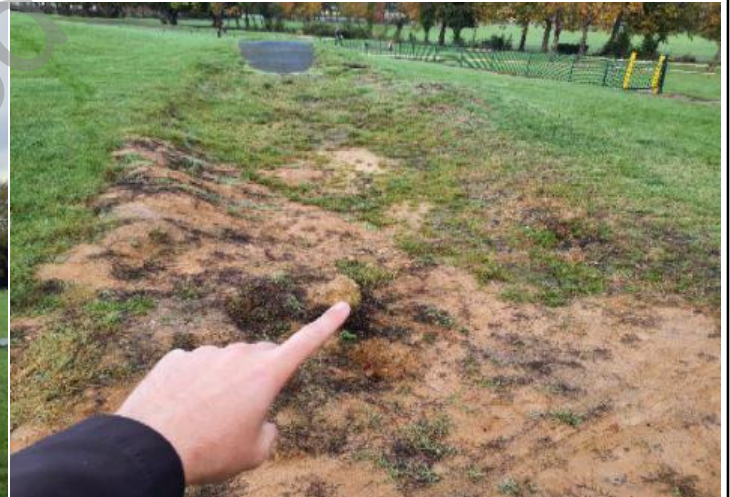
Finding: There are redundant bases in the area due to the removal of equipment and there are foundations that are exposed causing trips

Action: Consider removing bases and reinstating the surface to cover the exposed foundations

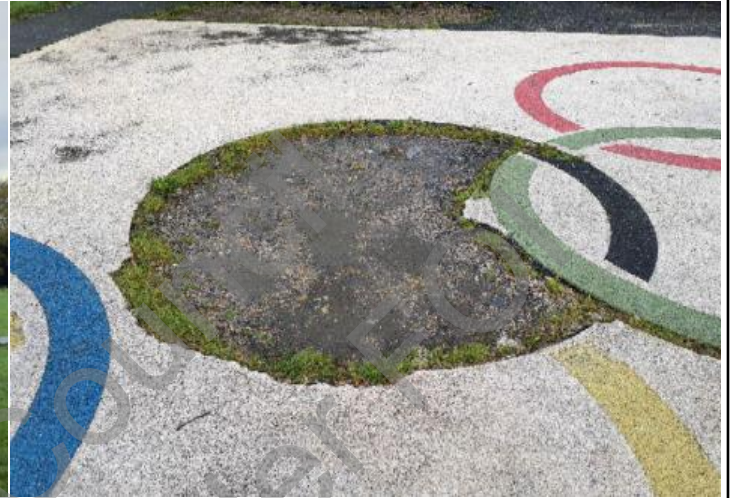
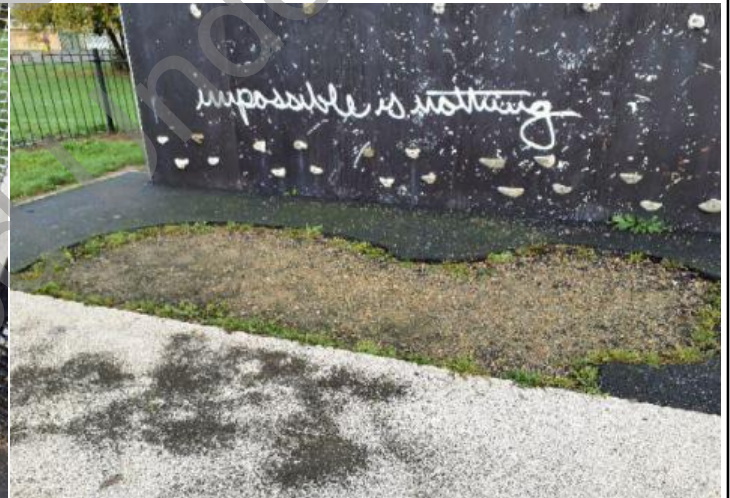
Finding: There is moderate damage to the surface

Action: Repair the damaged areas of surfacing

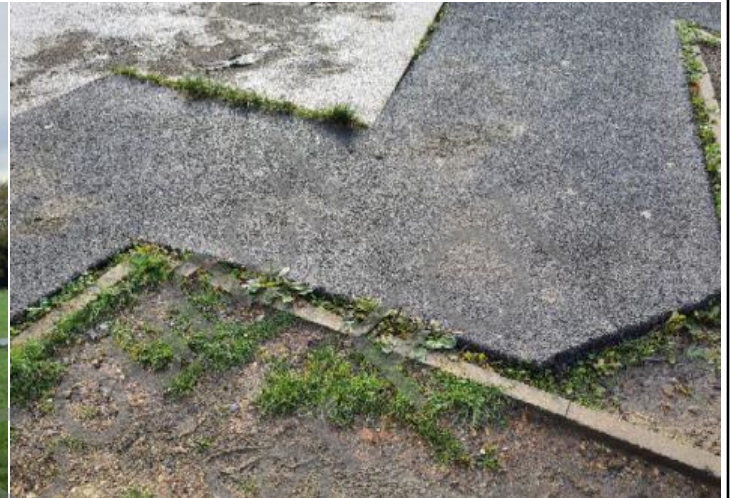
Finding: The surface is lifting at the edges and creating trip points
Action: Repair perimeter of surfacing to remove trip points

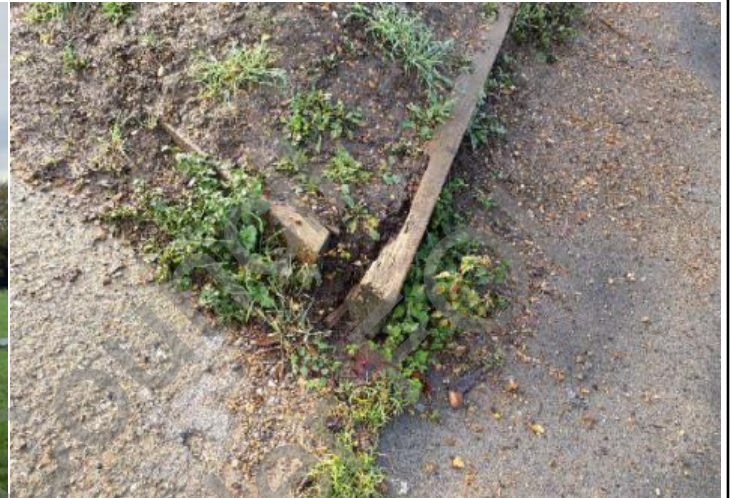
Finding: There are areas or parts of the timber edgings that have rotted or are missing
Action: Replace all affected timbers

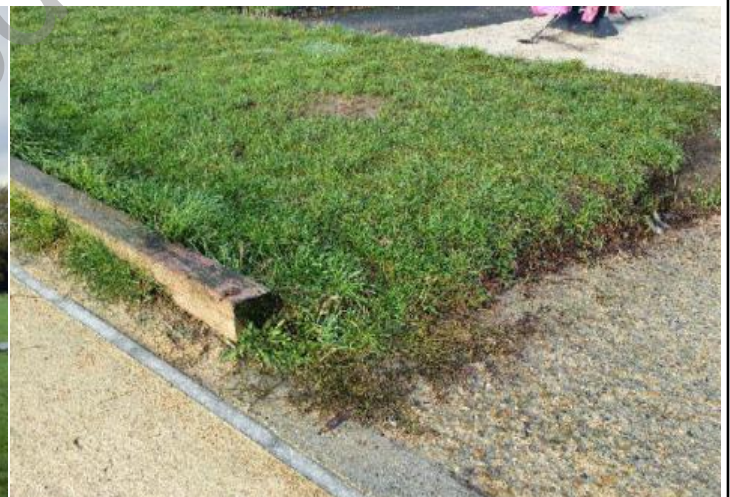
Finding: There are sleepers missing from the timber retaining wall
Action: Replace the missing sleepers

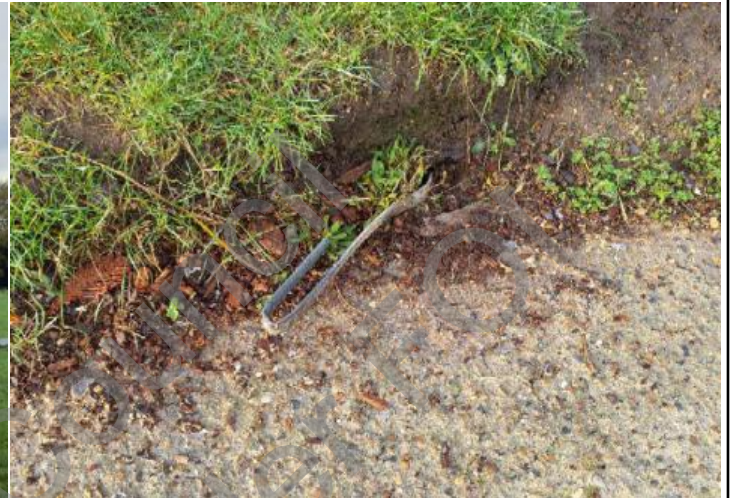
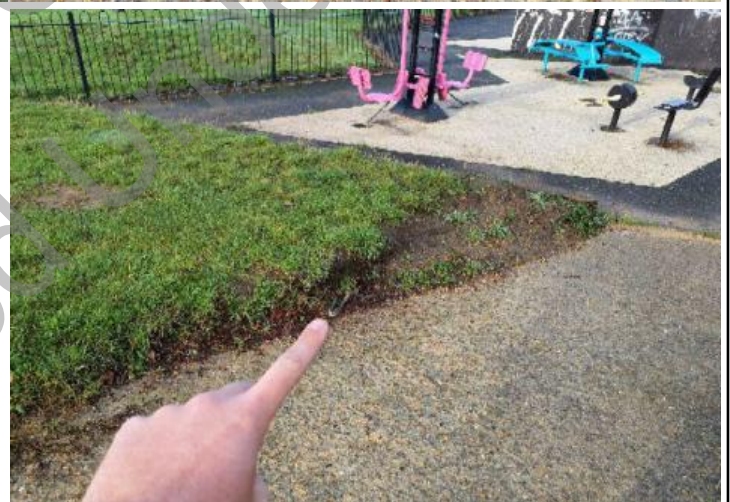
Finding: There is an exposed metal foundation present by the walkway

Action: Remove

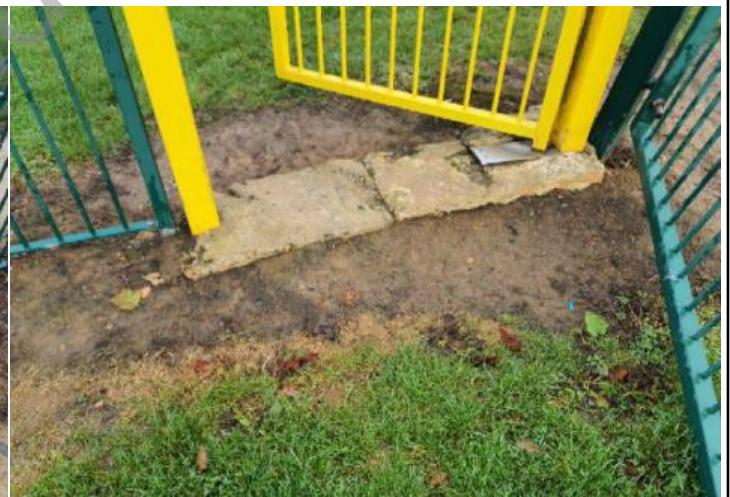
Finding: The surface has eroded in some areas and may be slippery in wet conditions

Action: Reinstate the surface

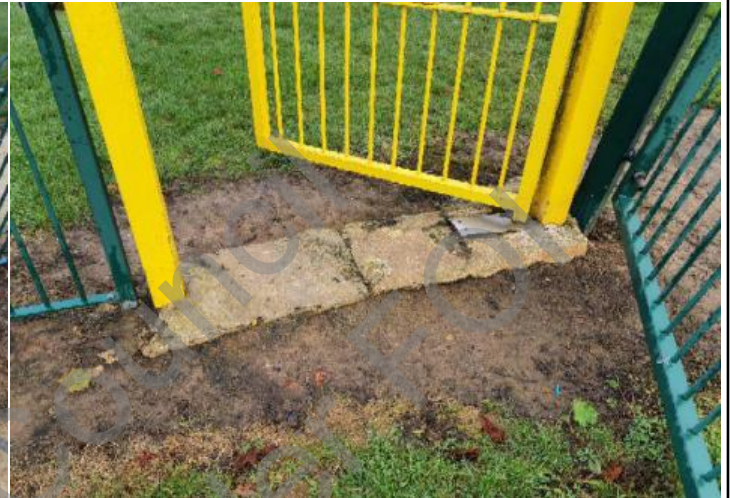
Finding: The area under the gate has eroded leaving uneven areas, or the concrete foundations exposed, resulting in trip hazards at the entrance/exit to the playground

Action: Reinststate to level with surrounding surfaces

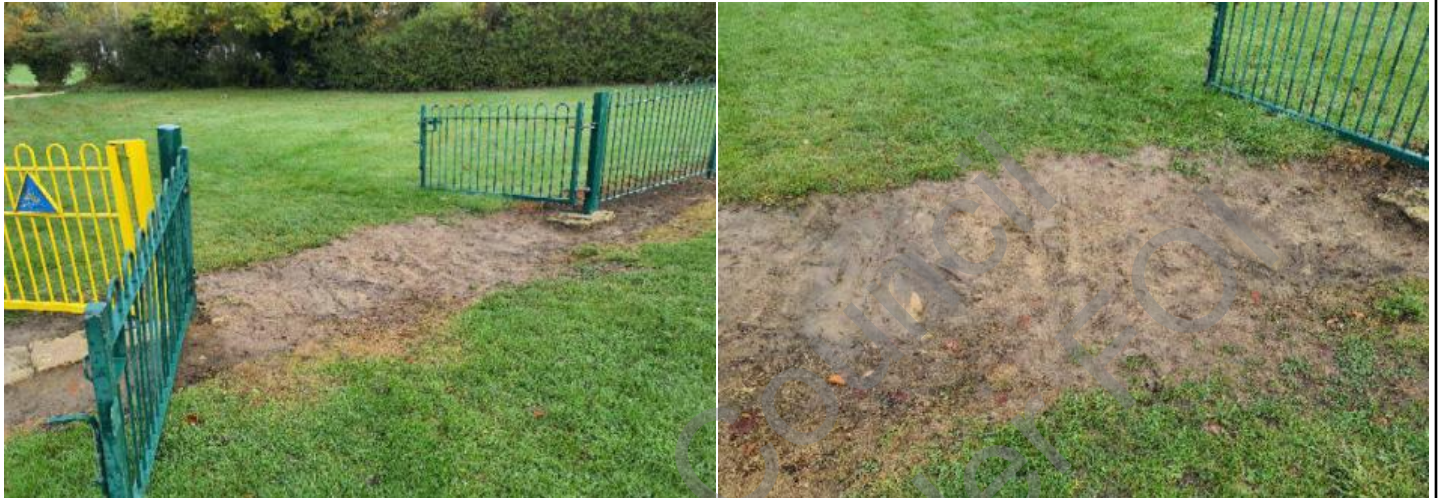
Finding: The surface has eroded in some areas and may be slippery in wet conditions
Action: Reinststate the surface

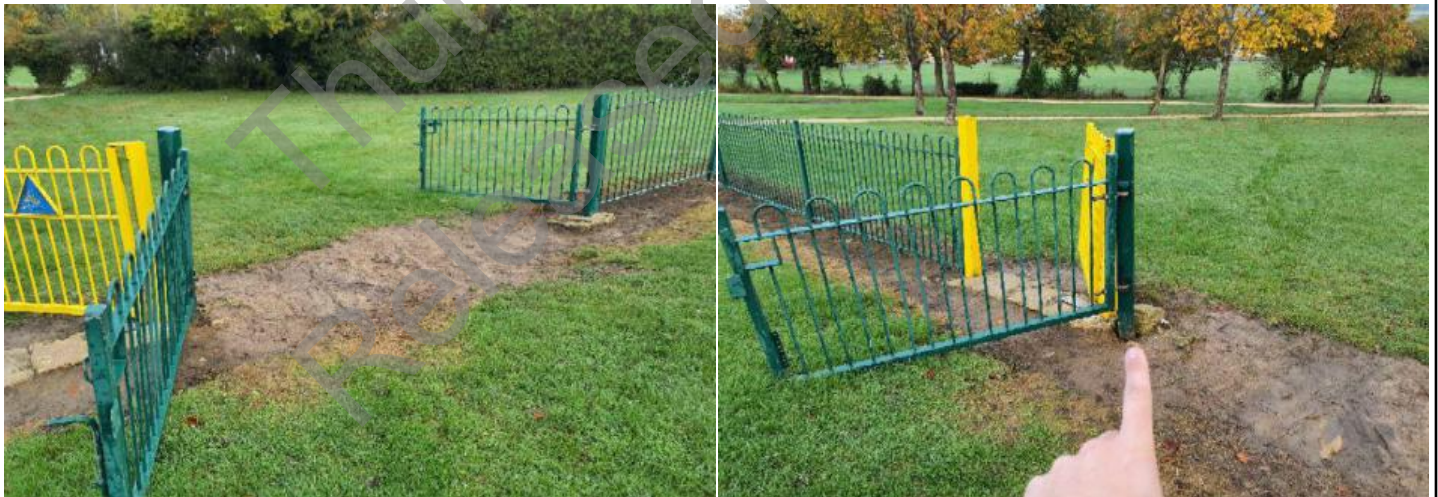
Finding: The item is loose in its foundations
Action: Reinstall item to secure

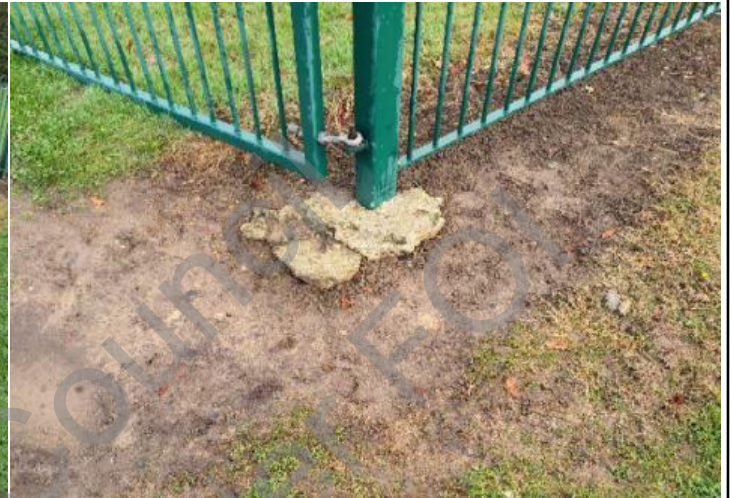
Finding: The surface has eroded and the foundations are exposed

Action: Reinstate surrounding surfaces to cover the foundations

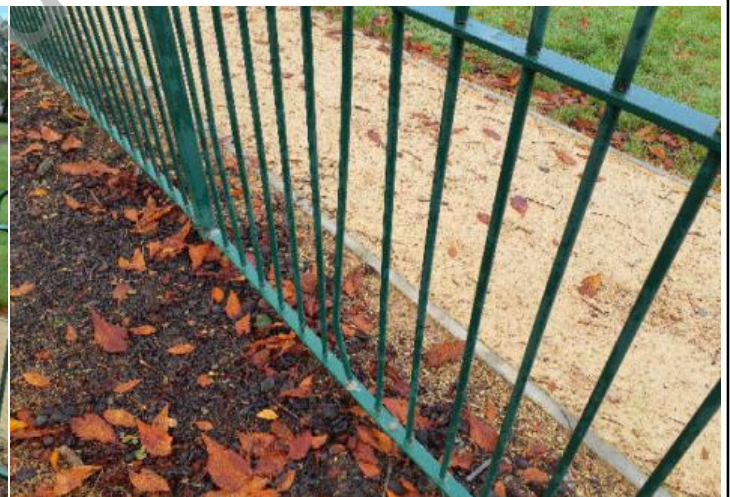
Finding: There is some damage to the fence sections

Action: Monitor for any further deterioration and repair as required

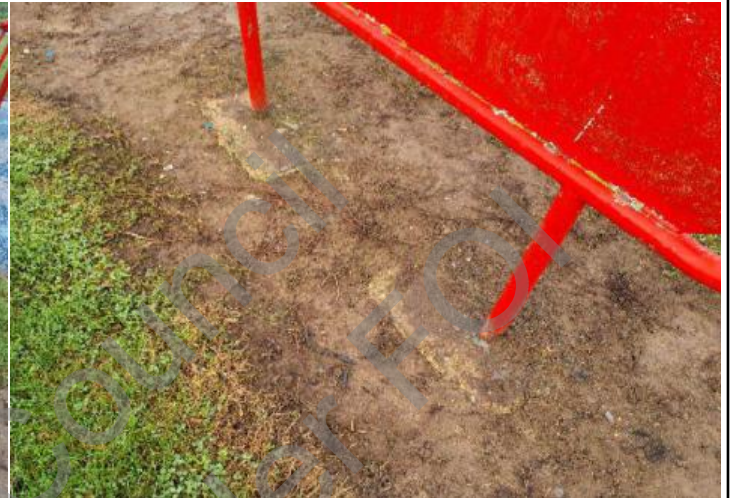
Finding: The surface has eroded and the foundations are exposed

Action: Reinststate surrounding surfaces to cover the foundations

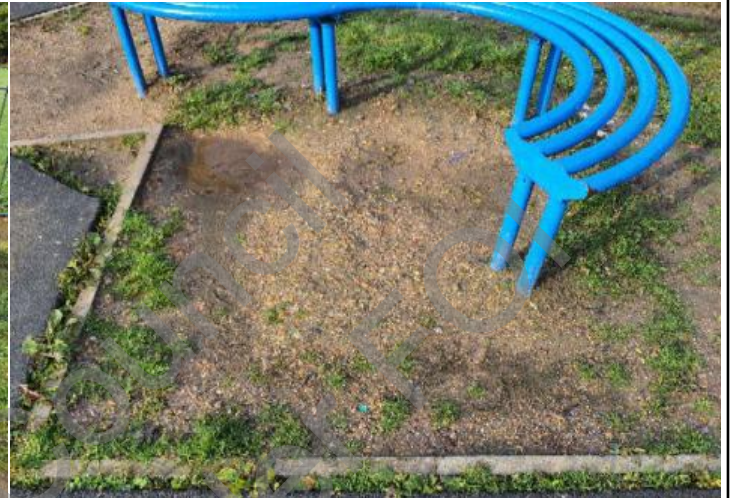
Finding: The surface has eroded in some areas and may be slippery in wet conditions
Action: Reinstate the surface

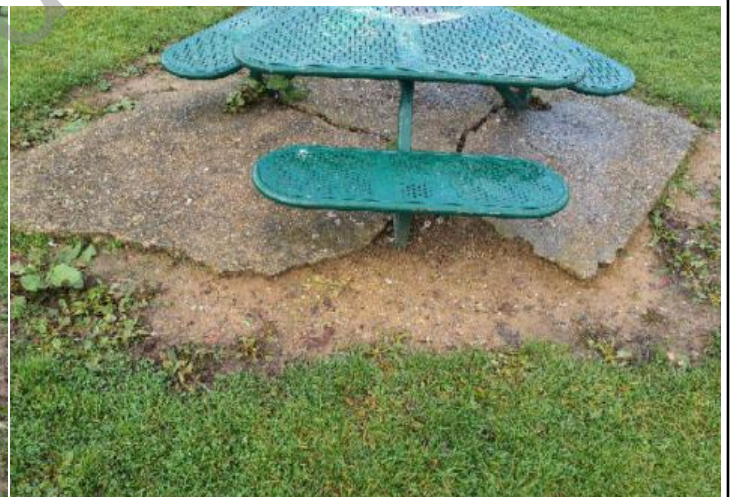
Finding: The surfacing is severely damaged
Action: Repair damaged areas of surfacing

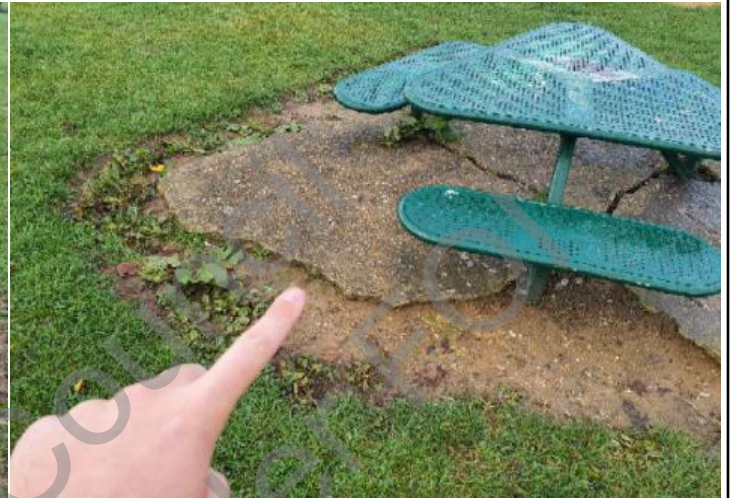
Finding: There are trip hazards at the edges of the surface

Action: Reinstate surrounding surface levels to remove the trip points

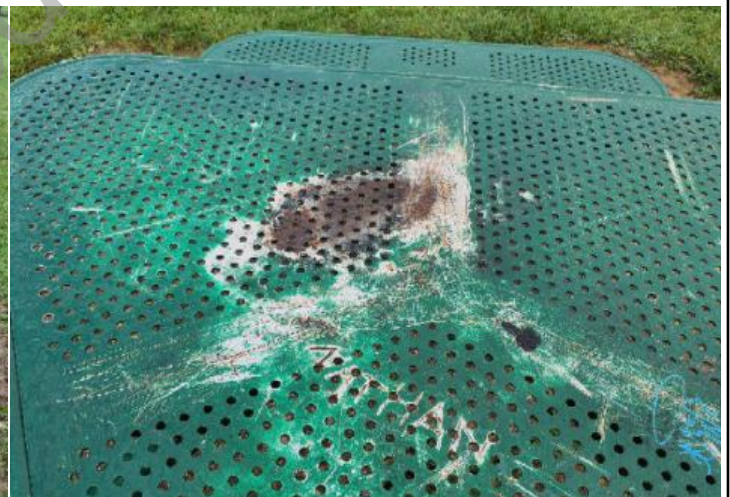
Finding: There is some evidence of fire damage to the item

Action: Monitor for any further deterioration and repair as required

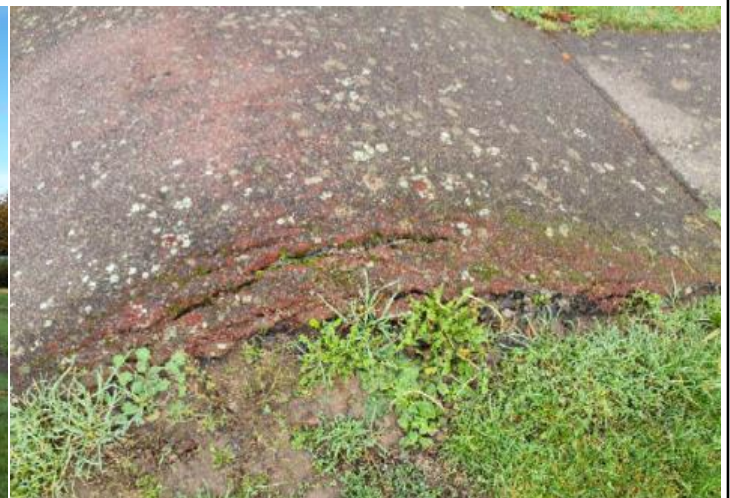
Finding: There are minor stress fractures in the tarmac surface

Action: Monitor and repair if required

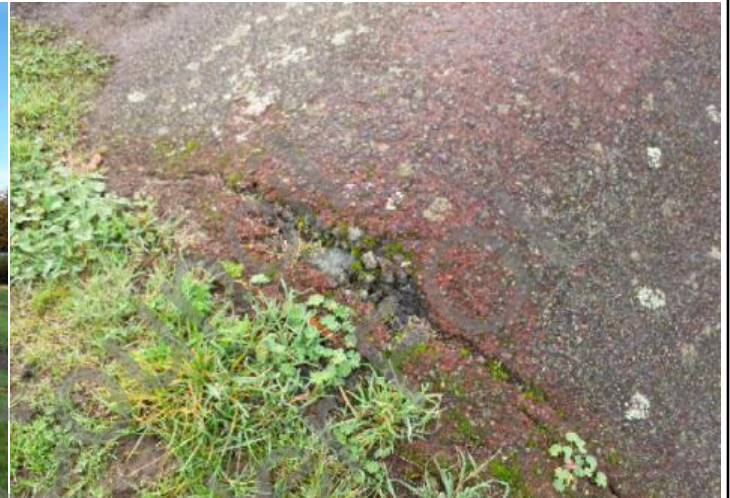
Finding: The riding surface of the ramp has some damage apparent

Action: Monitor for any further deterioration and repair as required

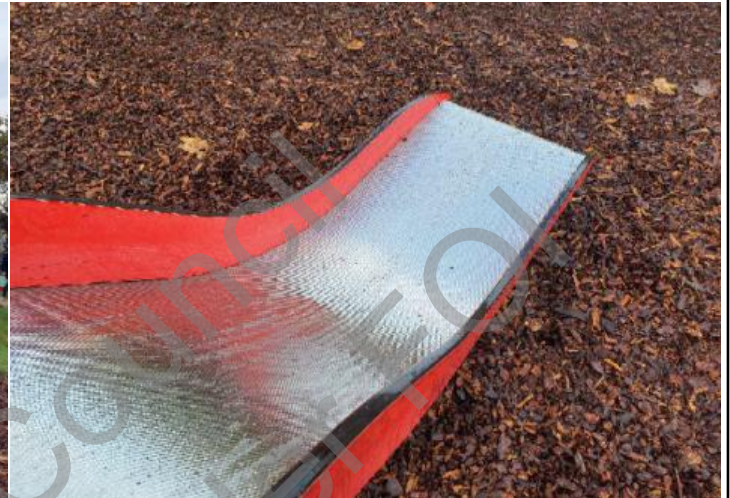
Finding: There are a number of dents in the slide surface

Action: Monitor for any further deterioration and repair as required

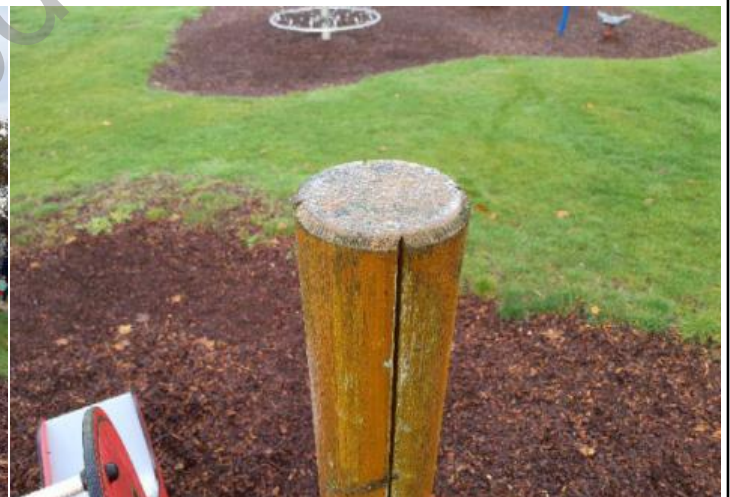
Finding: There are post / end caps missing from the item

Action: Replace missing post caps

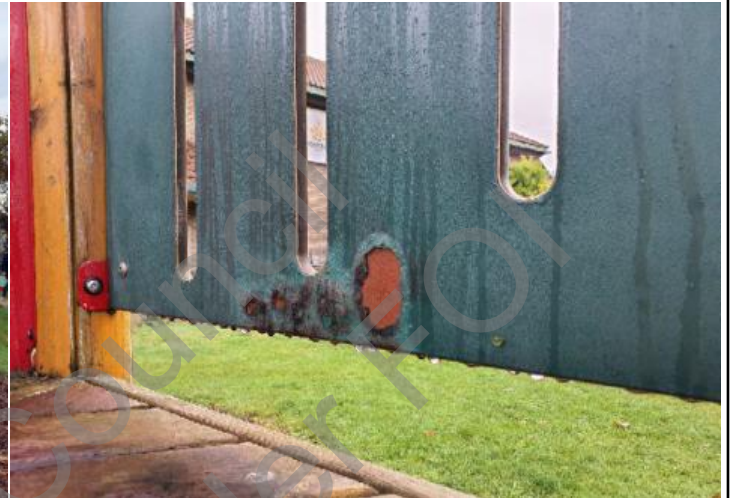
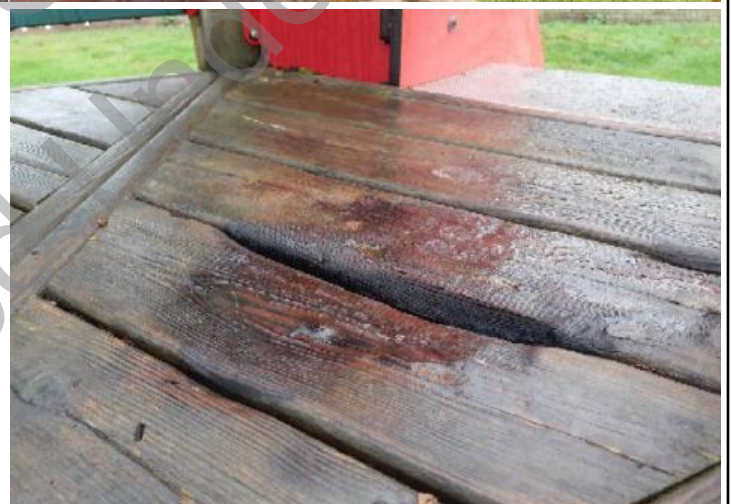
Finding: There is some evidence of fire damage to the item **Action:** Monitor for any further deterioration and repair as required

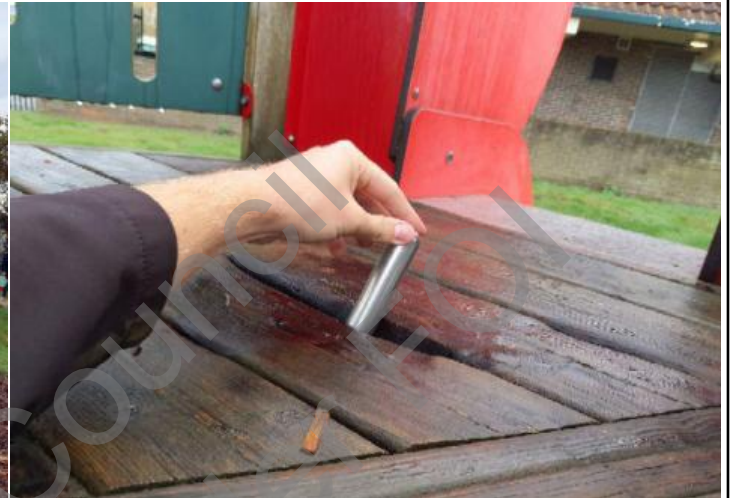
Finding: There is/are finger entrapment/s in the platform due to fire damage and the item fails to meet the requirements of BS EN 1176 Part 1 4.2.7.6 Entrapment of fingers

Action: Replace damaged slats to remove entrapment

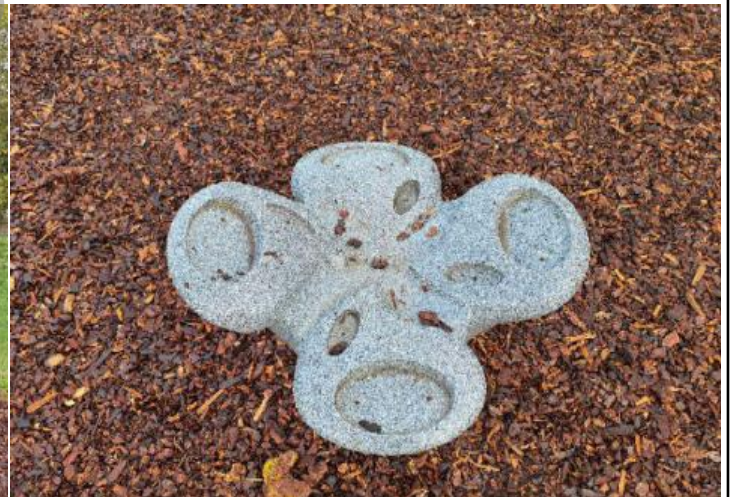
Finding: The item has missing component(s)

Action: Consider replacing missing components

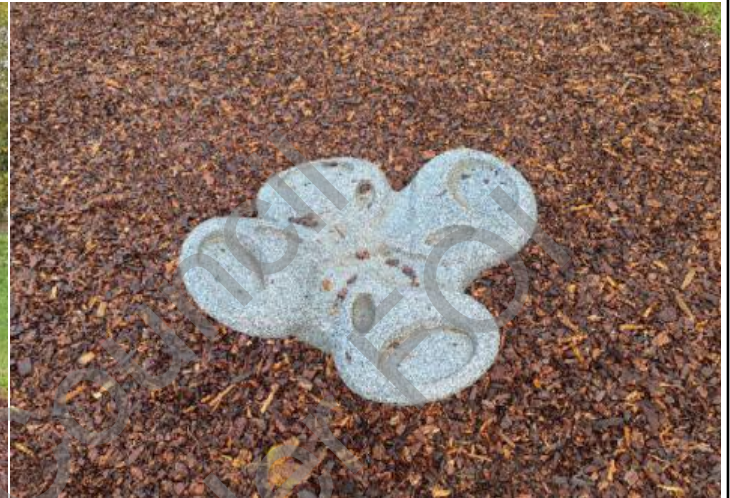
Finding: The bearing is showing signs of wear

Action: Monitor for any further deterioration and replace as required

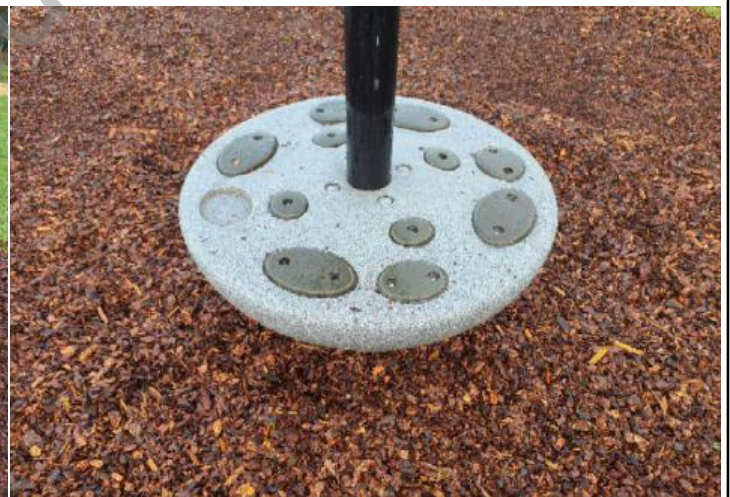
Finding: The bearing is showing signs of wear

Action: Monitor for any further deterioration and replace as required

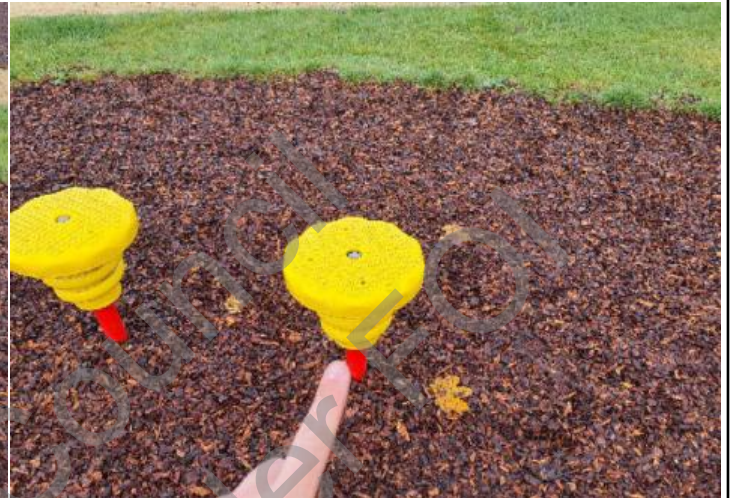
Finding: The item has been damaged

Action: Monitor for any further deterioration and replace as required

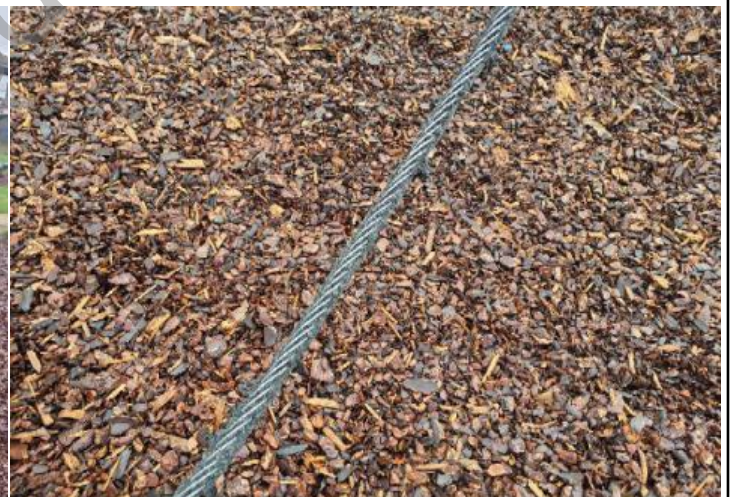
Finding: The rope has worn and wire strands are exposed

Action: Replace rope or net

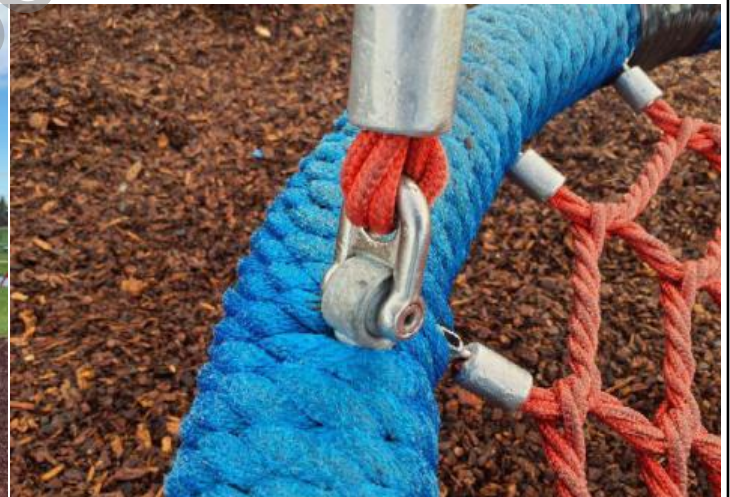
Finding: The bushes are showing signs of wear

Action: Monitor for any further deterioration and replace as required

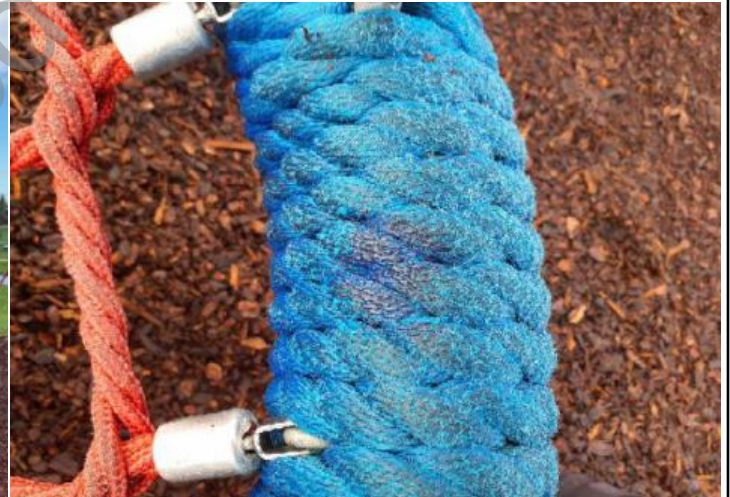
Finding: There is some evidence of fire damage to the item

Action: Monitor for any further deterioration and repair as required

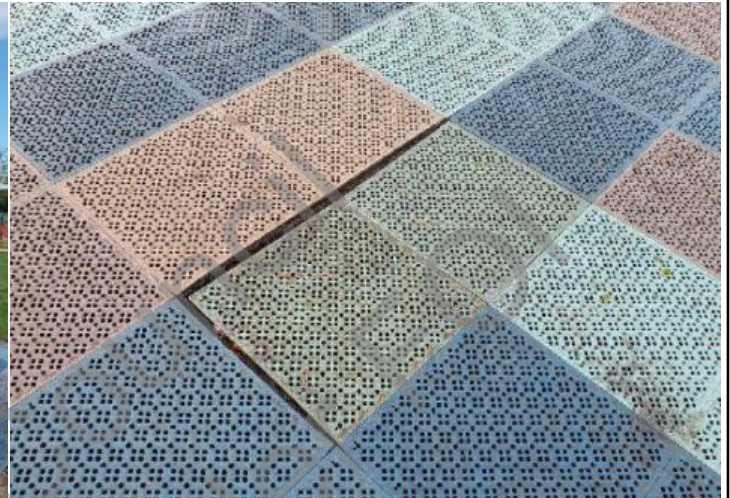
Finding: There are gaps opening in between the tiles

Action: Monitor for any further deterioration and repair as required

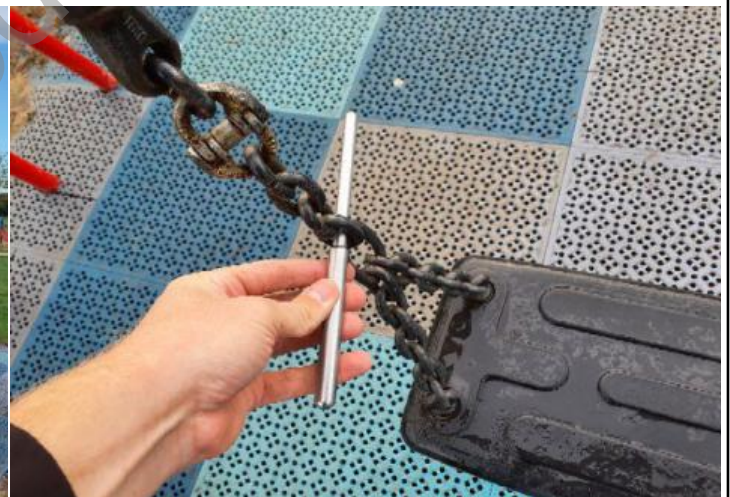
Finding: The chain openings are in excess of 8.6mm and do not meet the recommendations of BS EN 1176 Part 1

Action: Monitor - No remedial work recommended

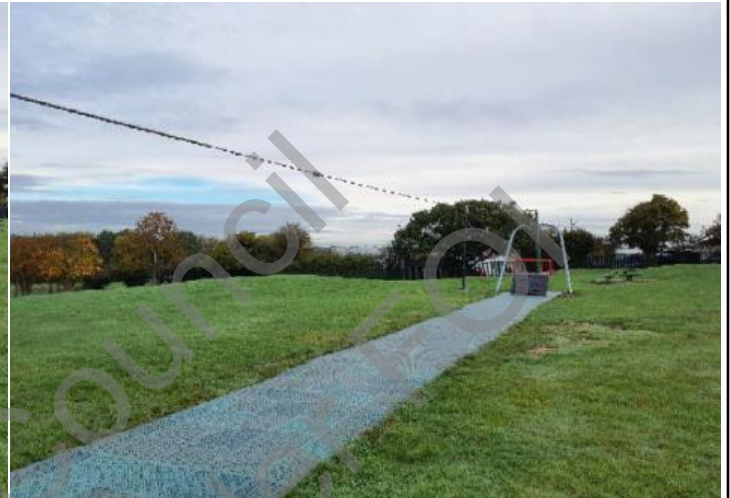
Finding: We have completed a visual inspection of the suspension links, cable and fixing points from ground level, however it is not possible to fully inspect these areas without either hiring equipment to gain access or removing the cable and suspension and inspecting at ground level. We recommend that the main cable and fixing security is thoroughly inspected at least in accordance with the manufacturers recommendations to check for wear, damage, security or internal rusting; this will help to ensure the continued safe use of the equipment

Action: Inspect in accordance with the manufacturers recommendations

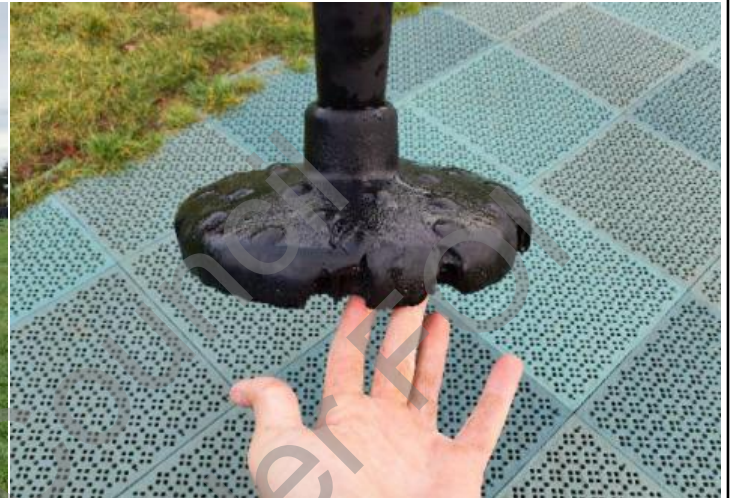
Finding: The cableway seat has been damaged

Action: Monitor for any further deterioration and replace as required

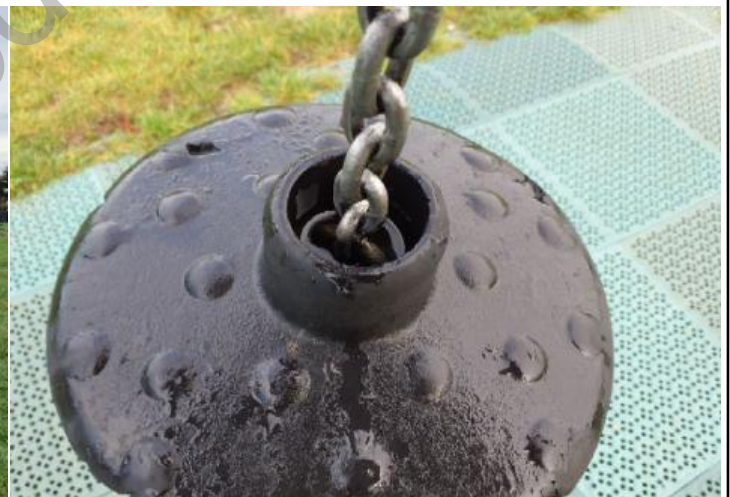
Finding: There is some notable evidence of chain wear

Action: Monitor for any further deterioration and replace when 40% worn

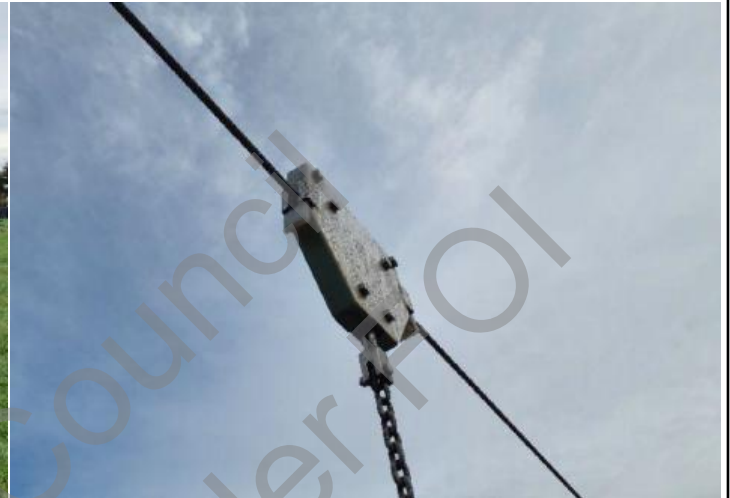
Finding: The nylon inserts are worn or missing at the point the cable enters the traveller

Action: Replace worn or missing inserts as required

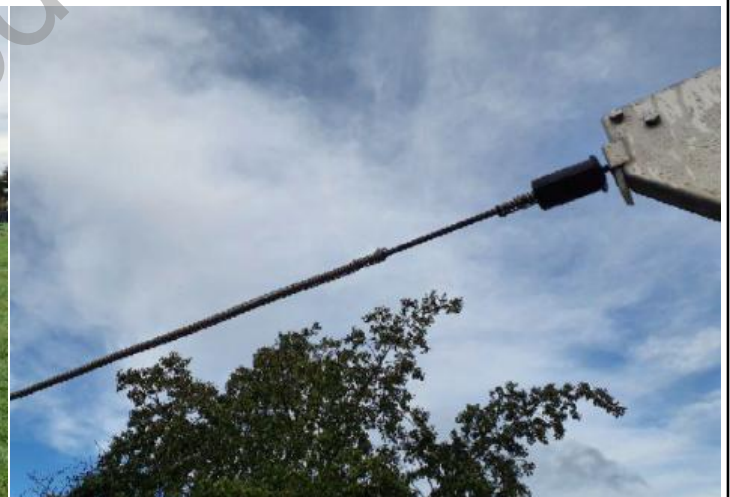
Finding: The dampening spring or tyre is damaged or broken on the item

Action: Replace spring or tyre

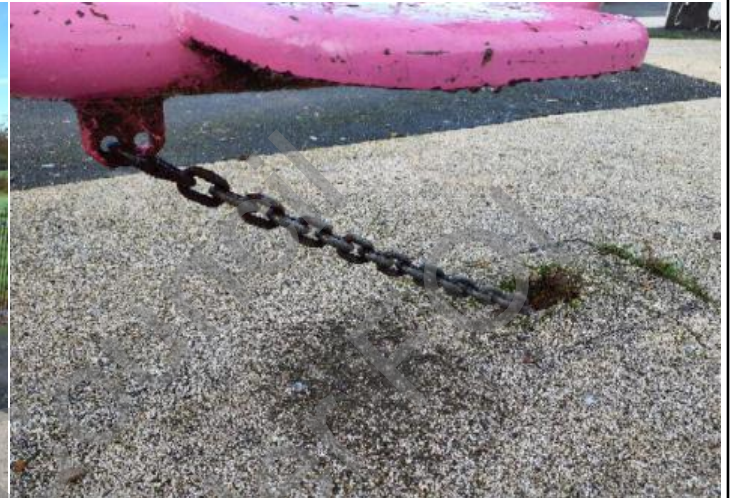
Finding: There is some notable evidence of chain wear

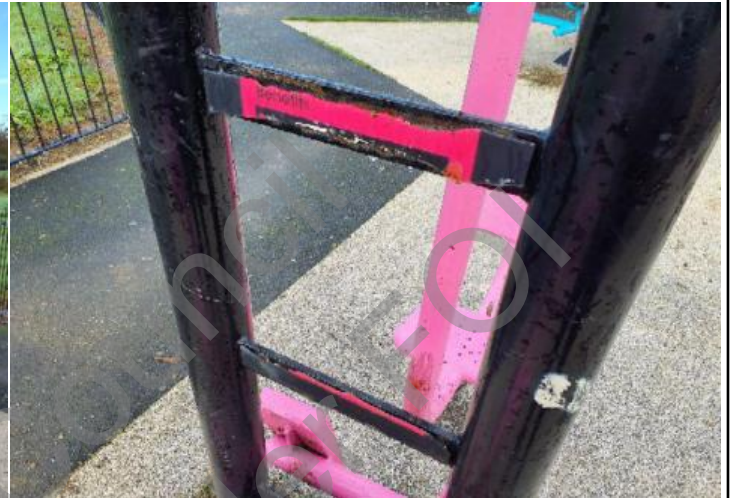
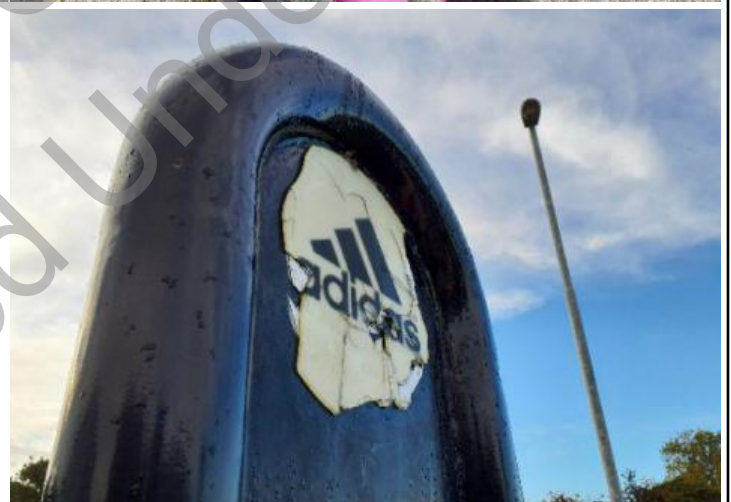
Finding: The signage is damaged and sharp edges are present

Action: Replace signage

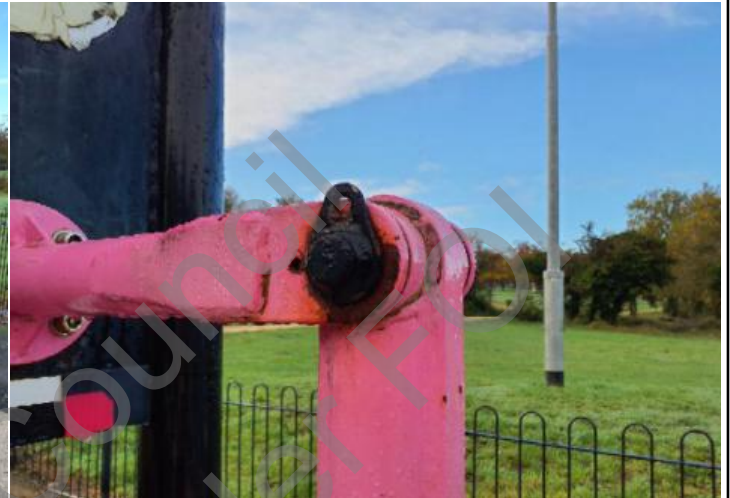
Finding: There is or are fixings missing on the item

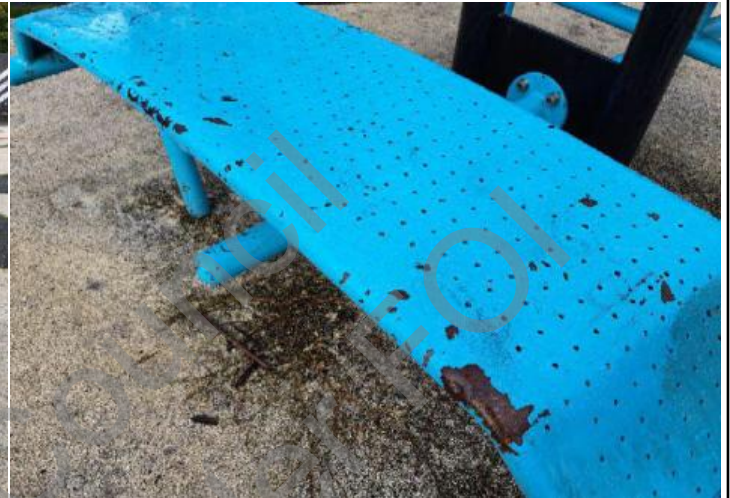
Finding: The paintwork on this item has been damaged or worn exposing the metal underneath which is rusting / corroding

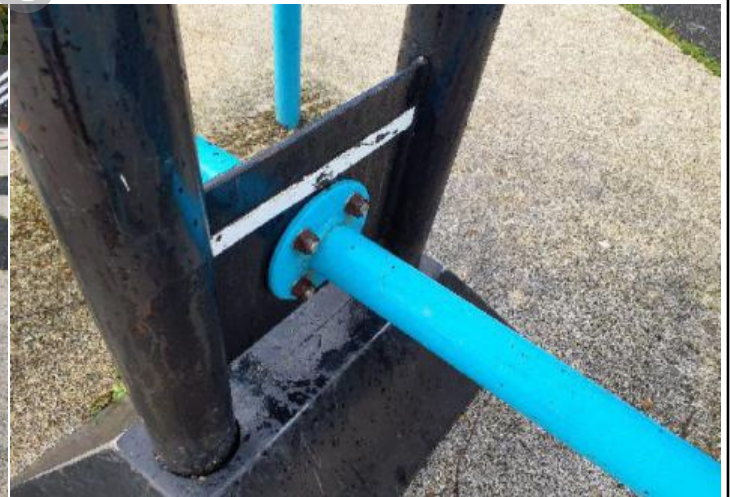
Finding: There is/are bolt cap covers missing or damaged on the item

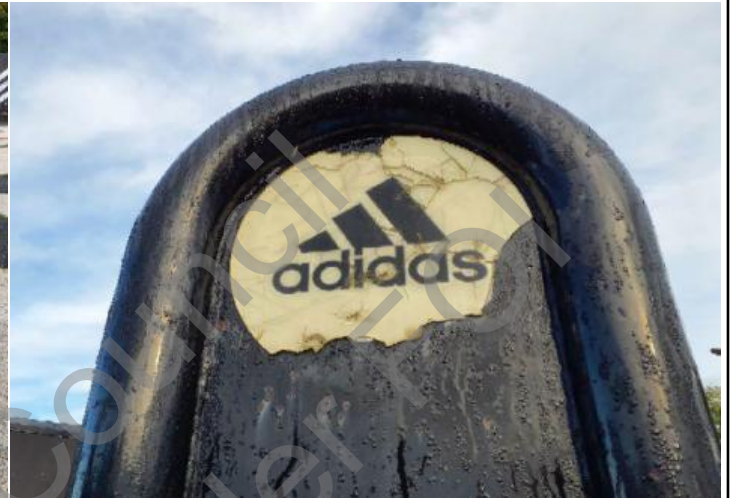
Finding: The signage is damaged and sharp edges are present

Action: Replace signage

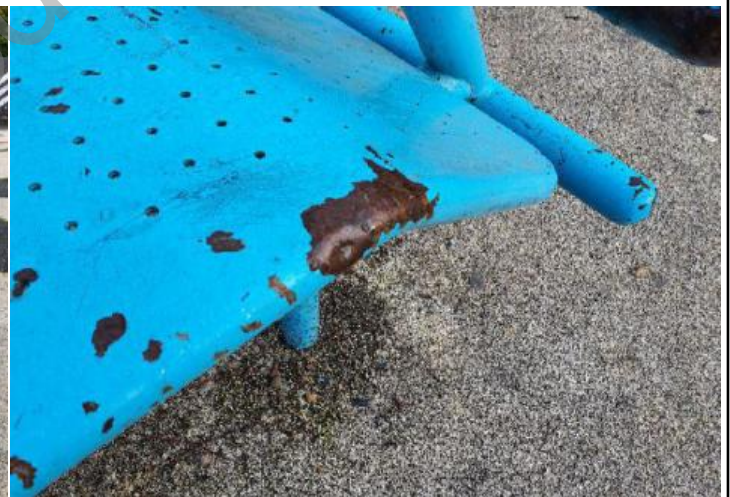
Finding: There is some damage to the item

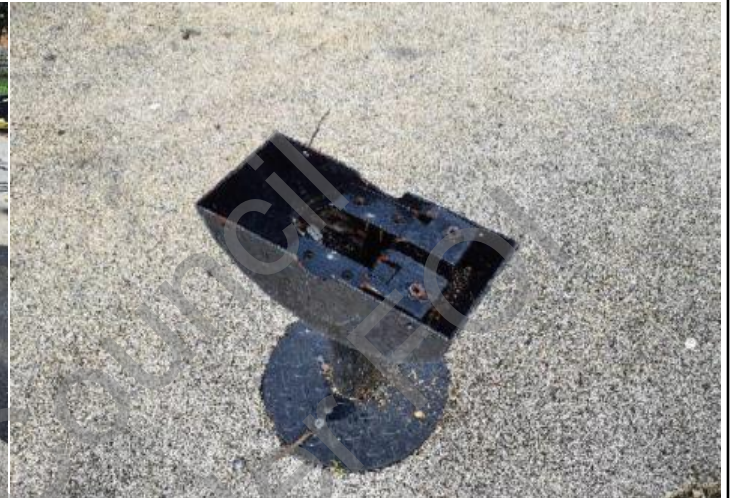
Finding: The mechanism has been removed from one item **Action:** Replace the missing components or remove the item completely

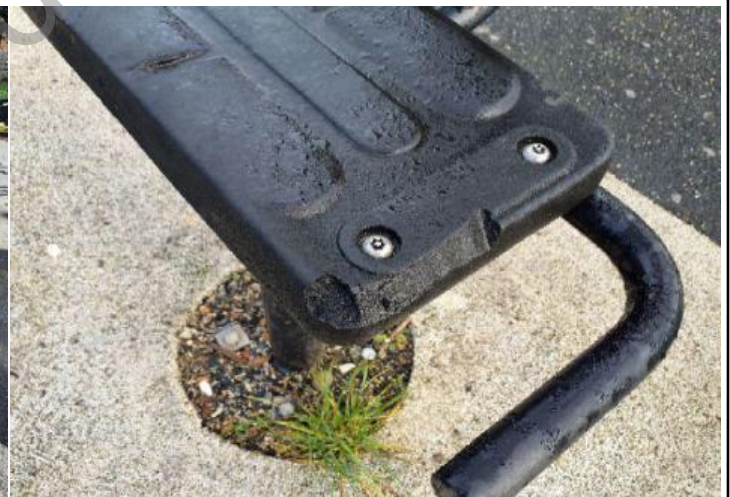
Finding: There is some damage to the seat **Action:** Monitor for any further deterioration and repair as required

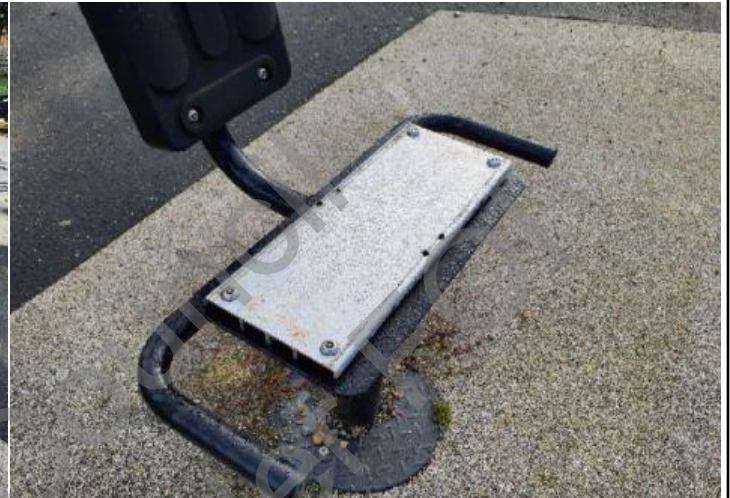
Finding: One seat is missing

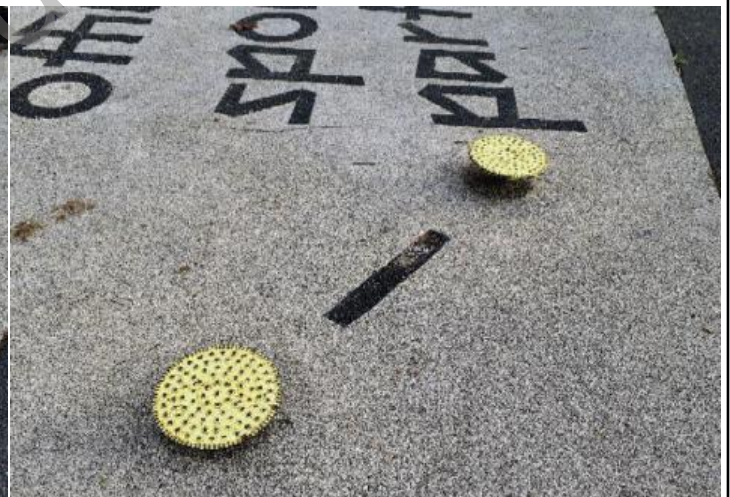
Finding: The frame has been removed
Action: Consider replacing missing components

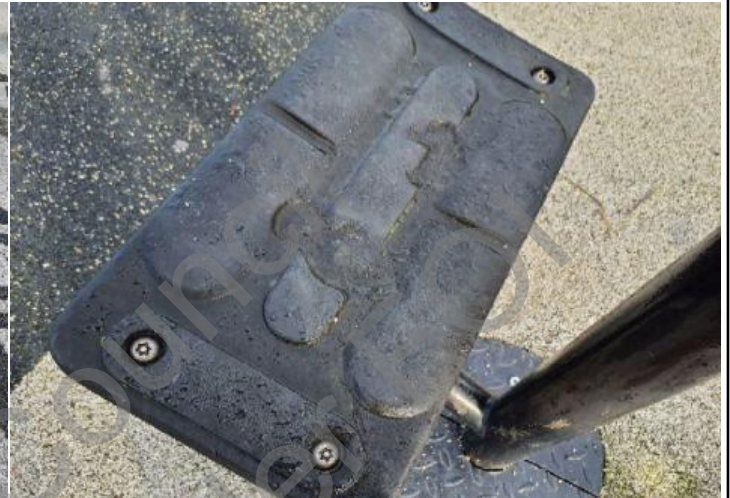
Finding: There is some evidence of fire damage to the item **Action:** Monitor for any further deterioration and repair as required
