Annual Inspection

Thurrock Council

Corringham Town Park

Springhouse Road, Corringham, Essex, SS17 7NB

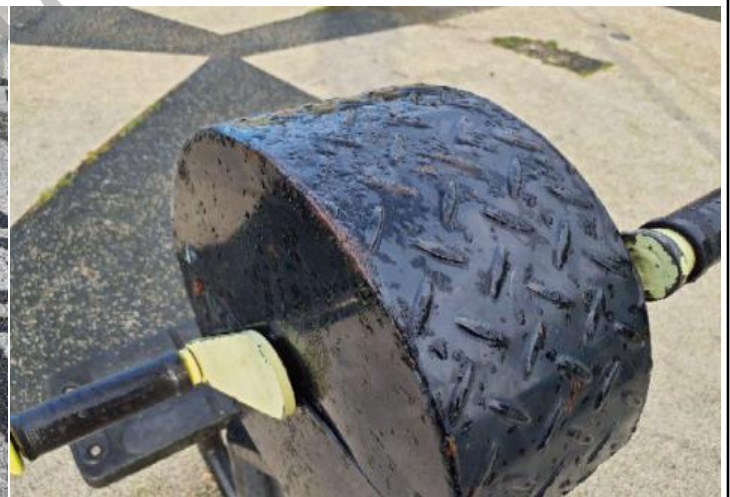
Finding: The paintwork on this item has been damaged or worn exposing the metal underneath which is rusting / corroding **Action:** Treat affected areas and repaint

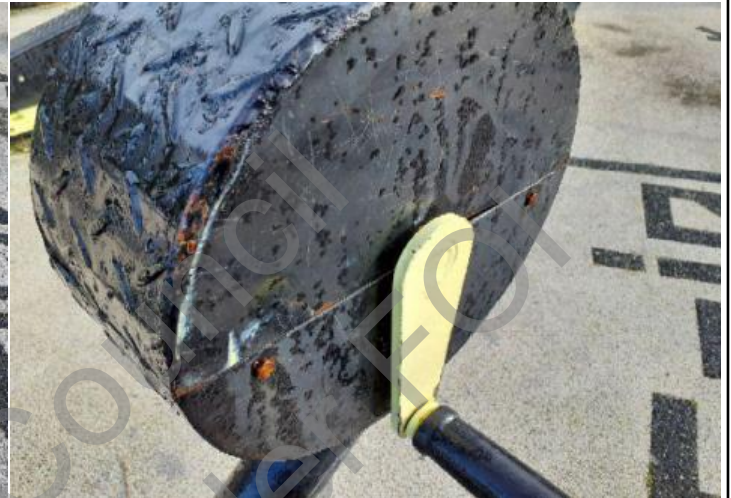
Finding: The bushes are worn or missing

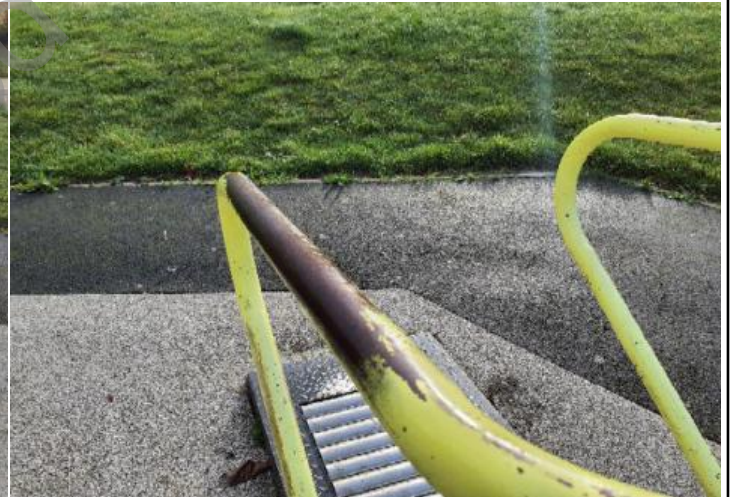
Finding: The paintwork on this item has been damaged or worn exposing the metal underneath which is rusting / corroding

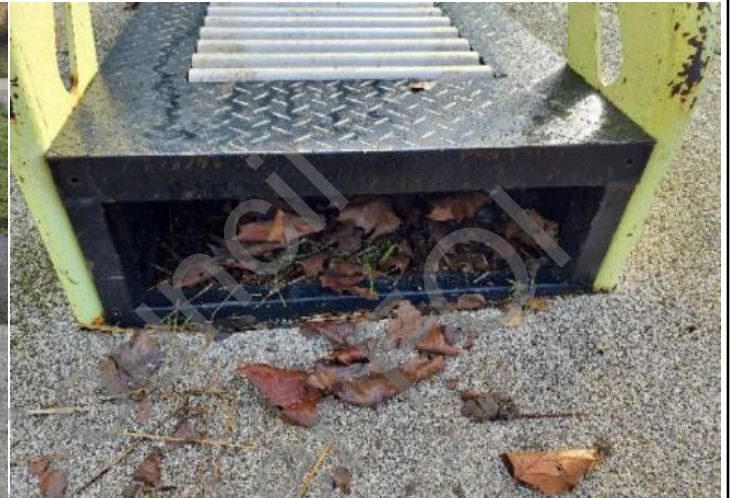
Finding: The inspection plate has been removed

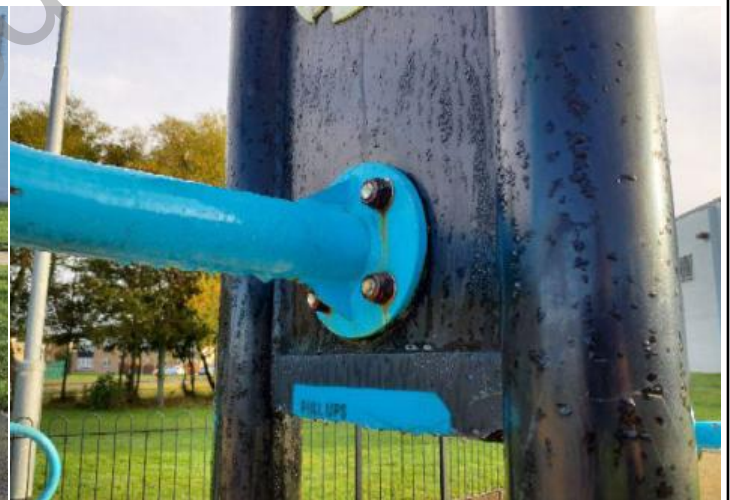
Finding: There is/are bolt cap covers missing or damaged on the item

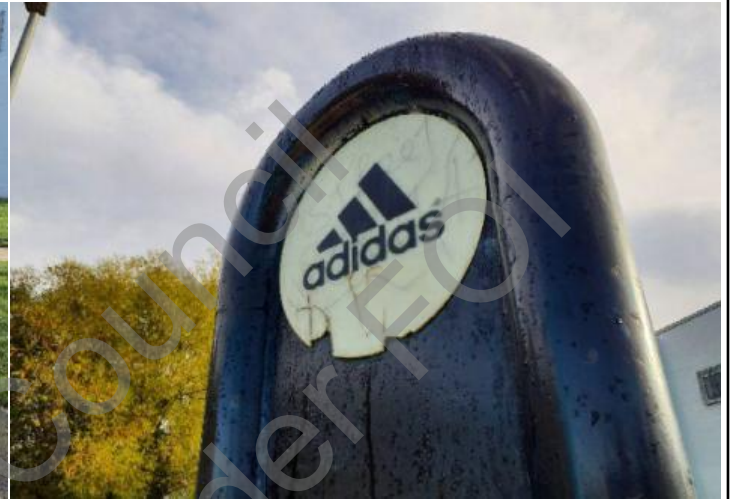
Finding: The signage is damaged and sharp edges are present

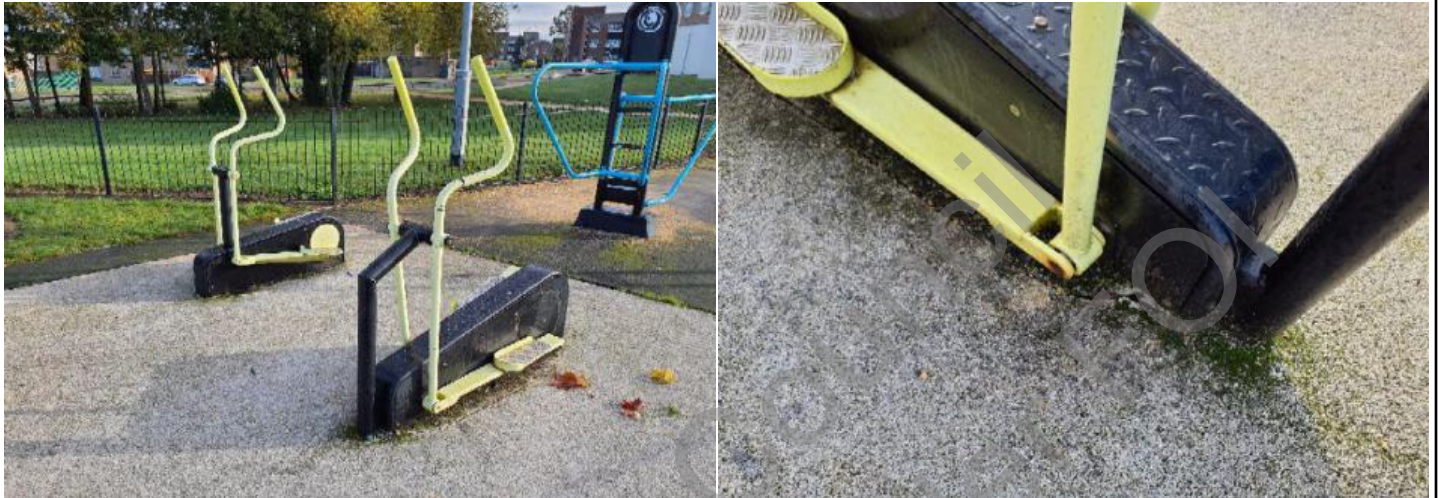
Finding: The bushes are worn or missing

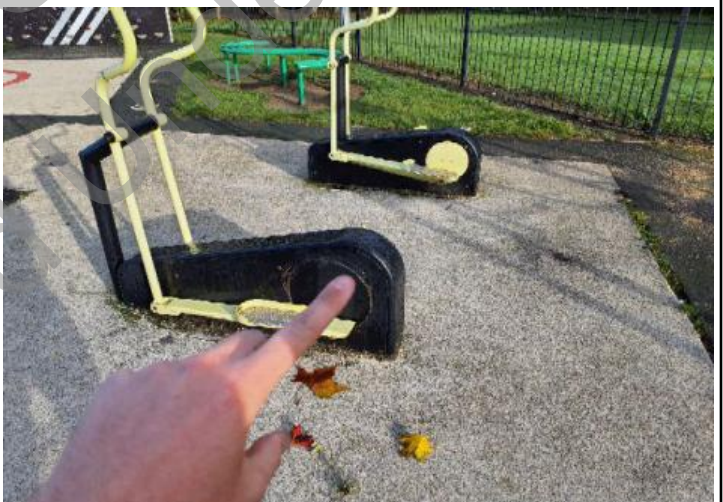
Finding: There is or are fixings missing on the item

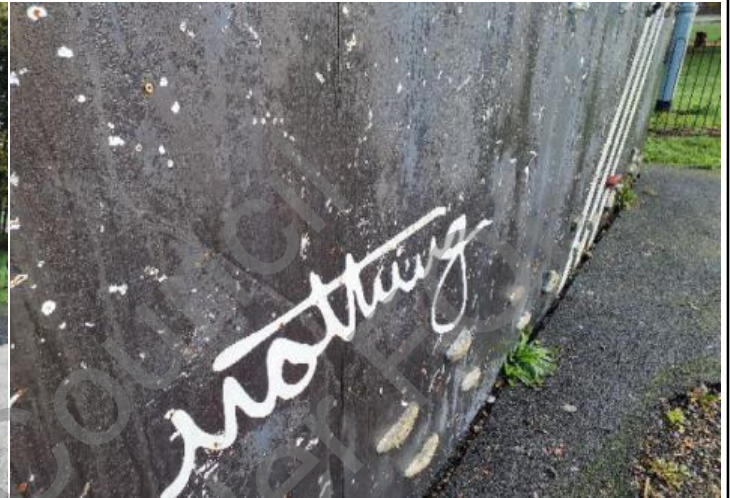
Finding: There is some damage to the item

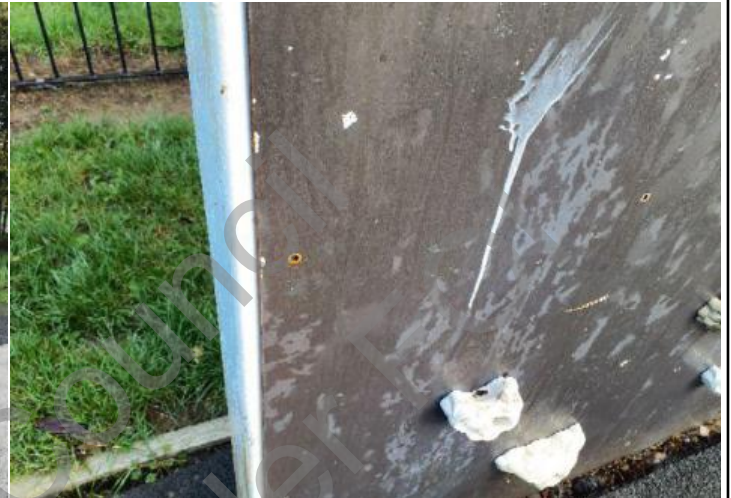
Finding: There is or are fixings missing on the item

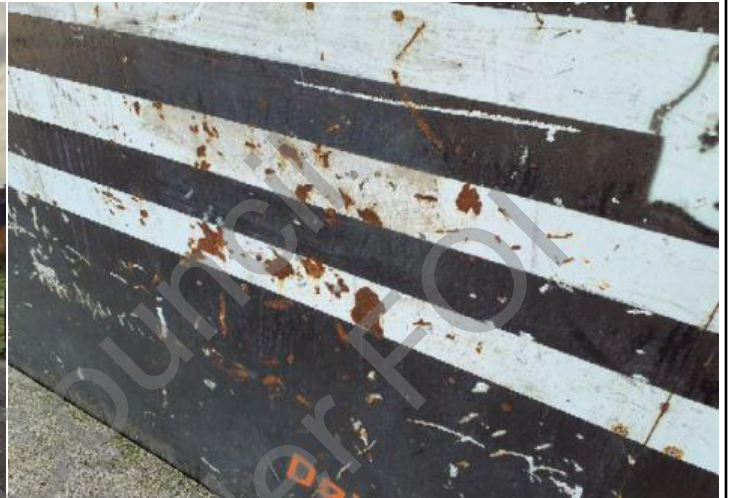
Finding: The paintwork on this item has been damaged or worn exposing the metal underneath which is rusting / corroding

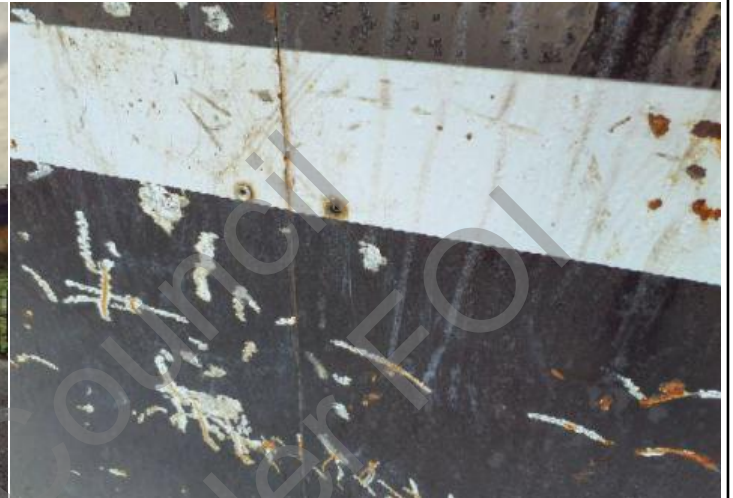
Finding: There is or are fixings missing on the item
