Character Appraisal and
Management Plan

Corringham Conservation Area

April 2023

Authored by Historic Environment Team,
Place Services, Essex County Council

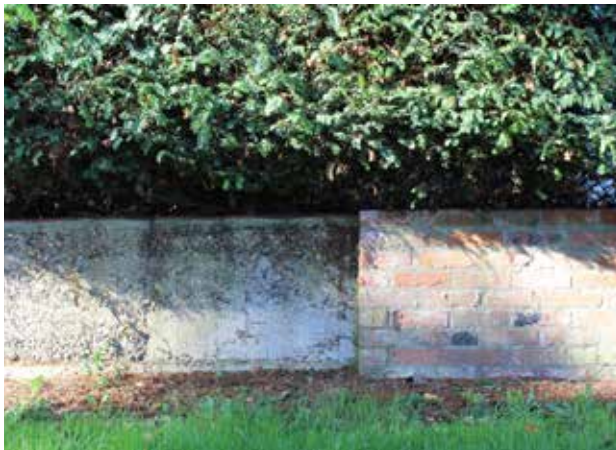
Figure 82: Replacement of low brick wall with concrete, which is out of keeping with the material palette of the area

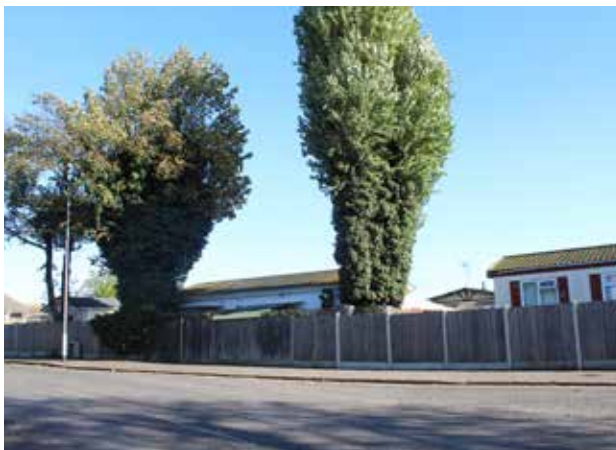
Throughout the Conservation Area, particularly on the north of Church Road, standard close board fencing with concrete plinths and posts has been used as a boundary treatment. This material is aesthetically utilitarian and modern, and out of keeping with the historic, green character of the Conservation Area. These boundary treatments are often prominent in views, impacting the appreciation of the special interest of the area.

Figure 83: Example of close board fencing

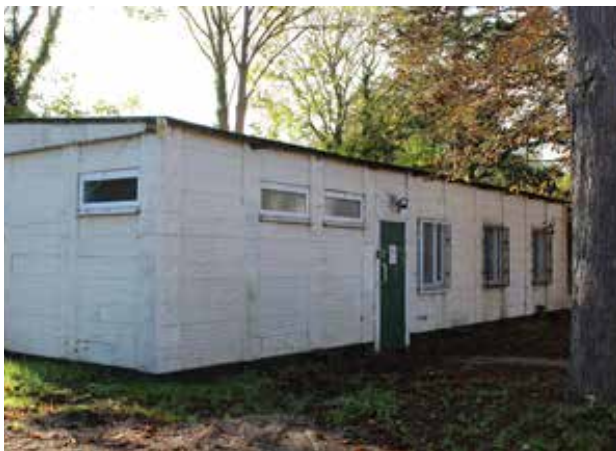
Figure 84: The Hall on Chestnut Walk

Corringham has suffered from the gradual, and in some cases irrevocable, loss of architectural detail which gave the village its unique and distinctive character. This includes the removal of historic doors, windows and rainwater goods and installation of replacements which do not match the quality of the original in material, craftsmanship or detailing.

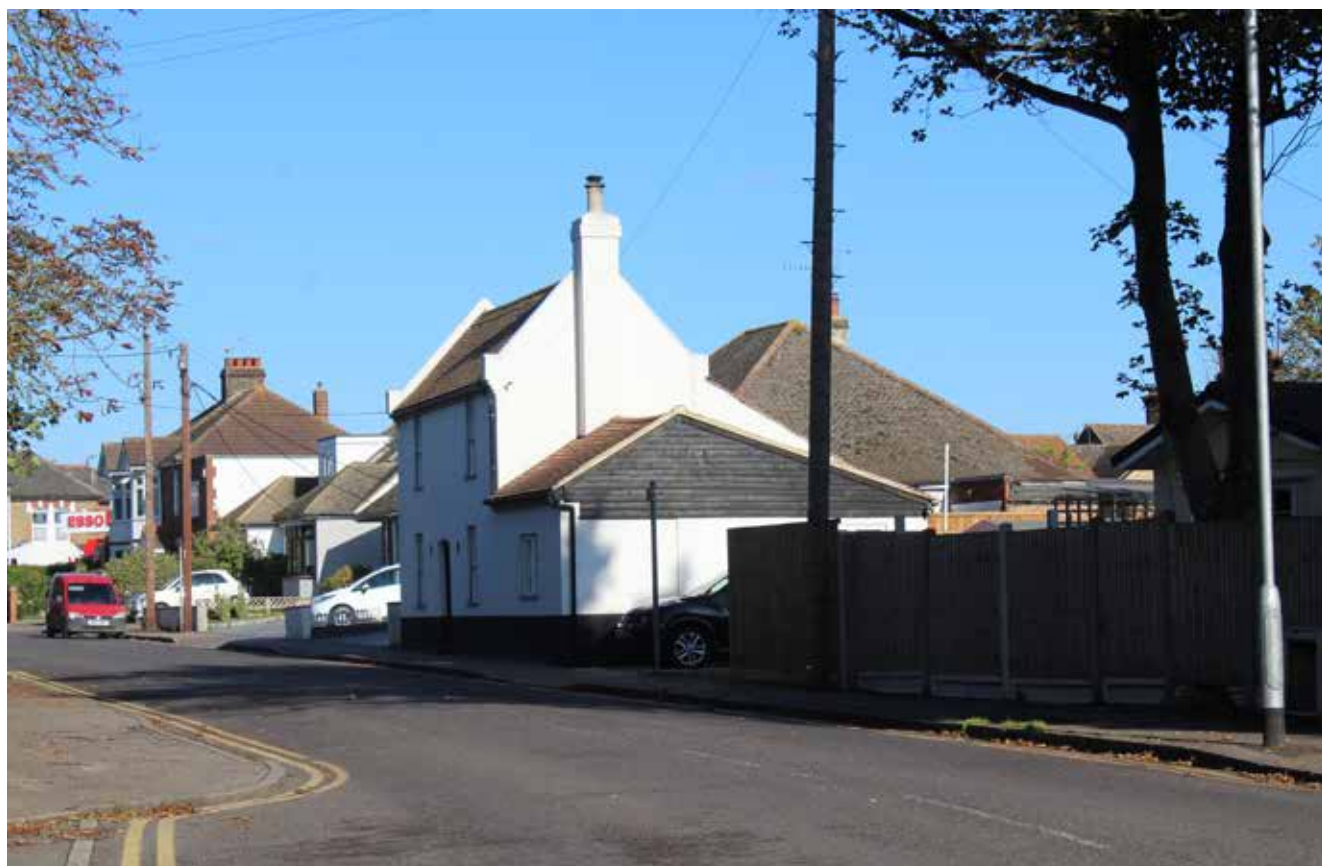
The character of the Conservation Area Church Road is defined as much by the trees and hedges which line it, providing a sense of enclosure, as it is by the buildings. This is especially prevalent where the buildings are set back from the road behind grass verges and garden plots. In some places, trees and hedges have been removed or not replanted when land has been developed. This has had a negative impact upon the character and appearance of the area.

Figure 88: View north highlighting lack of trees and hedgerows as boundary treatment
