Part 6: West Tilbury

Contents

The Rural Settlement Assessment of West Tilbury describes the origins of this study area through a description and analysis of the archaeological, historic landscape, built heritage, and historical evolution of the village settlement, its context and setting: this provides core information to allow insights into how the past has influenced the present so we can make informed decisions about its future.

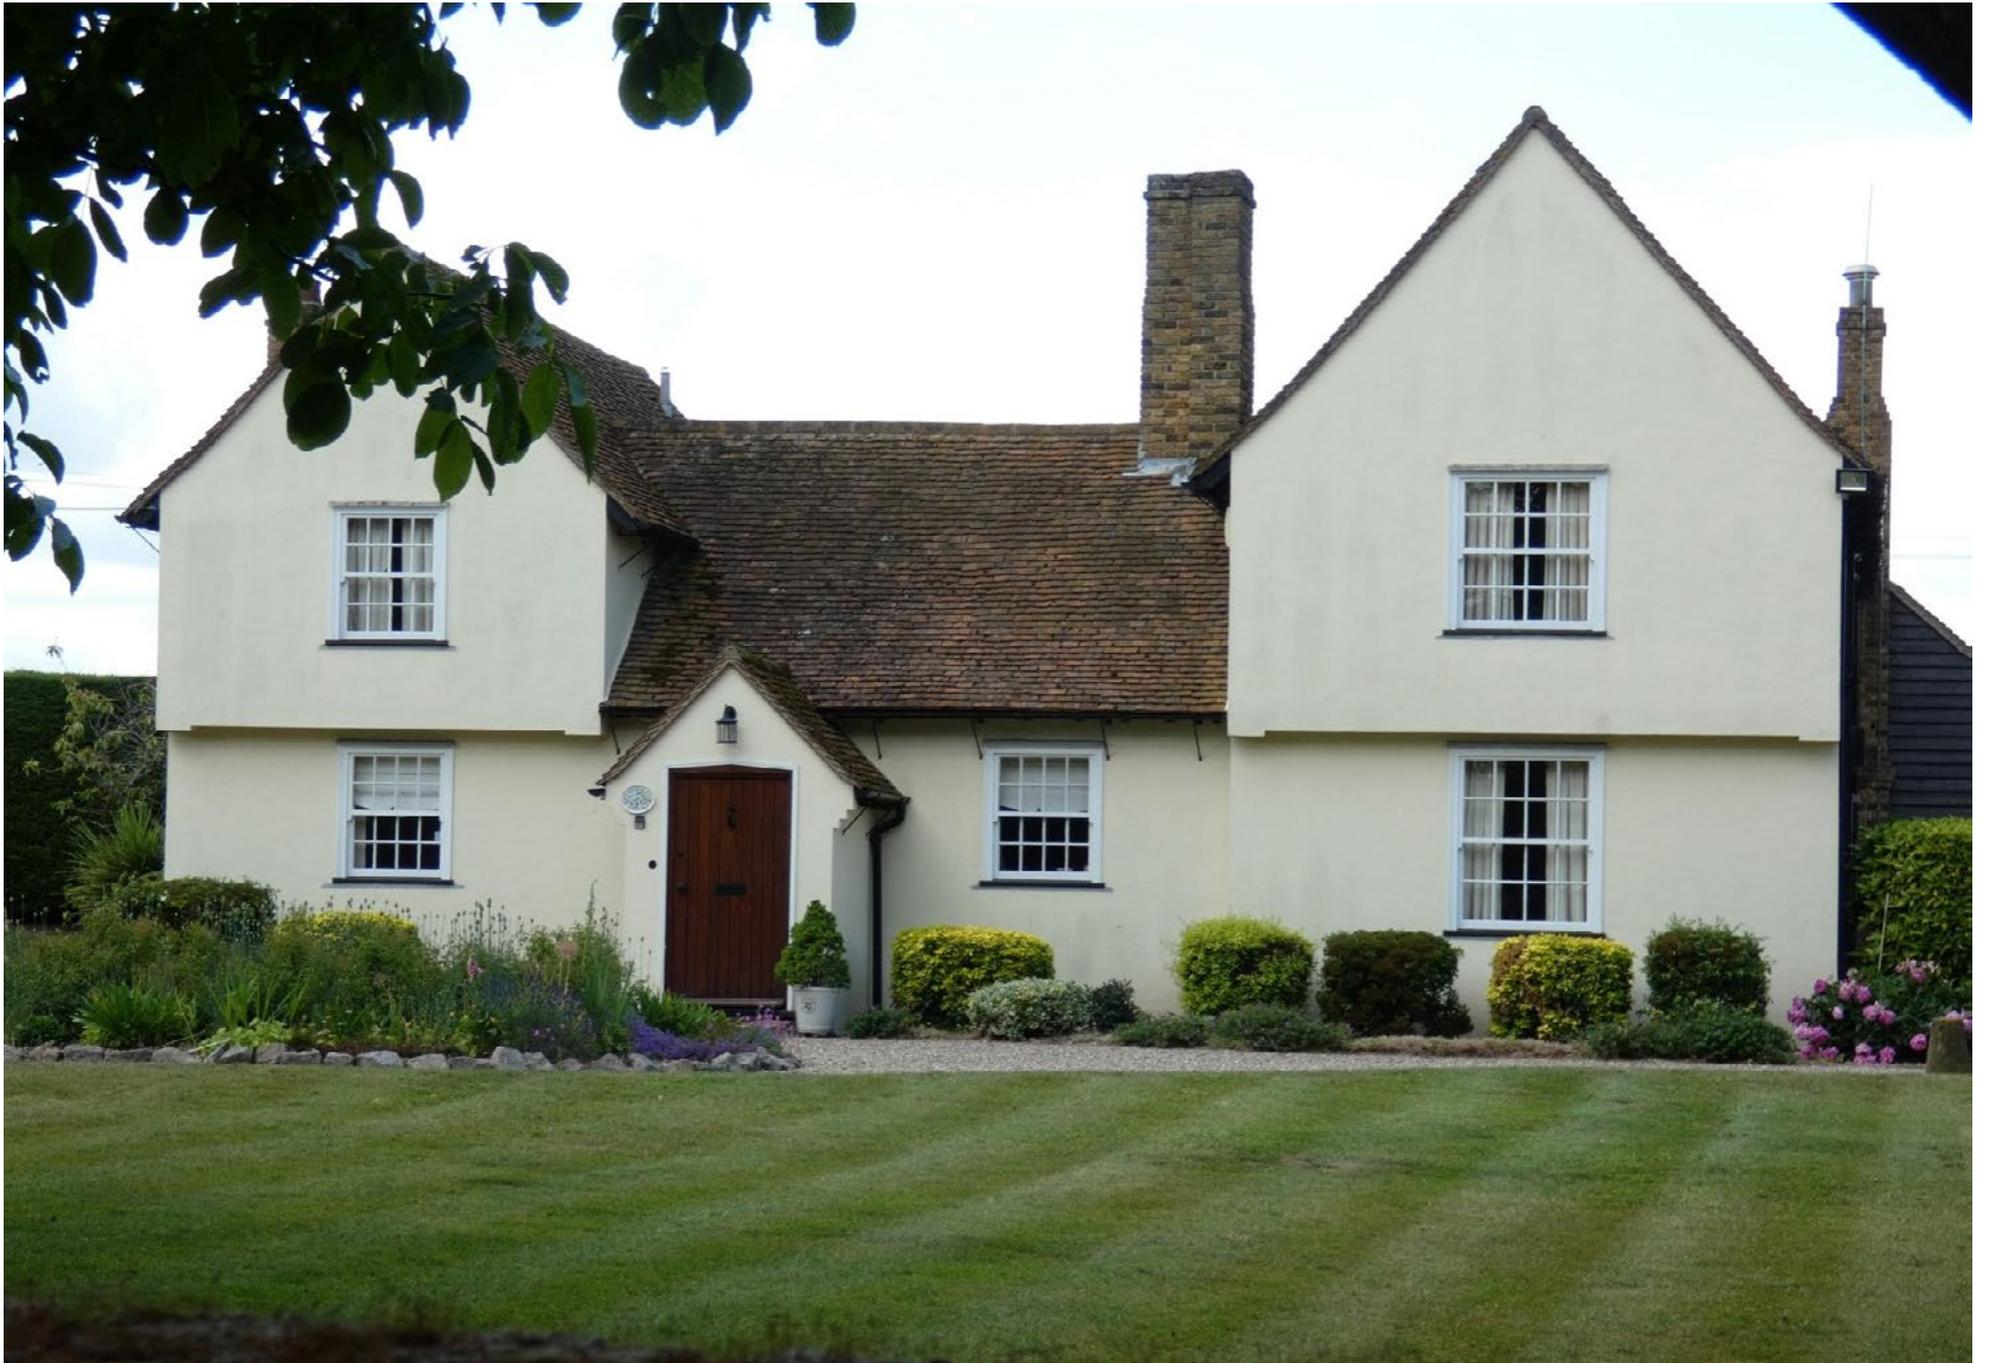
Fig 26. Grade II Listed Marshall's Cottages*

There is a single surviving late medieval building in the study area, Marshalls Cottages (LB 1337058) comprising an early 15th century hall-house with cross-wings, the Marshalls name is first referenced in 1203. In Low Street, Walnut Tree Cottage (formerly Condovers) is a 15th century house (LB 1111624), the place-name Condovers is associated with the family of John Condover in 1523. The Listed Barn to the north of West Tilbury Hall is 16th century in origin (LB 1308889).

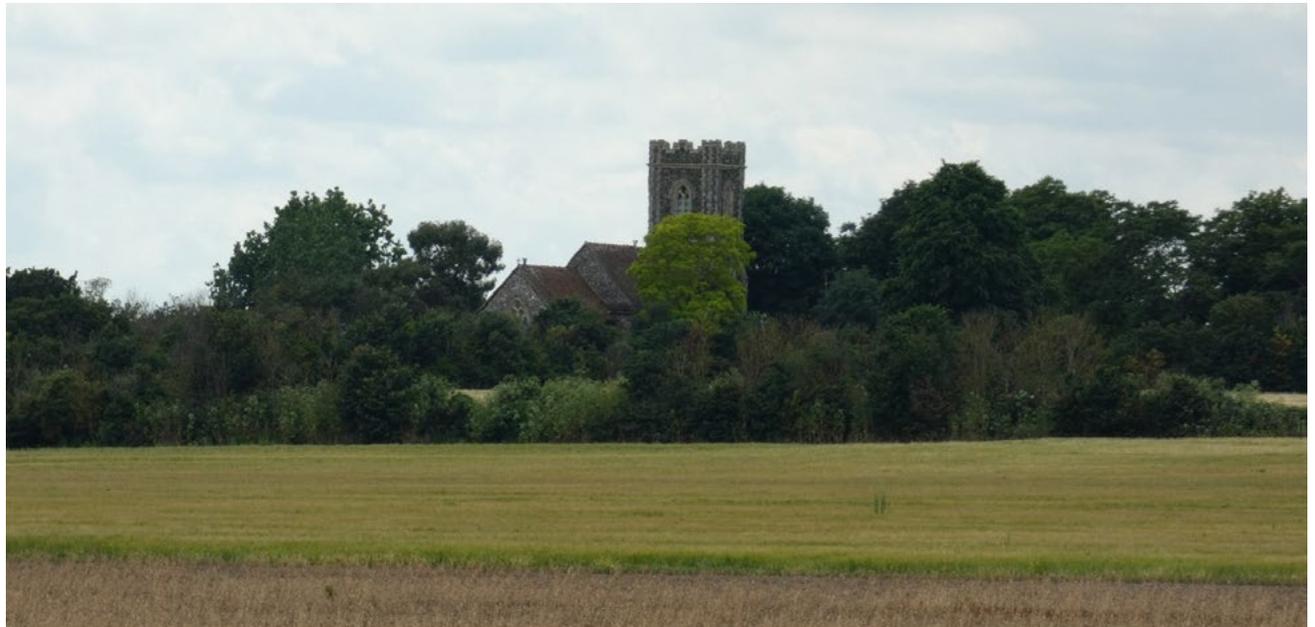
Fig 54. There are clear views of Grade II listed St James Church to the west.*

Dominated by high voltage power lines to its eastern edge (top image), the area is entirely under arable agricultural use (lower left image). Like Division H, this Division also affords clear views of Grade II listed St James Church to the south. Distant views east from viewpoint 18 afford a clear vantage over the Bata Heritage Centre at East Tilbury (image lower right)

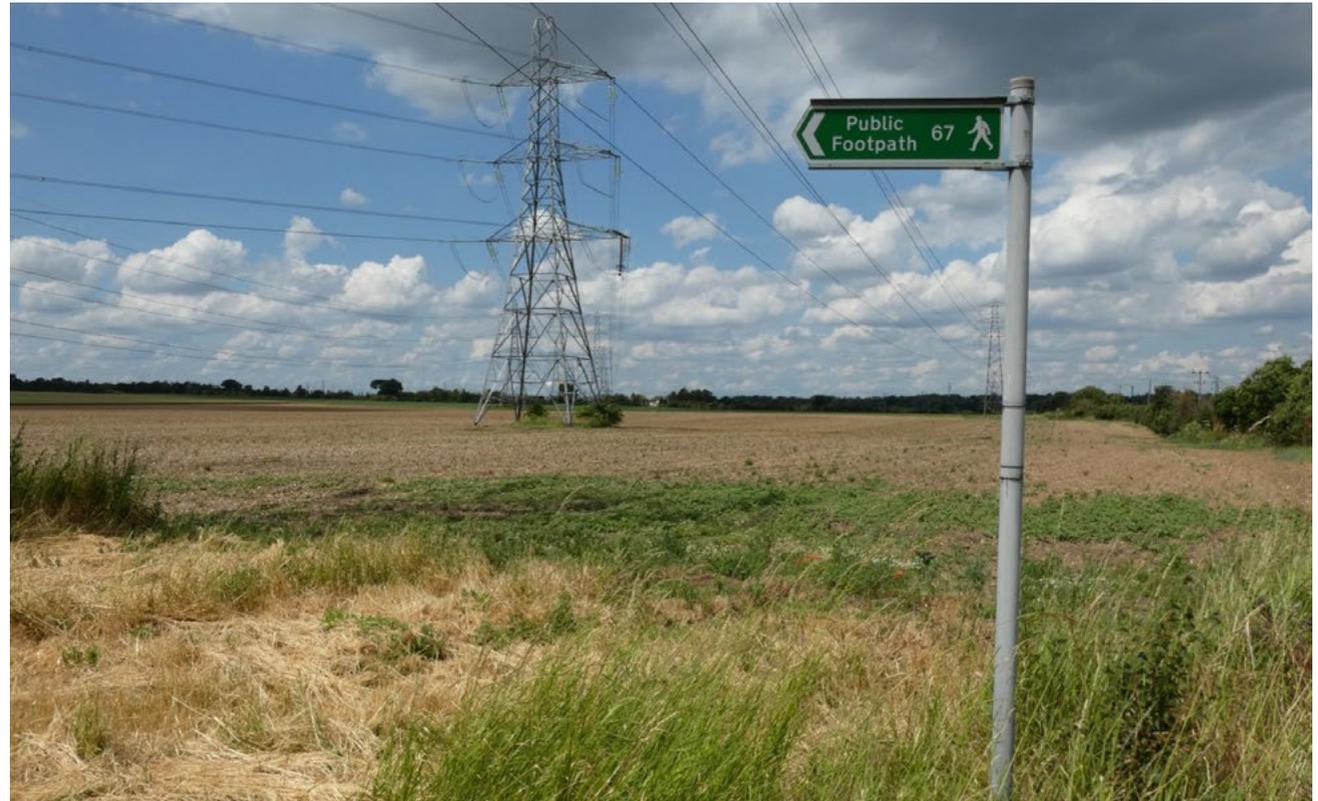
Fig 55. The Division is dominated by high voltage power lines to its eastern edge - image looking north-west from viewpoint 18

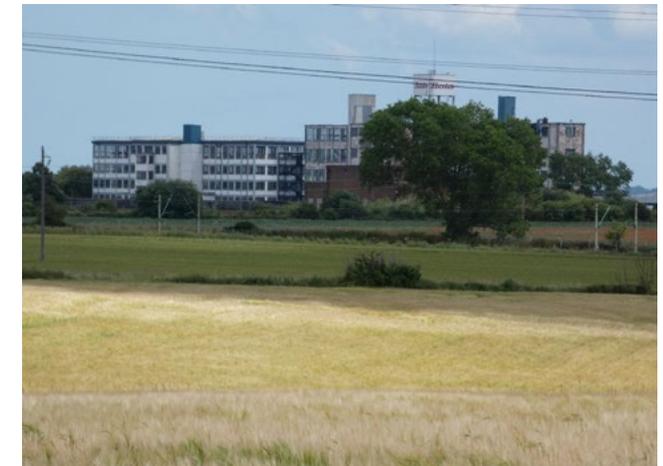
Fig 57. Distant views from viewpoint 18 towards Bata Heritage Centre

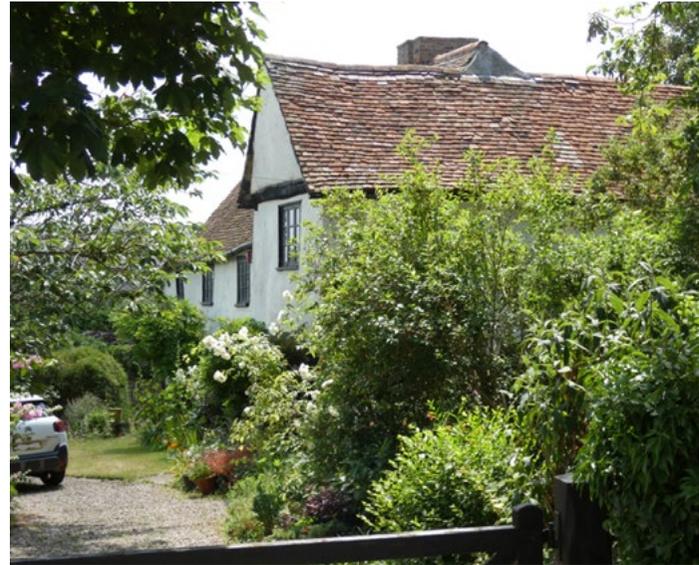
The area is partly developed and includes Grade II listed c15 Walnut Tree Cottage 'q' that is partly obscured by trees and shrubs (top left image). It also includes Grade II listed c17 yellow stock brick-built Polwicks.

Fig 58. Grade II listed c15 Walnut Tree Cottage from Viewpoint 16

Because of the setting, massing and materiality of these listed buildings, its heritage impact potential is rated **AMBER** to safeguard these historic assets from future potential change.

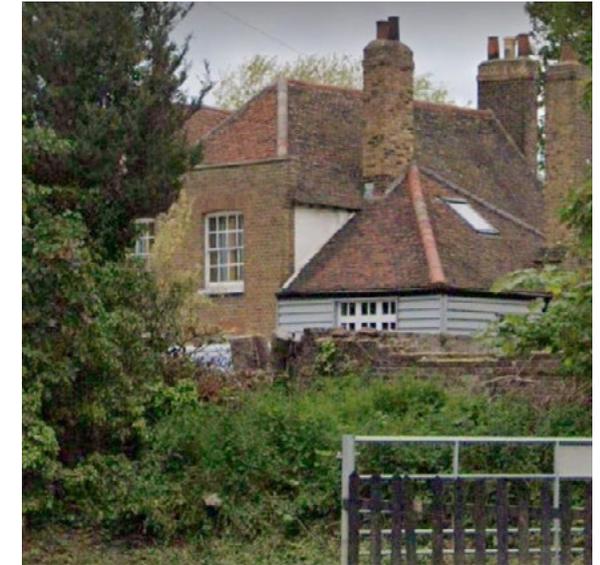
Fig 59. Grade II listed c17 yellow stock brick-built Polwicks from Google Streetview dated 2021

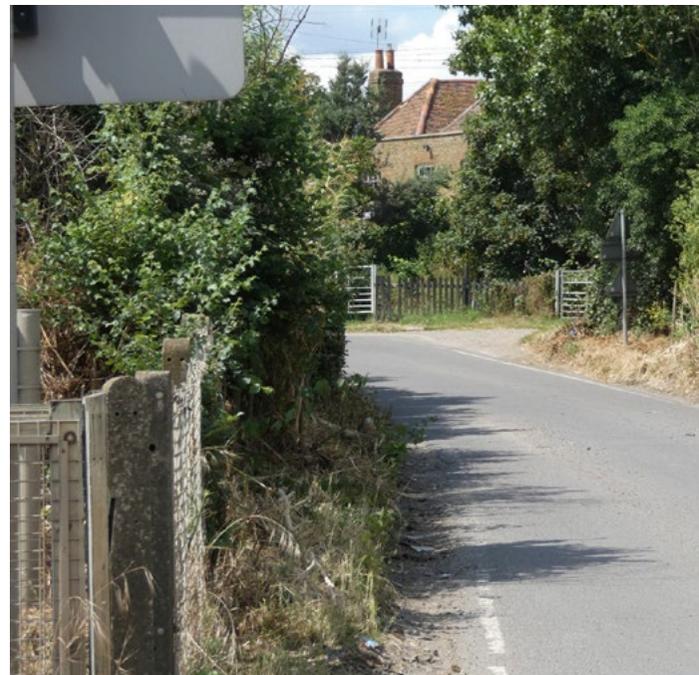
Fig 60. Polwicks from viewpoint 20

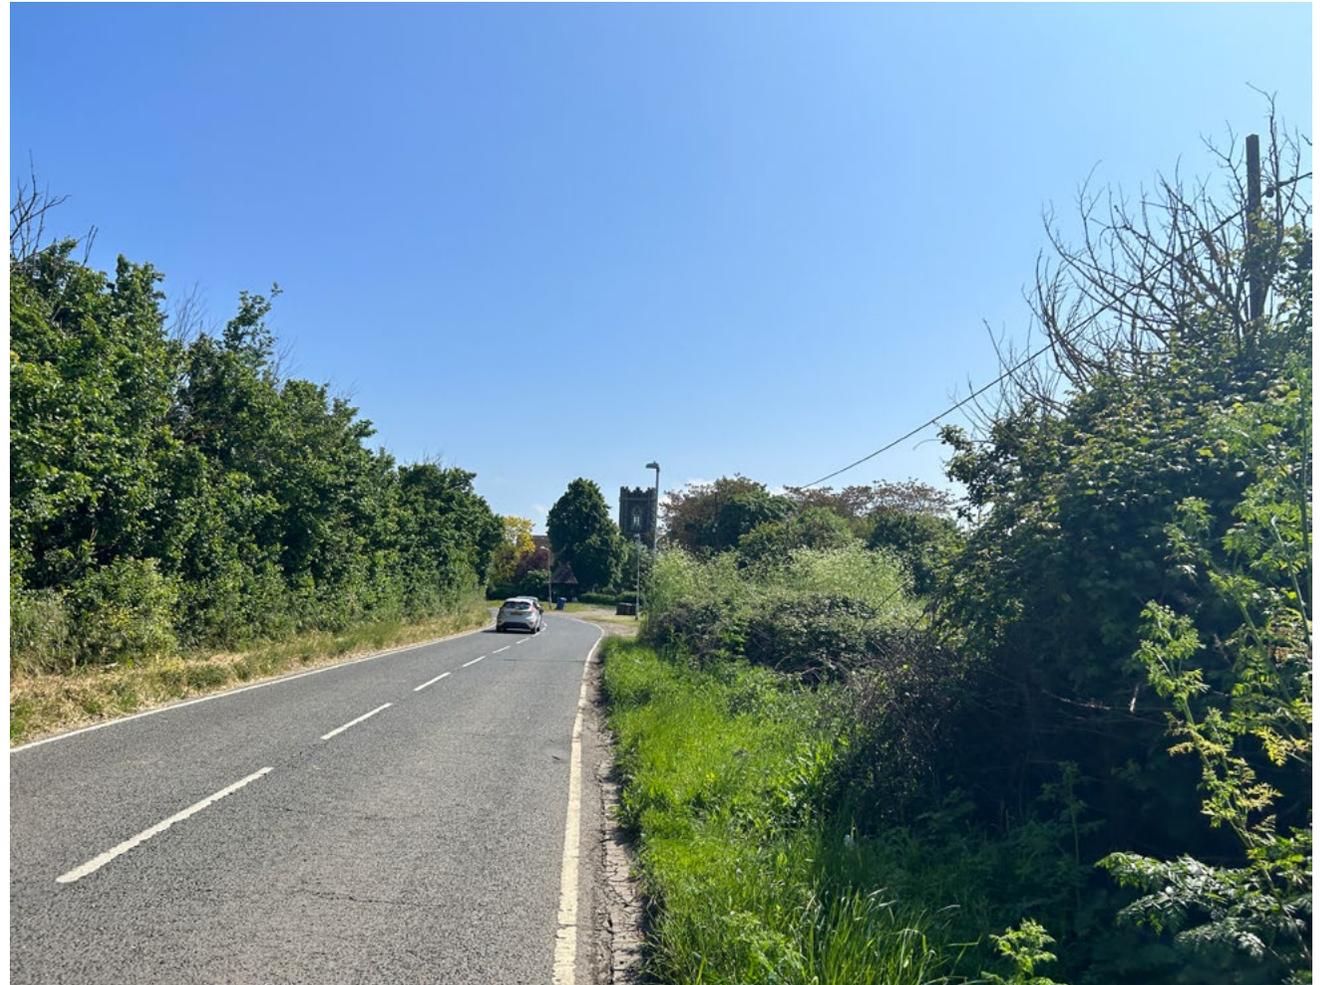
Fig 68. View looking south from the village along Church Road towards St James Church, which has now been converted into a house.

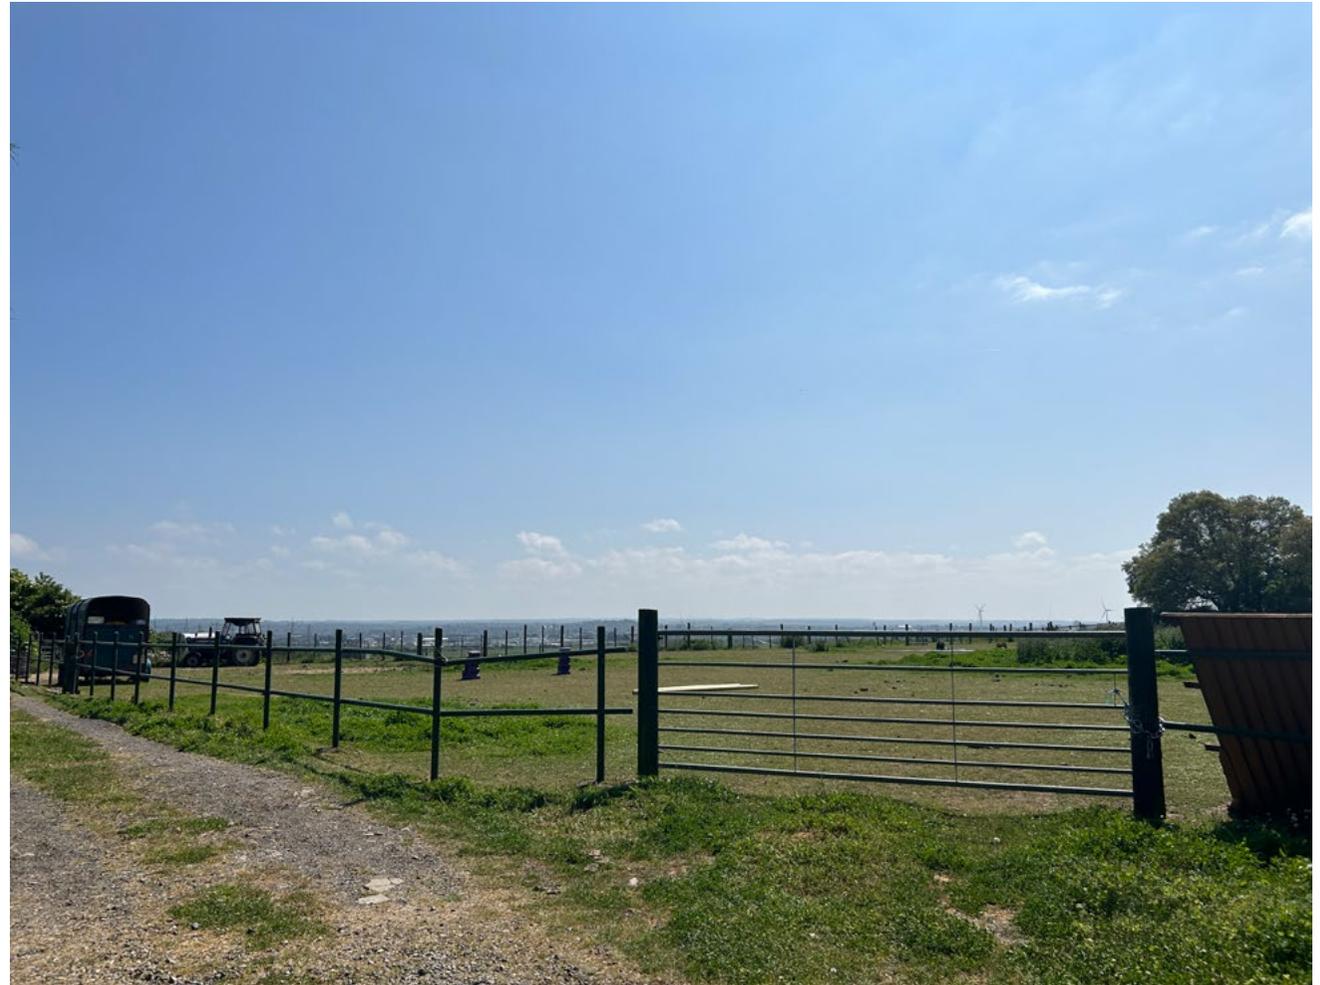
Fig 70. View looking south-west down the hill from the edge of the village adjacent to St James Church.

There are important views out from the footpath running through the churchyard over the marshes towards the Thames and Kent. The former power station and its remaining infrastructure have created a significant disturbance on this view. The emerging Tilbury 2 port, while extensive, does not currently include structures of a similar scale.

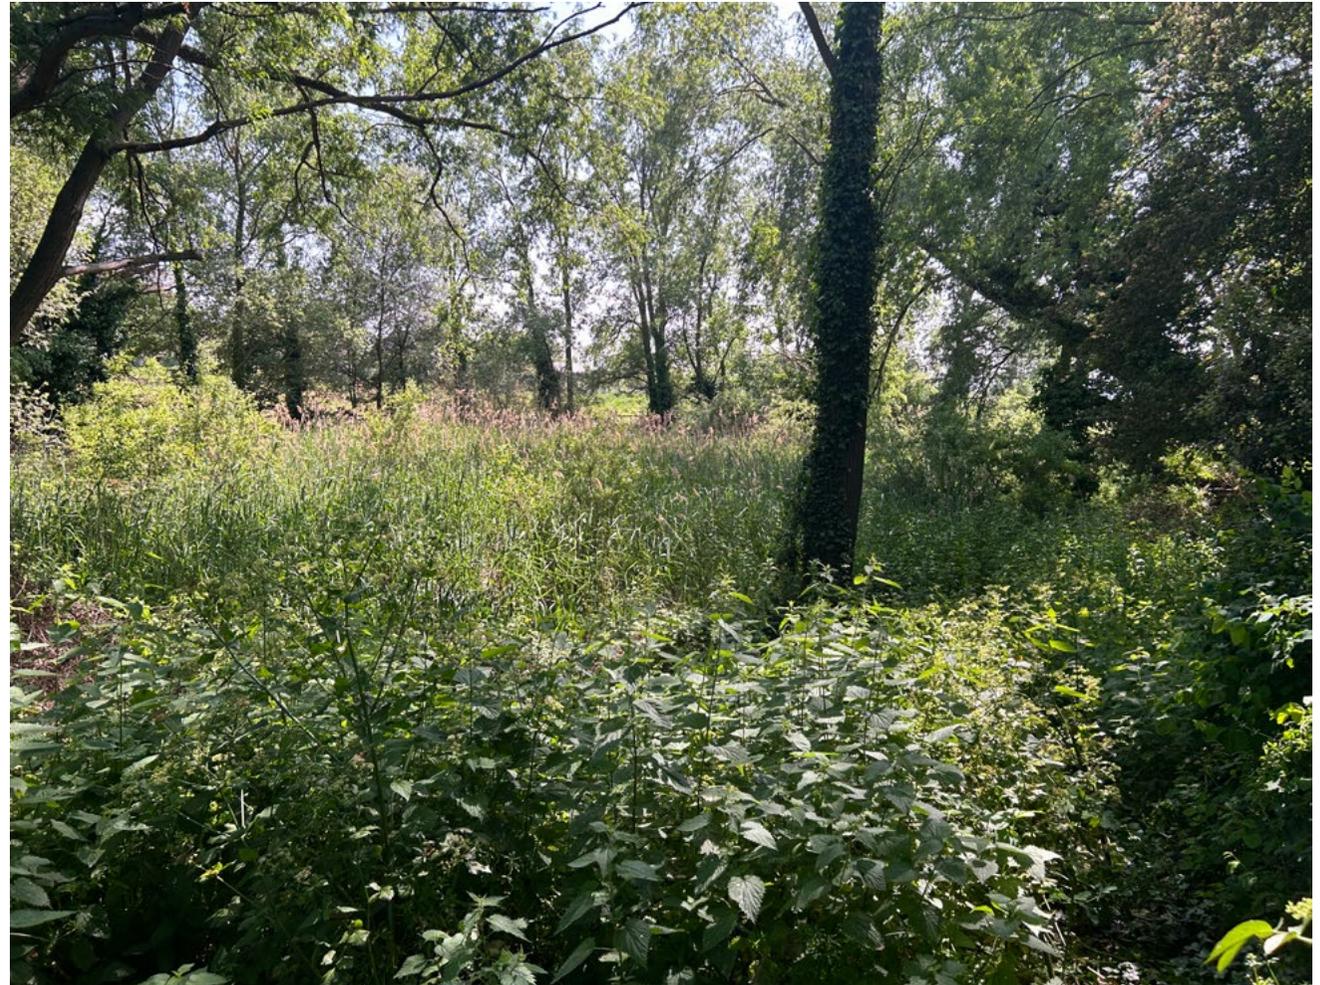
Fig 72. Pond area next to footpath 63

Footpath 68 which heads west out of the village, just to the south of the village green, passes a small mineral extraction area which holds water occasionally. In summer 2023, water was not visible at surface level due to planting. (See right)

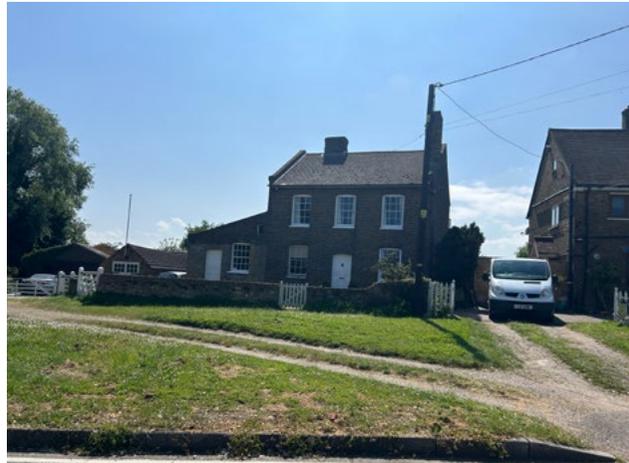
Fig 84. 1-2 Storeys Village Green

Most buildings are 2 storeys, there are occasional 3 storey buildings and some single storey buildings although these tend to be non-residential uses- the agricultural and community buildings.

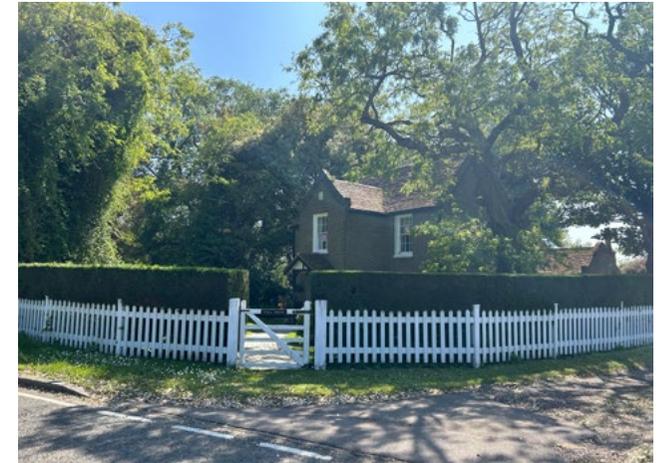
Fig 85. 2-3 Storeys Village Green

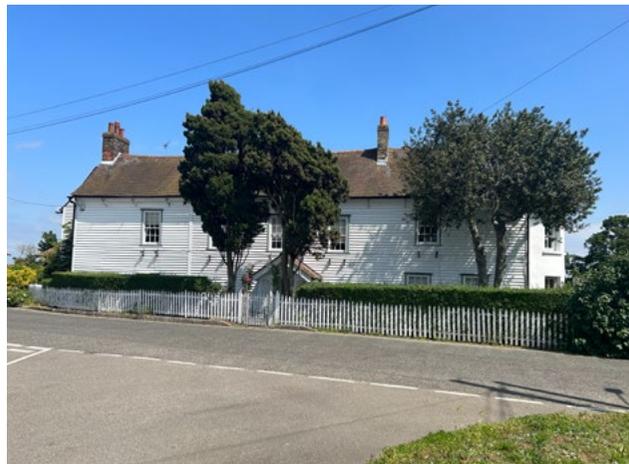
Fig 86. 2 storeys Church Road

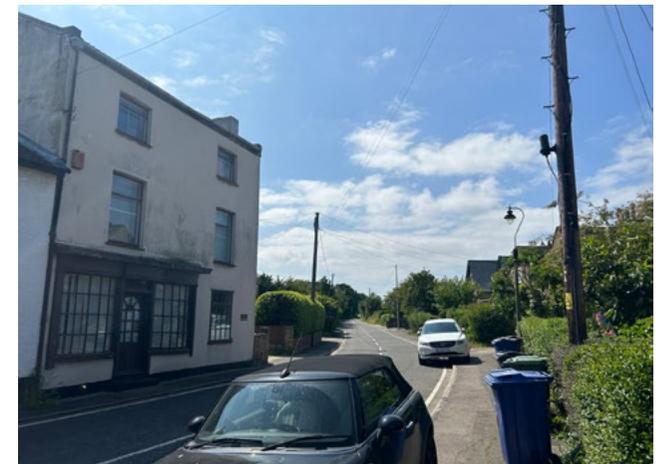
Fig 87. 3 storeys Rectory Road

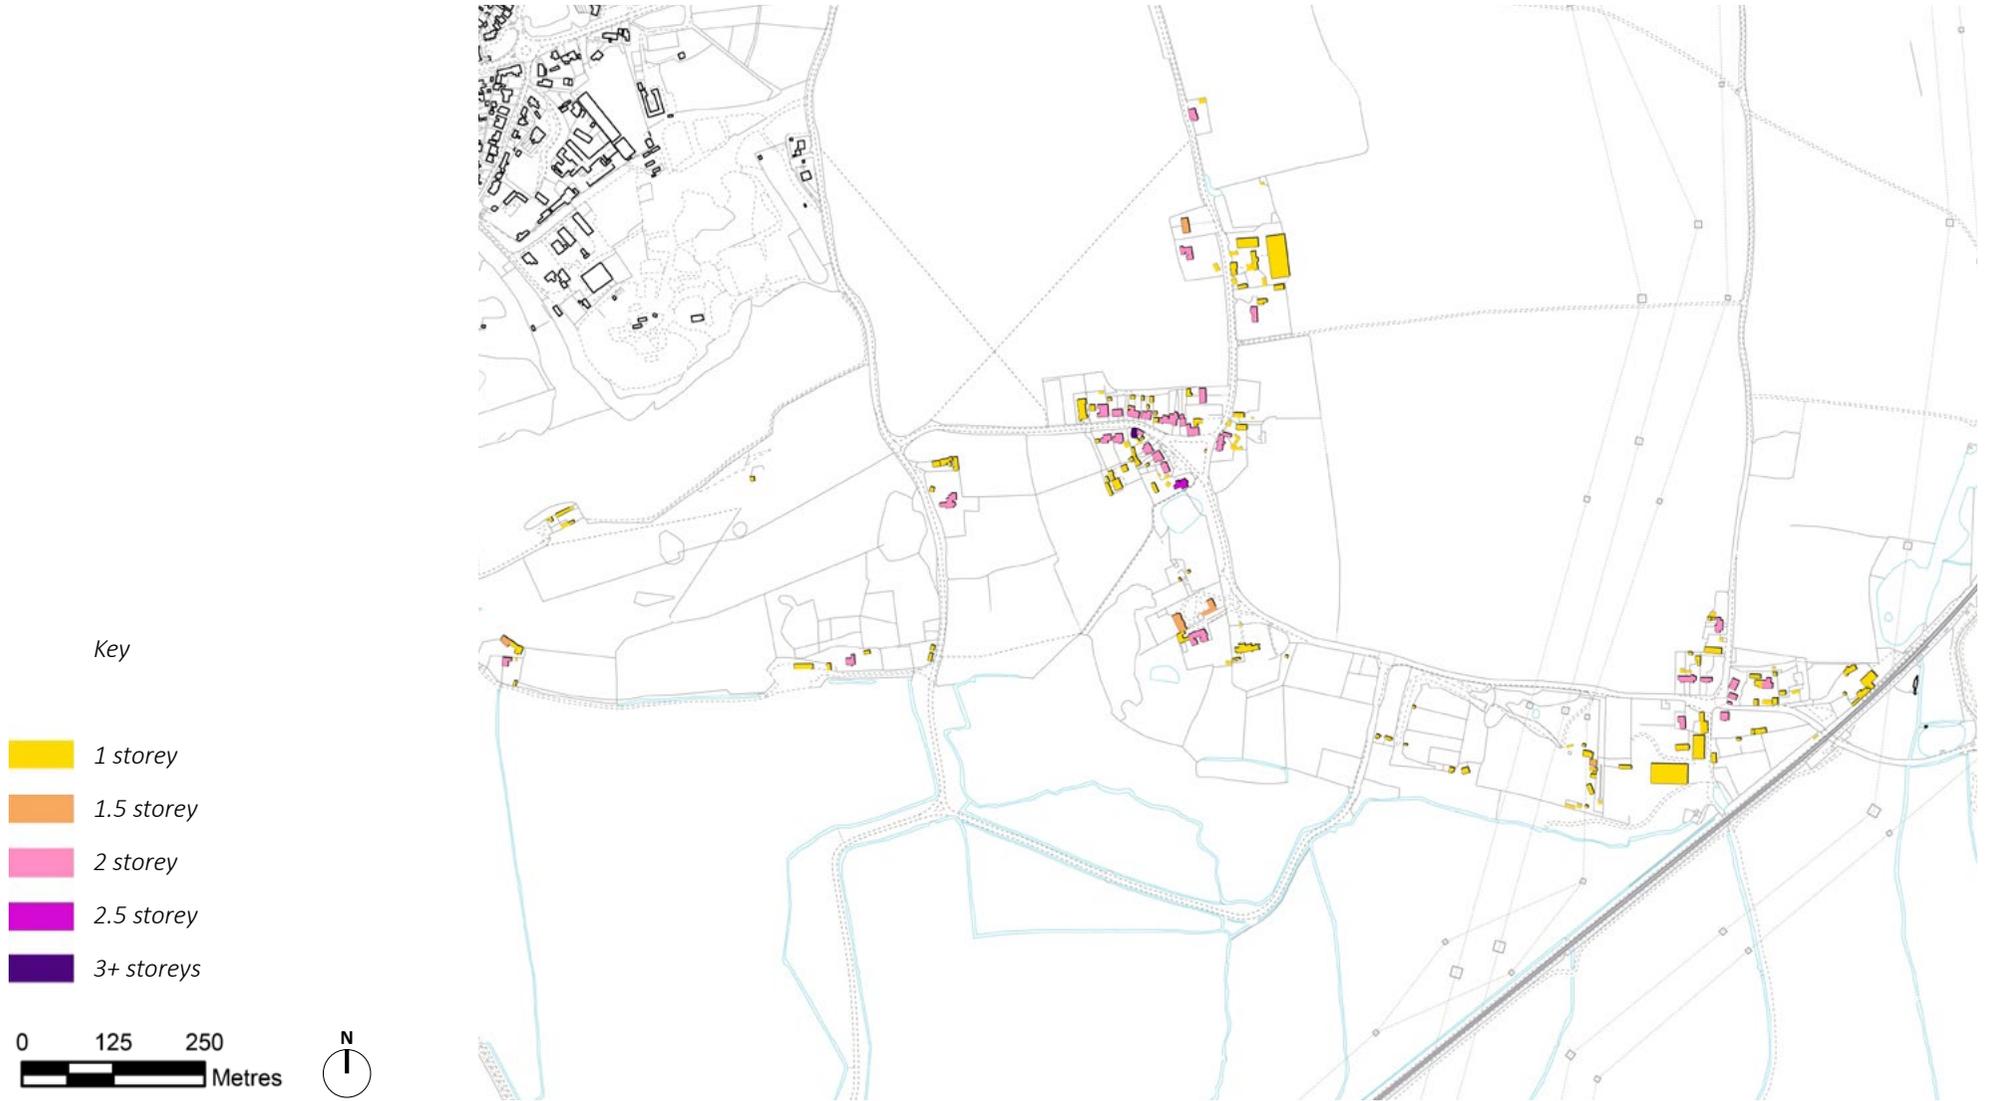
Fig 88. West Tilbury Building Height

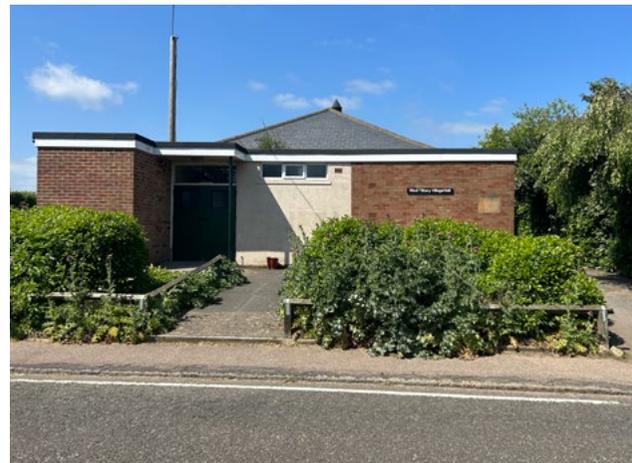
Fig 91. Village Hall

As well as the village hall, which is a single storey 20th century building, the Condovers Scout Activity Centre is located on Church Road, between the upper West Tilbury and Low Street. This consists mainly of an open activity field, as well as a bunk house and amenity storage sheds.
