West Thurrock Way Integration Feasibility Study

Lakeside Regional Town Centre

Thurrock Council

| Atkins Job Number: 5120007 | Document Reference: Lakeside Regional Town Centre West Thurrock Way Integration Study: Baseline Review | | | | | |

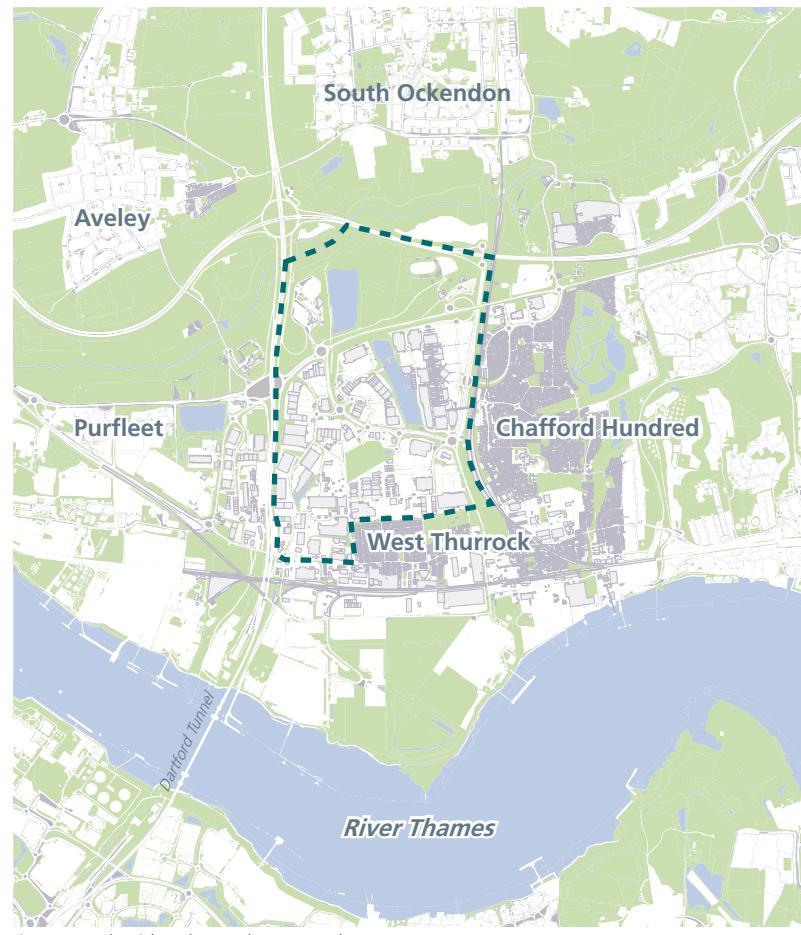
Figure 1 Lakeside, Thurrock Masterplan Area

The masterplan area outlined in the brief encompasses the Lakeside Retail Park and shopping complex, bounded by the A13, M25, A126 and Hilltop Road.

For the purposes of this study, a core study area centred around West Thurrock Way has also been highlighted (opposite) and forms the basis for subsequent visibility and accessibility analyses.

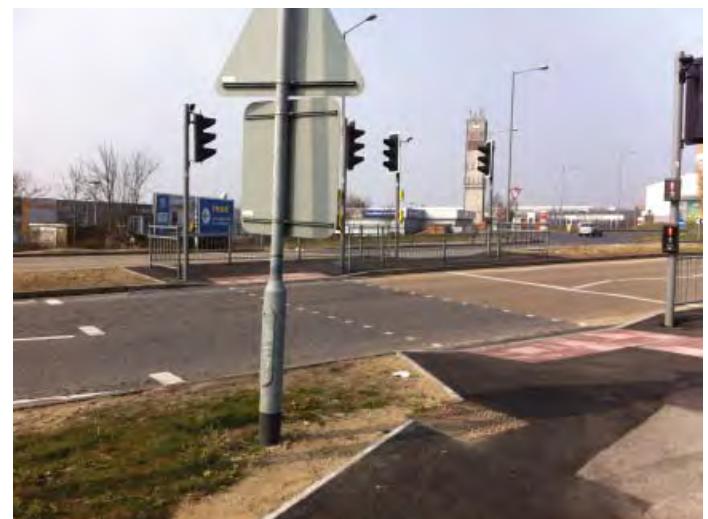
Figure 2 Pedestrian Crossing over West Thurrock Way

Other areas are linked by footways alongside main roads with four formal crossing points on West Thurrock Way: three pelican crossings and one zebra crossing.

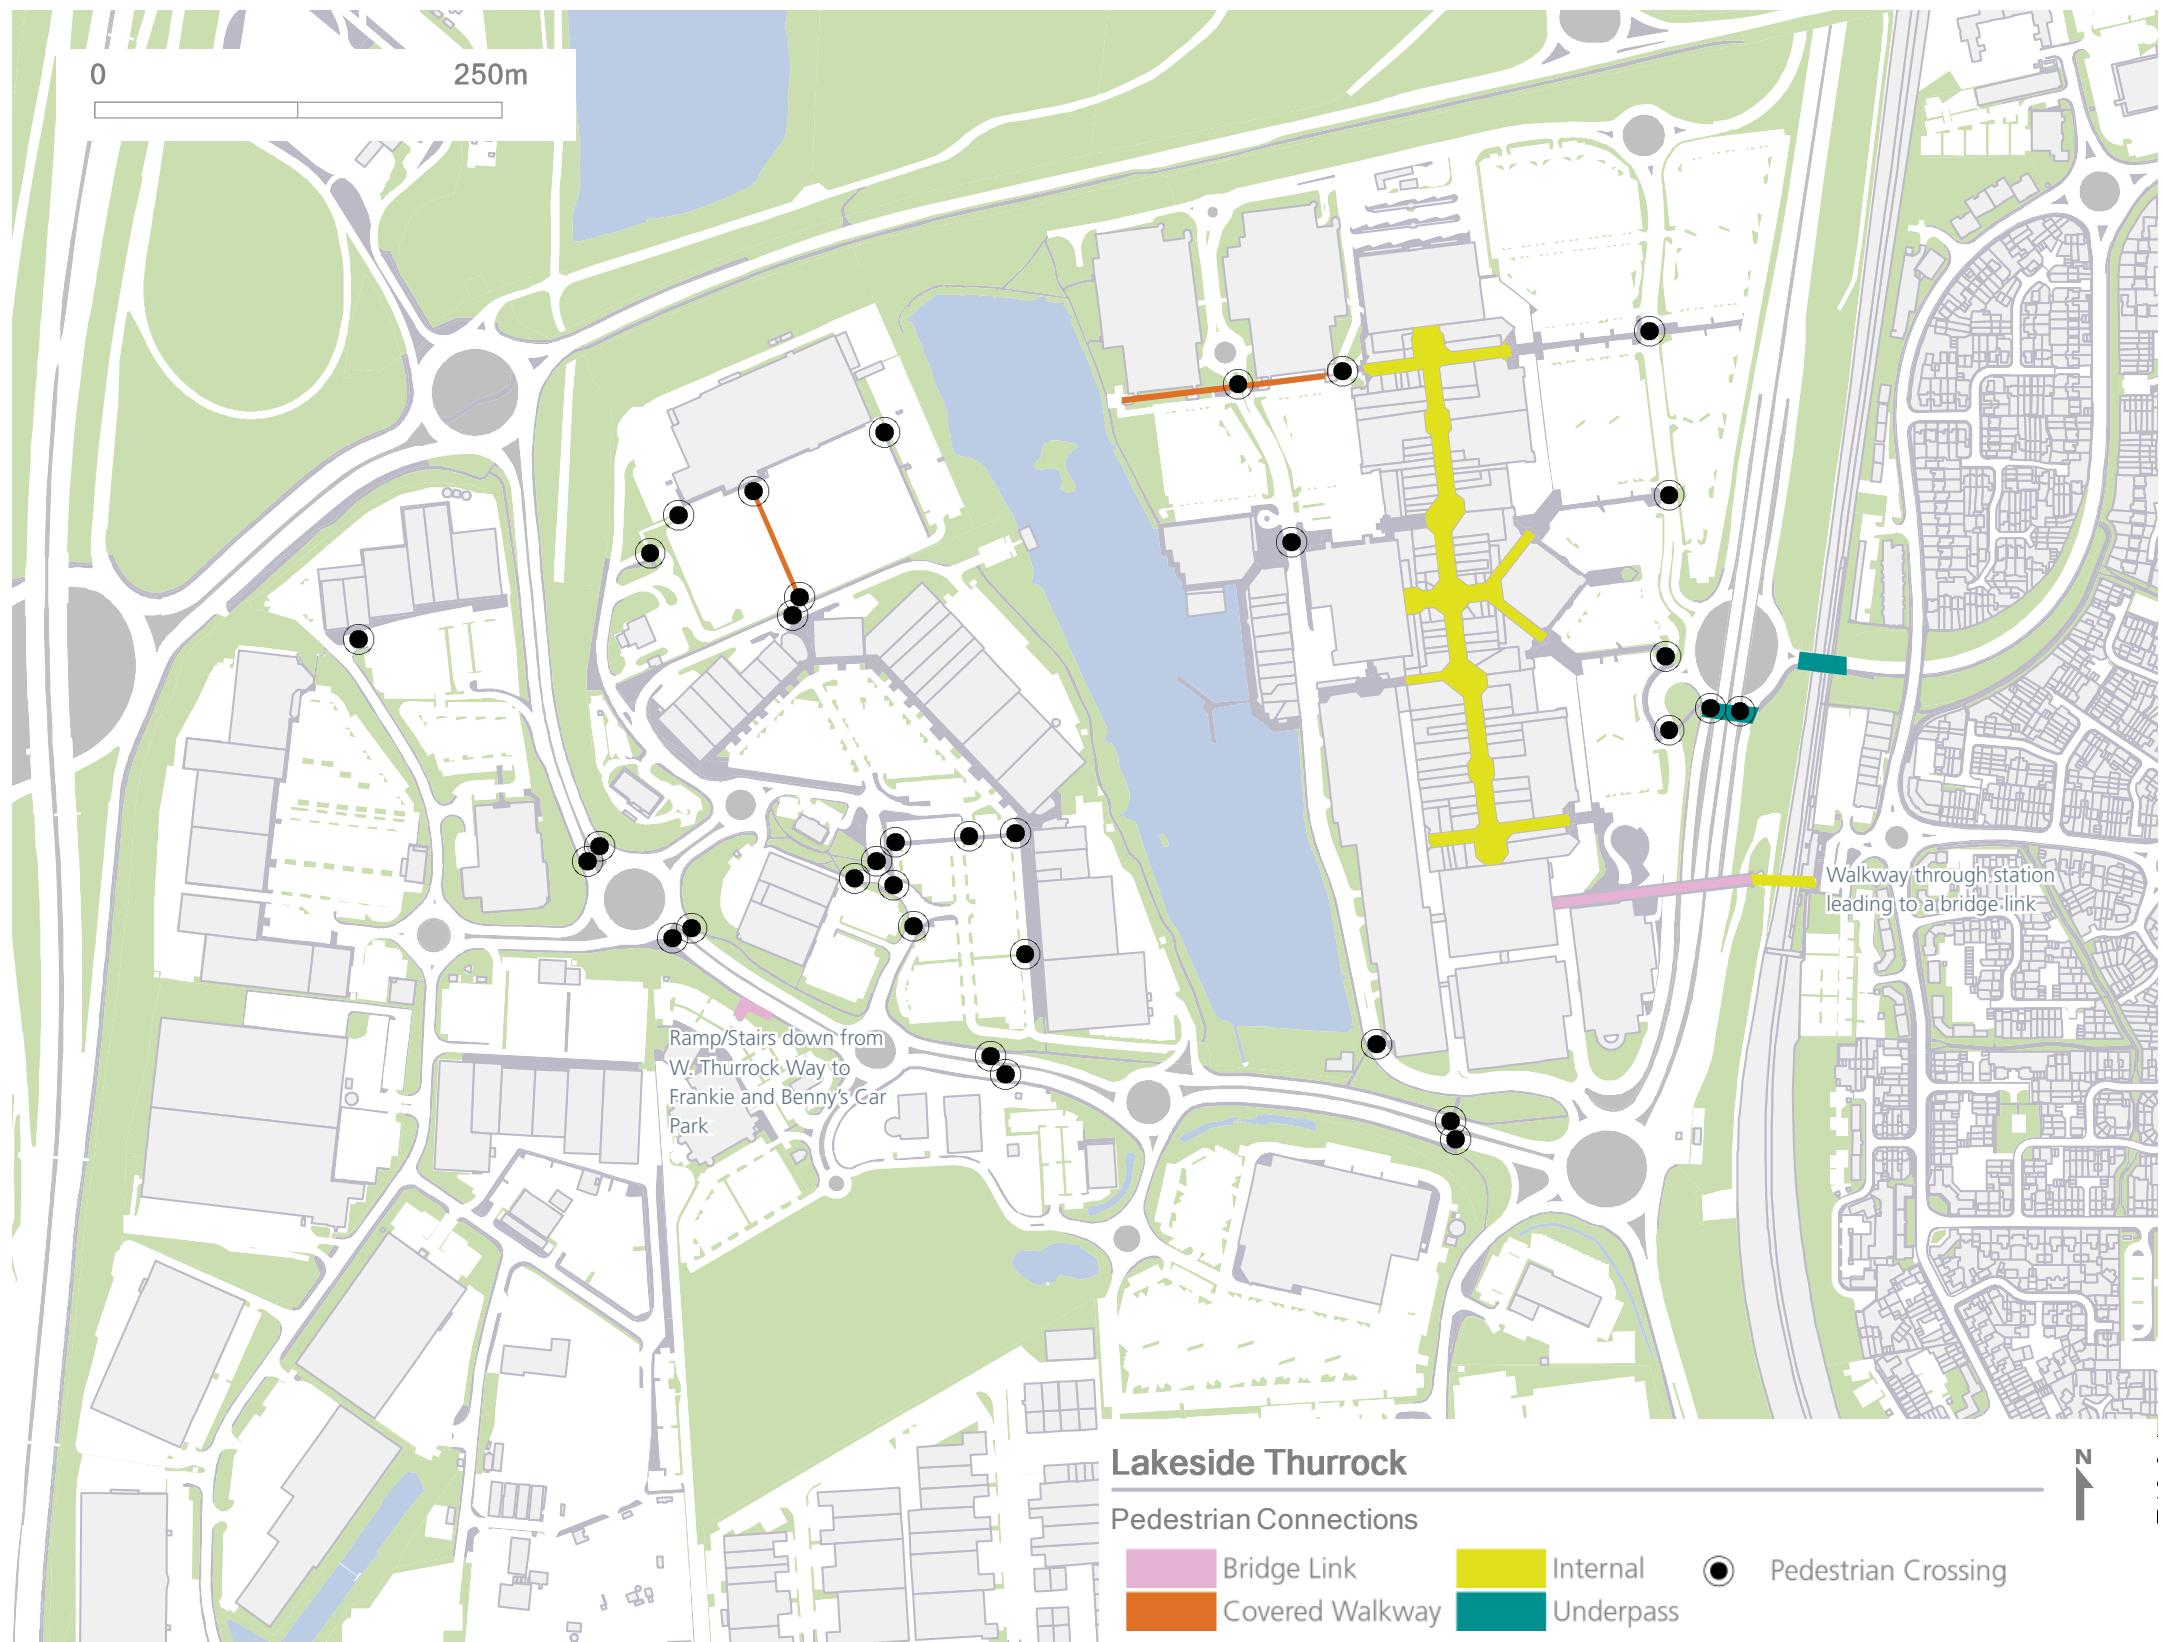
Figure 3 Pedestrian Connections across the West Thurrock Way Study Area

Car parks comprise a high proportion of the study area and pedestrian connections are provided on key routes to shops and supported with zebra crossings. Other pedestrian movements within these areas are generally on the carriageway or on grass verges.

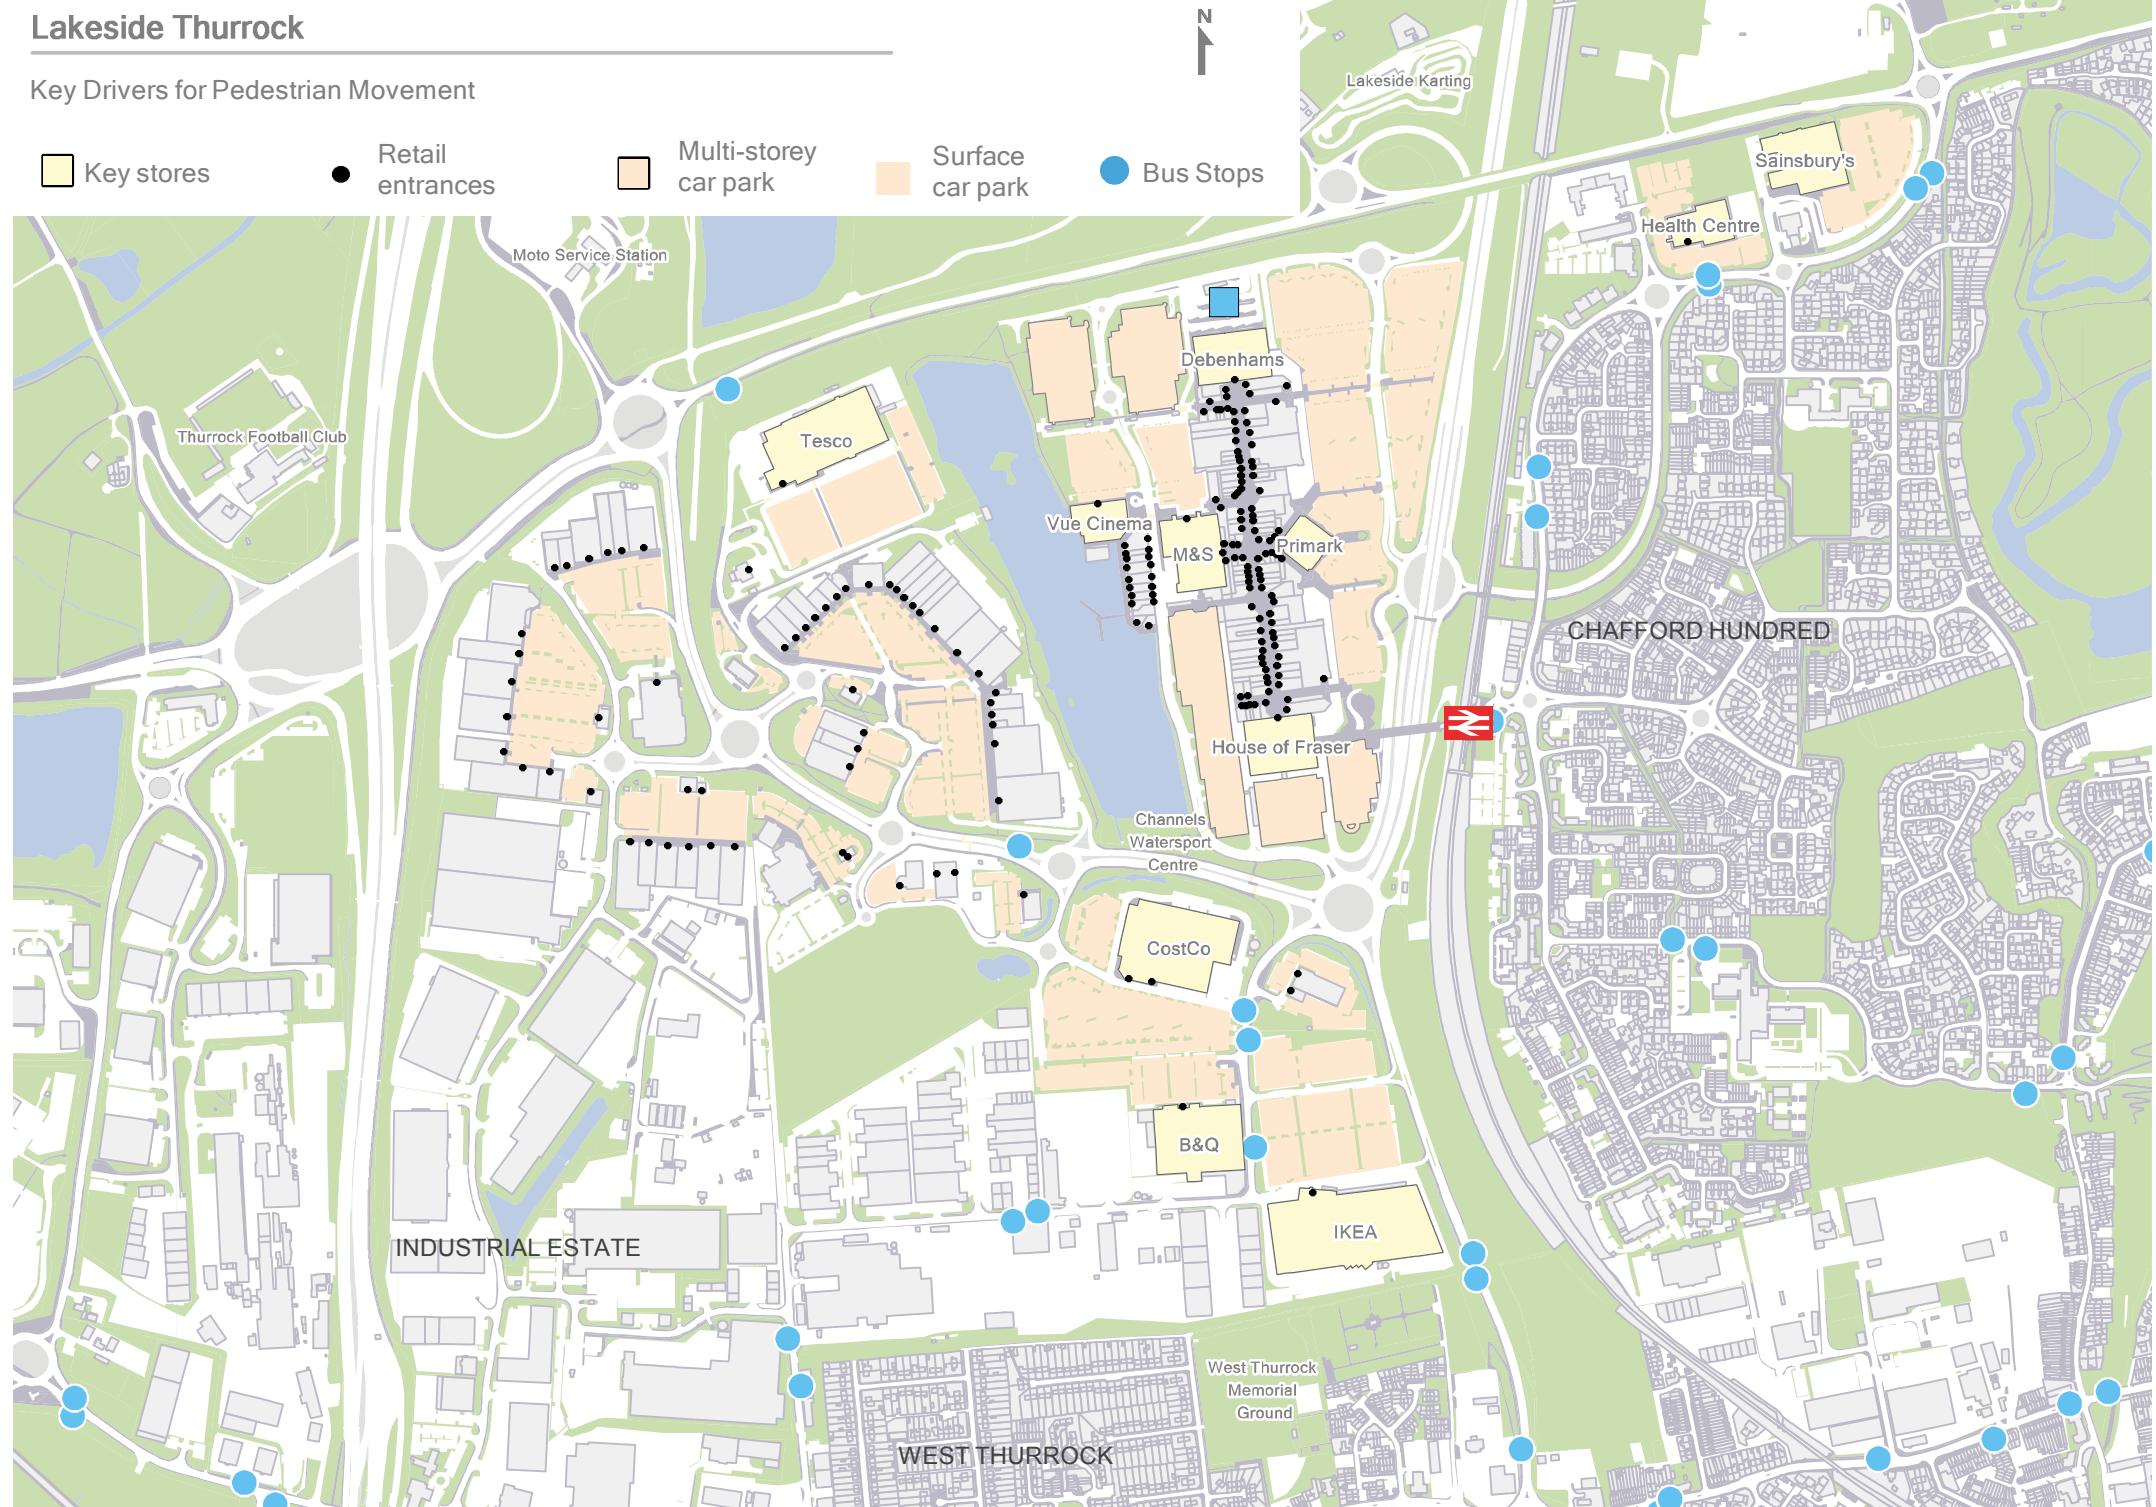
Figure 4 Key Drivers for Pedestrian Movement

The retail park and surrounding attractions are key drivers for pedestrian movement in the area. Major destination stores have been highlighted as likely significant nodes of activity, and other attractions outside the study area have been noted as peripheral drivers of pedestrian movement.

The location of car parks also represents a significant driver for certain movements as people walk between their car and retail entrances. This includes multi-storey car parks which generally have large expanses of inactive frontage but key entrances for movement.

The location of public transport infrastructure inherently plays a part in the movement of people through the study area, as pedestrians walk to and from bus stops and rail stations.

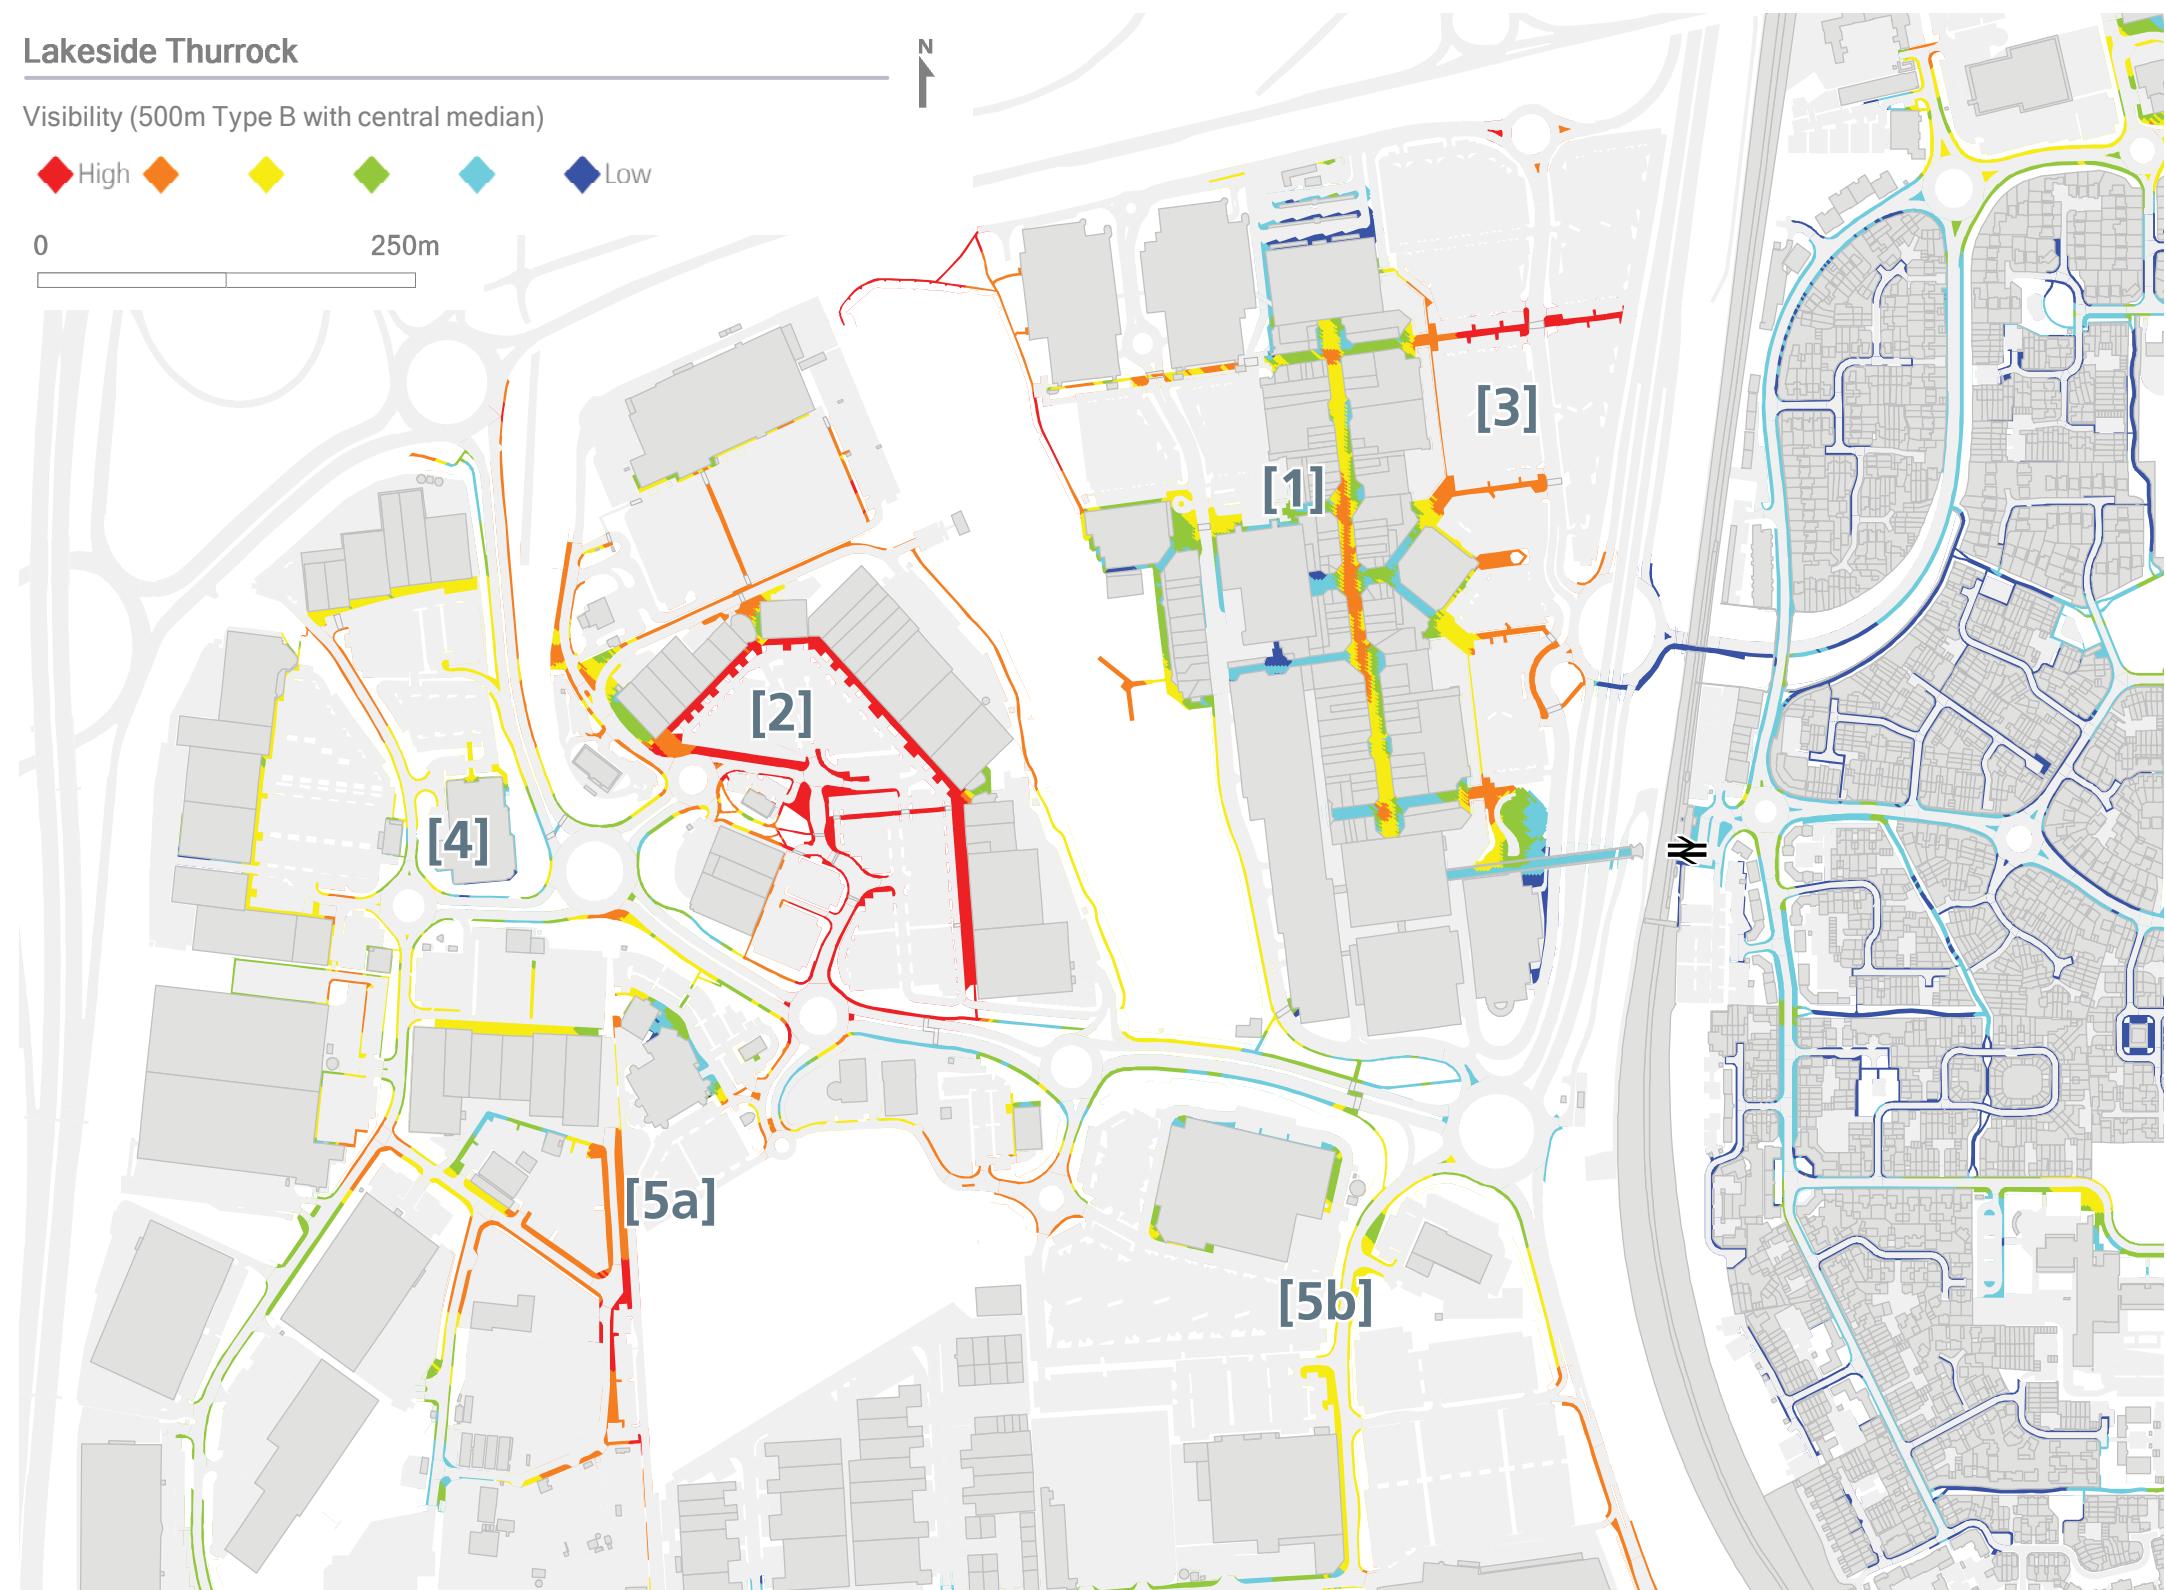
Figure 5 Street Network Visibility in Lakeside, Thurrock

The results show that the Lakeside Shopping Centre has moderate visibility internally, with lower levels at either end of the main hall. This is due to the slight kink (as noted at [1]) in the architecture of the building which restricts views from one end to the other. The shorter corridors perpendicular to the main central thoroughfare are inherently less visible.

Wider open spaces exhibit a higher field of visibility and therefore the central shopping park has highly visible footways [2]. The footway across the Lakeside car park is also highly visible as a result of its open aspect [3]. This improves the ease for pedestrians to navigate through the space. The retail outlets further west however have moderate visibility, as centrally located buildings sever sightlines and footway space is narrower.

The footways on West Thurrock Way highlight marked variations in visibility as one progresses west from the A126. The footways have relatively poor visibility until they open out onto the central retail space. Where trunk roads intersect the West Thurrock Way there is a temporary increase in visibility [5a & 5b], which improves navigational capacity for pedestrians.

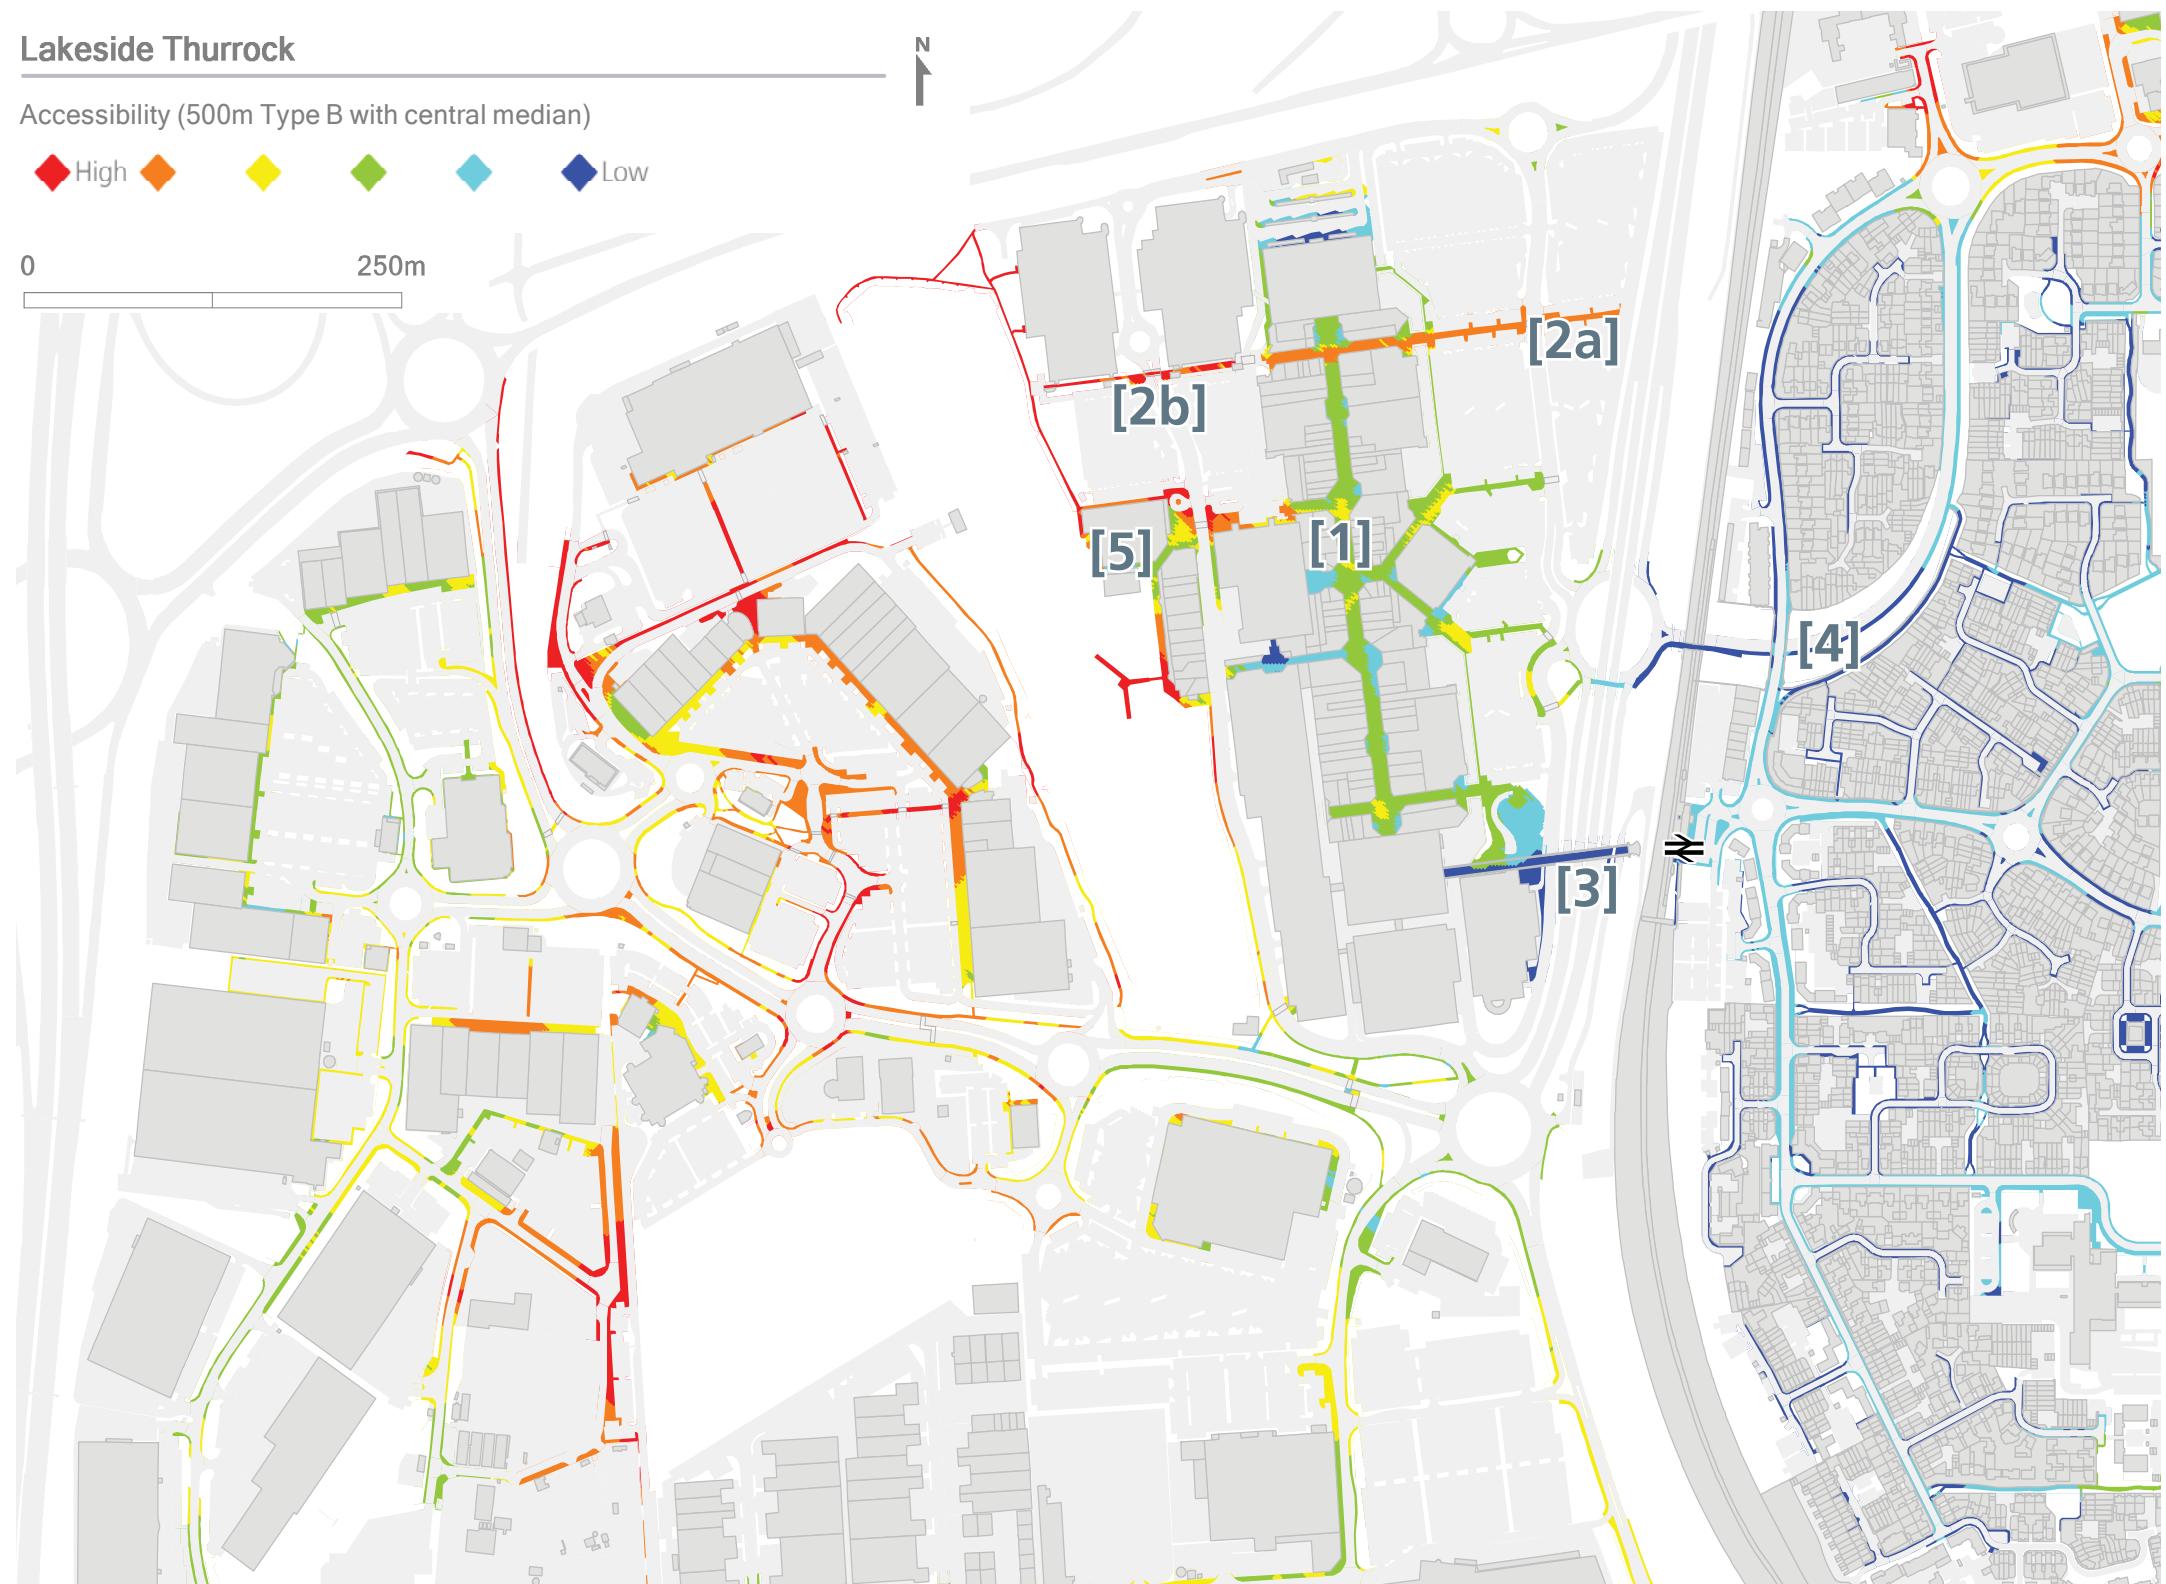
The south side of West Thurrock Way is shown to be less accessible than the north, as most of the pedestrian routes from the shopping centre link to the north side of the carriageway. The central stretch of this road is most accessible with peak values next to the roundabout around the main retail area. Further west, the retail outlets are more detached and are less accessible for pedestrians.

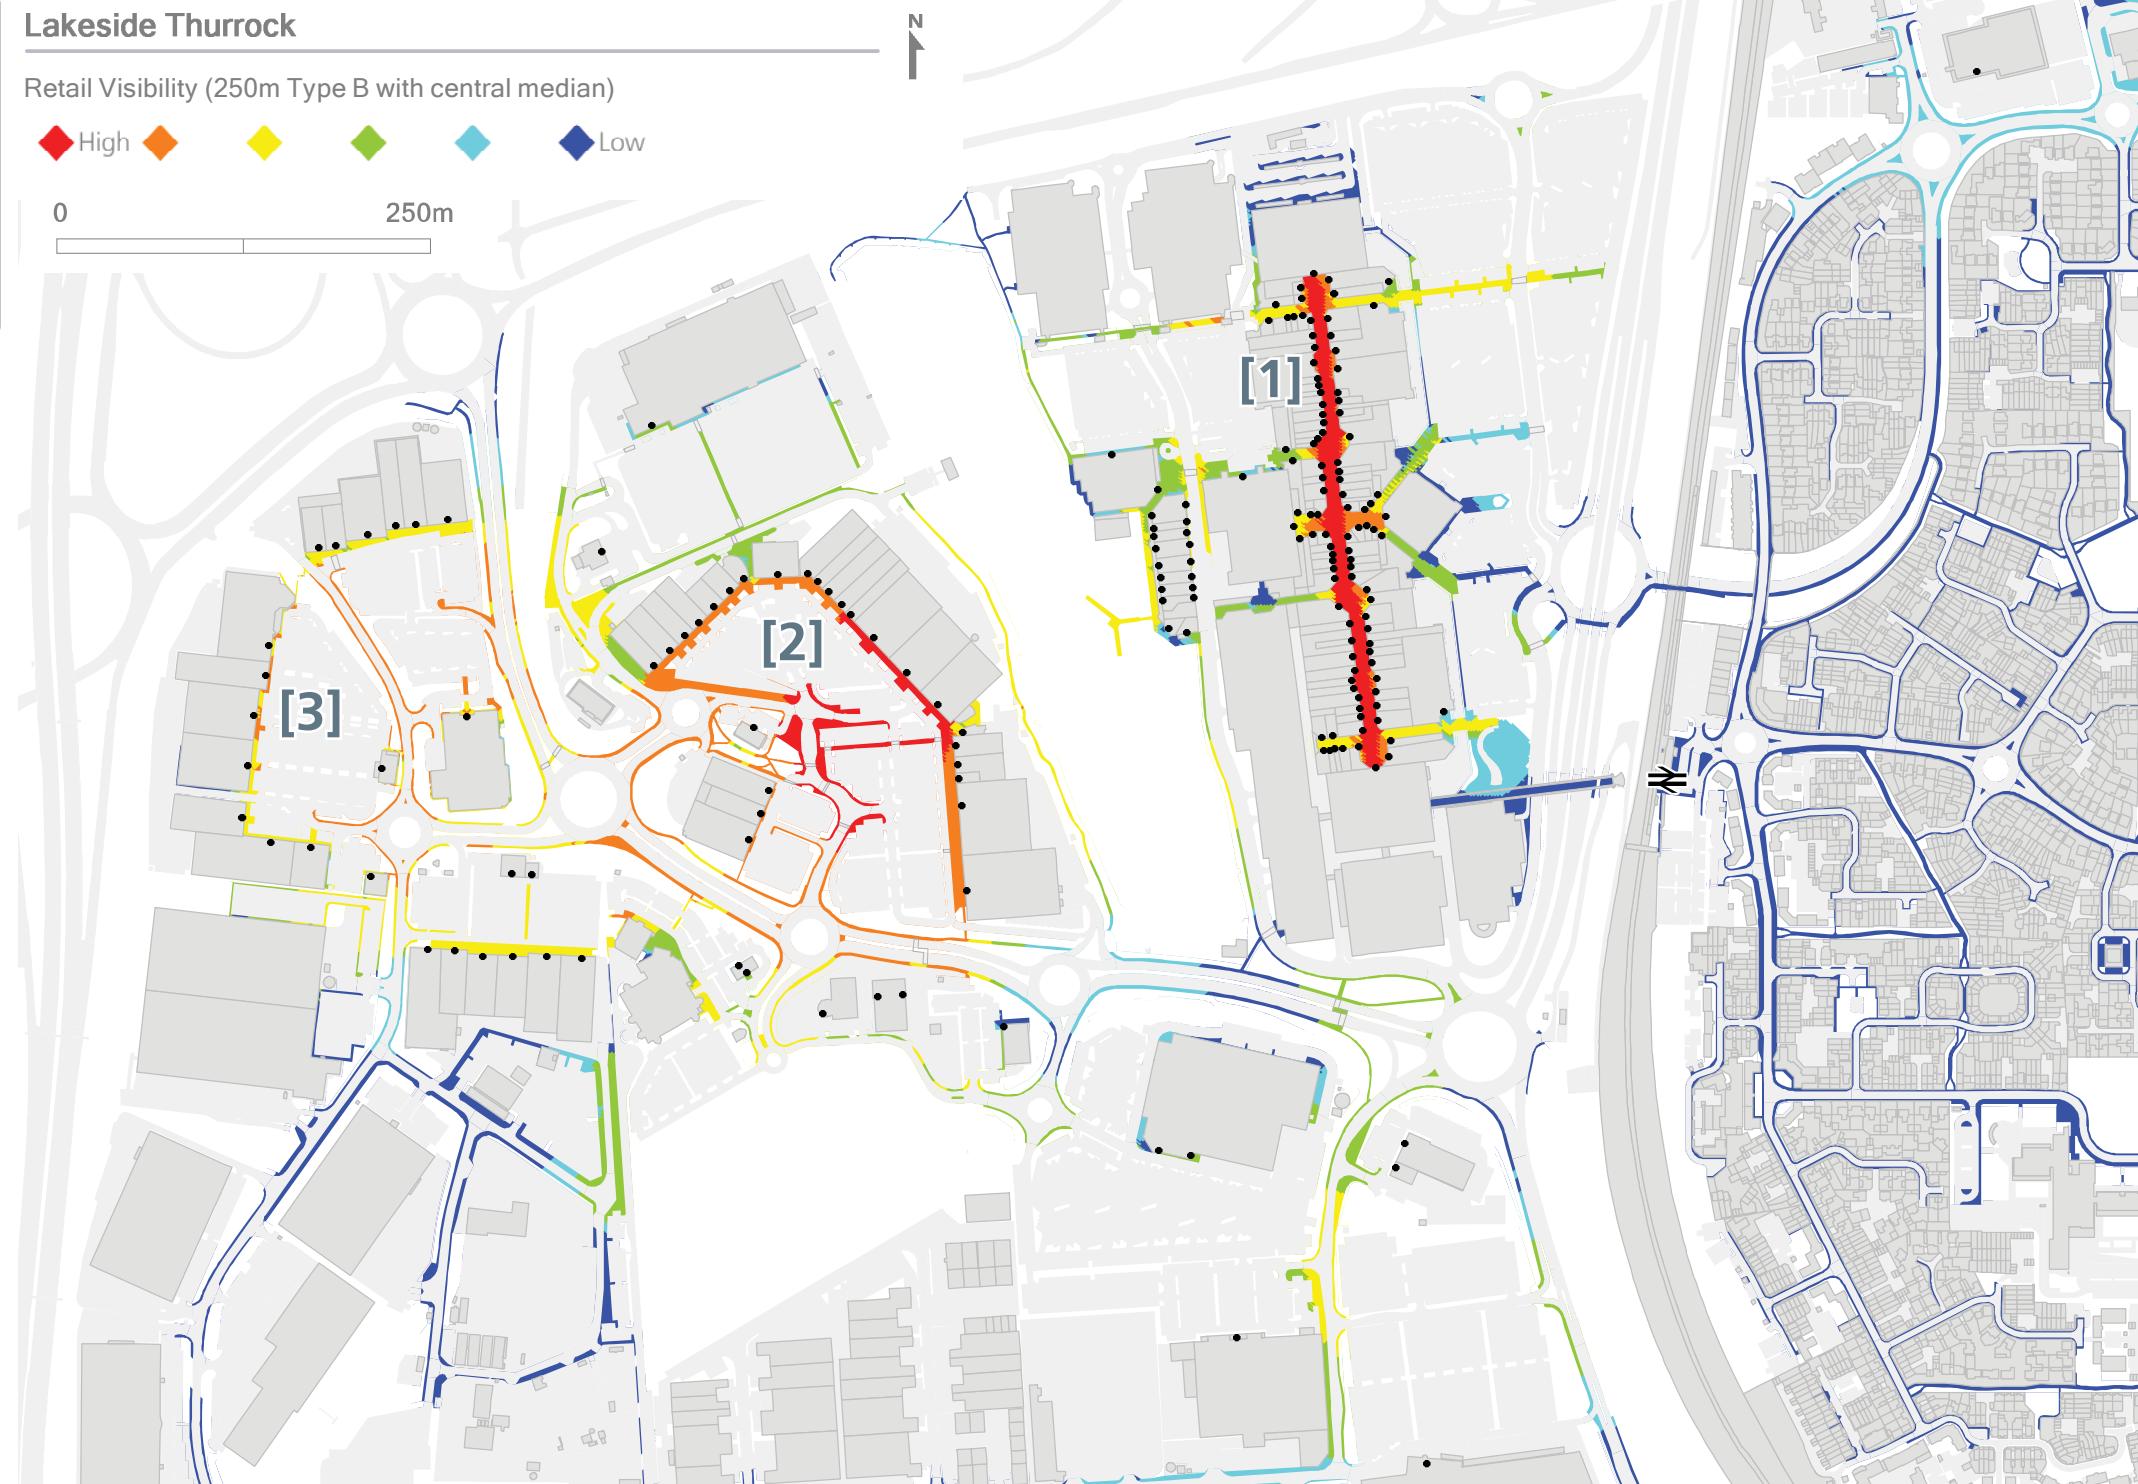
Figure 7 Retail Units in View in Lakeside, Thurrock

On West Thurrock Way, the retail visibility progressively increases from east to west, as the inward facing shopfronts of the Lakeside Centre are not visible while the more open architecture of the retail park becomes increasingly visible further west.

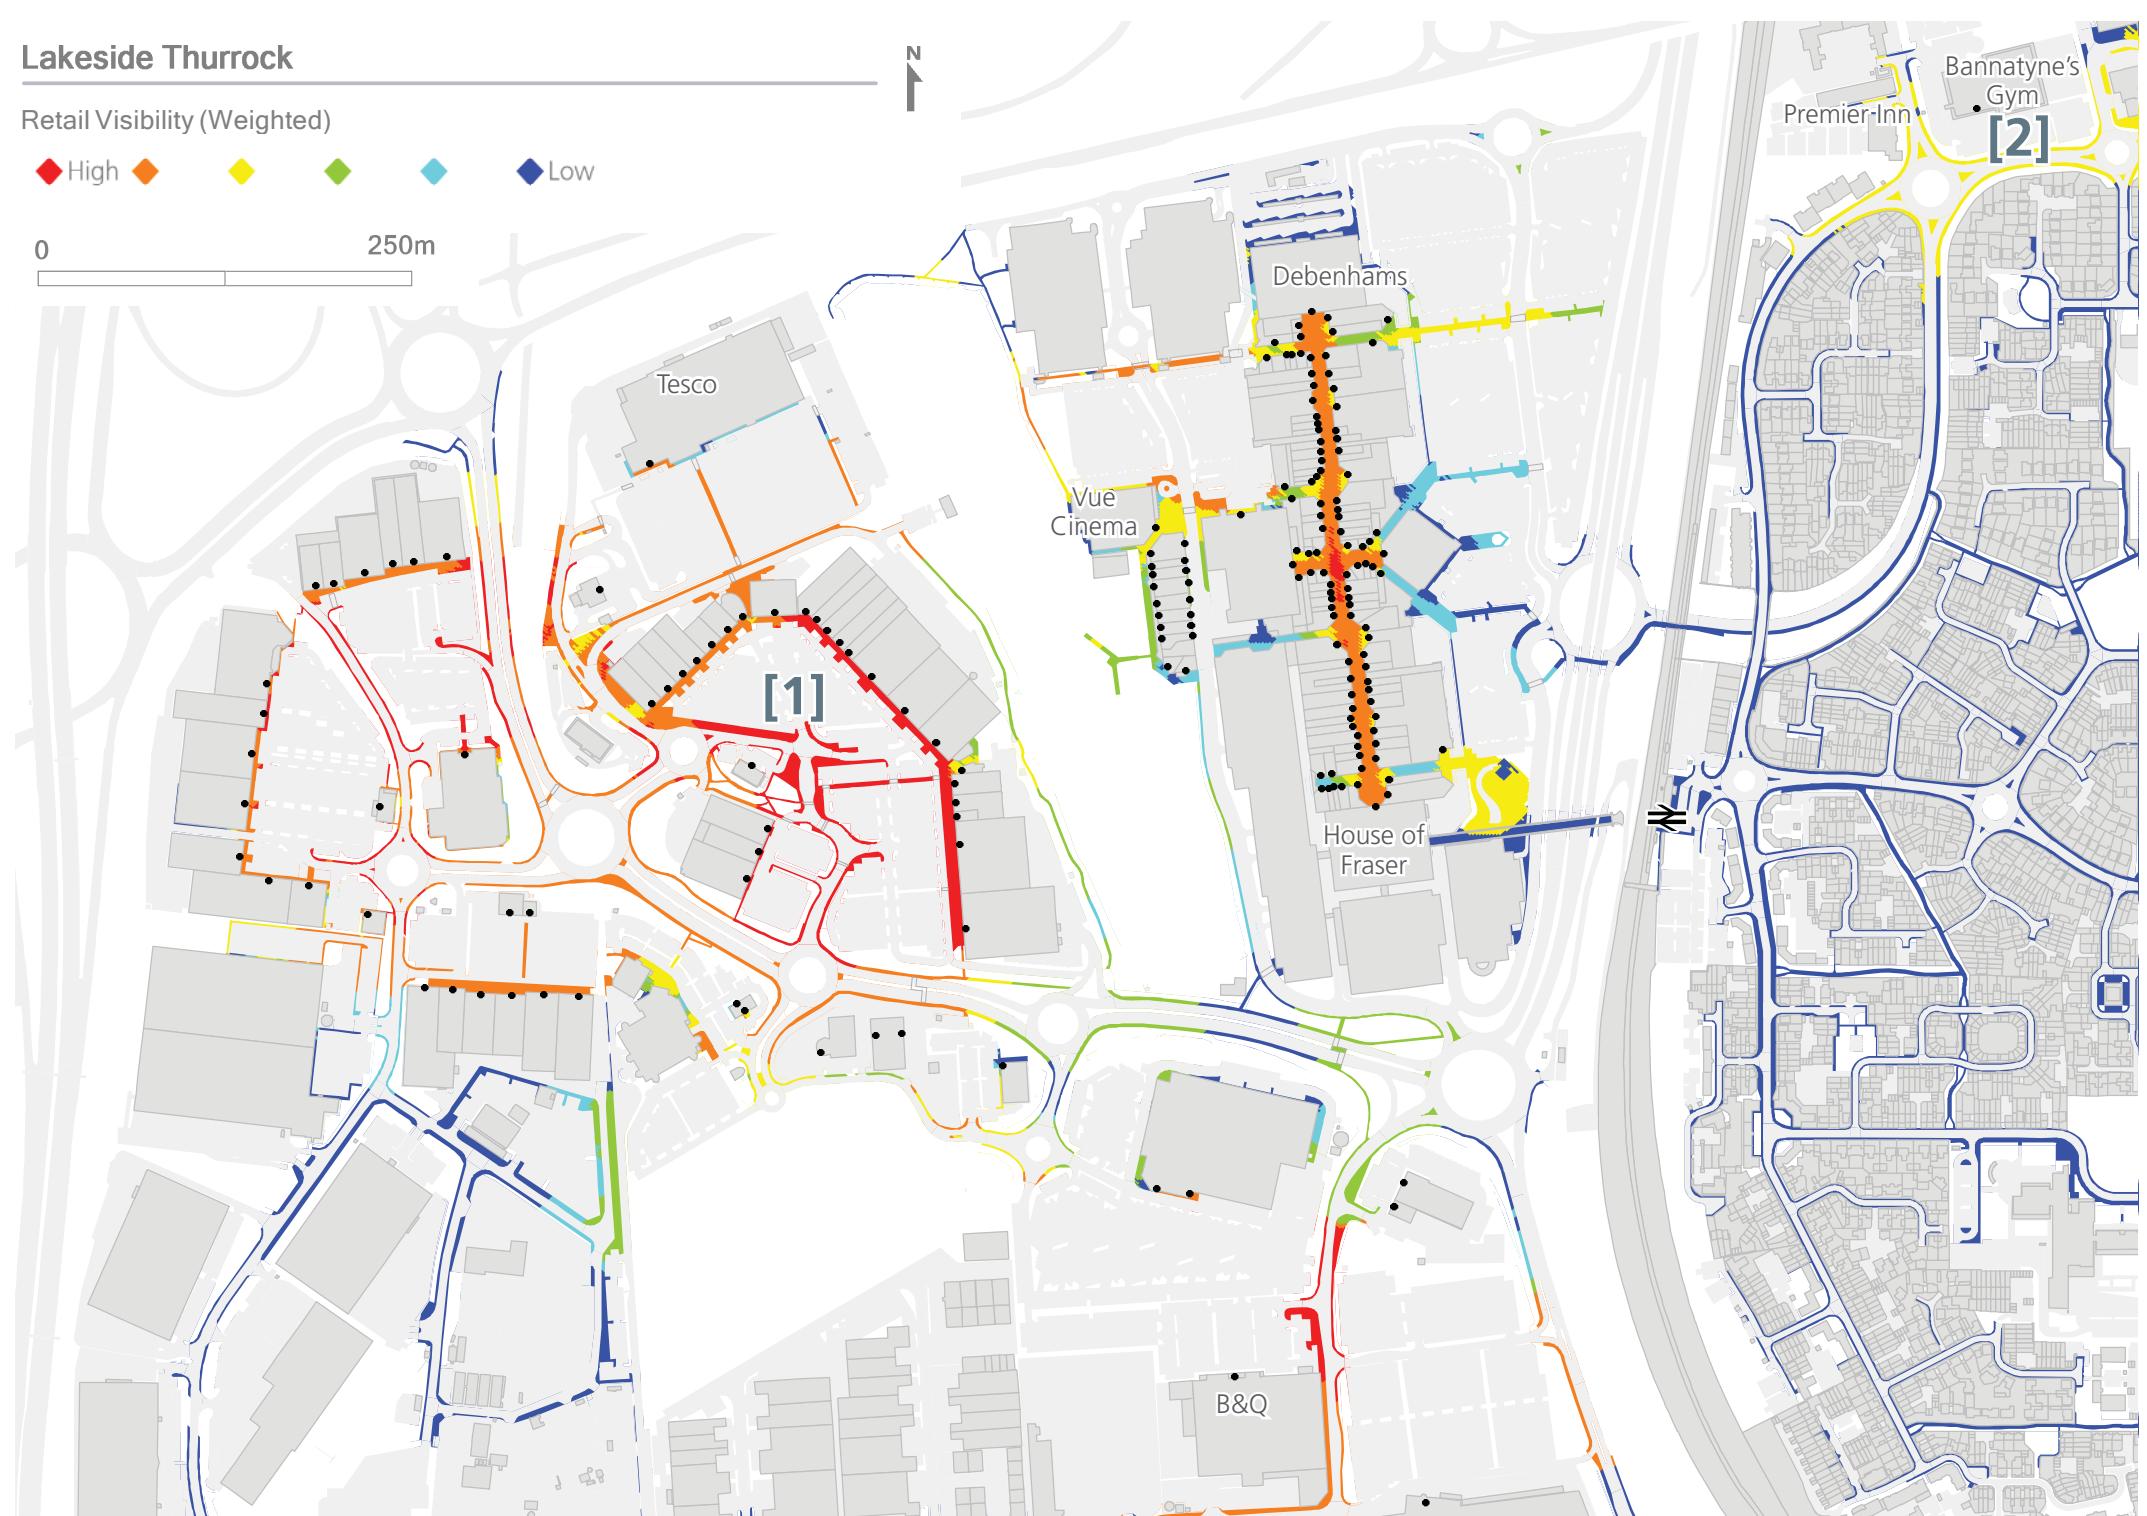
Figure 8 Retail Units in View (weighted by their ground floor area)

West Thurrock Way however remains generally low in retail visibility, especially towards the east end. The larger floor spaces occupied by Bannatyne's Gym and Sainsburys to the north east improve the attractiveness of this area in terms of visibility of retail, food and drink destinations [2].
