West Thurrock Way Integration Feasibility Study

Lakeside Regional Town Centre

Thurrock Council

| Atkins Job Number: 5120007 | Document Reference: Lakeside Regional Town Centre West Thurrock Way Integration Study: Baseline Review | | | | | |

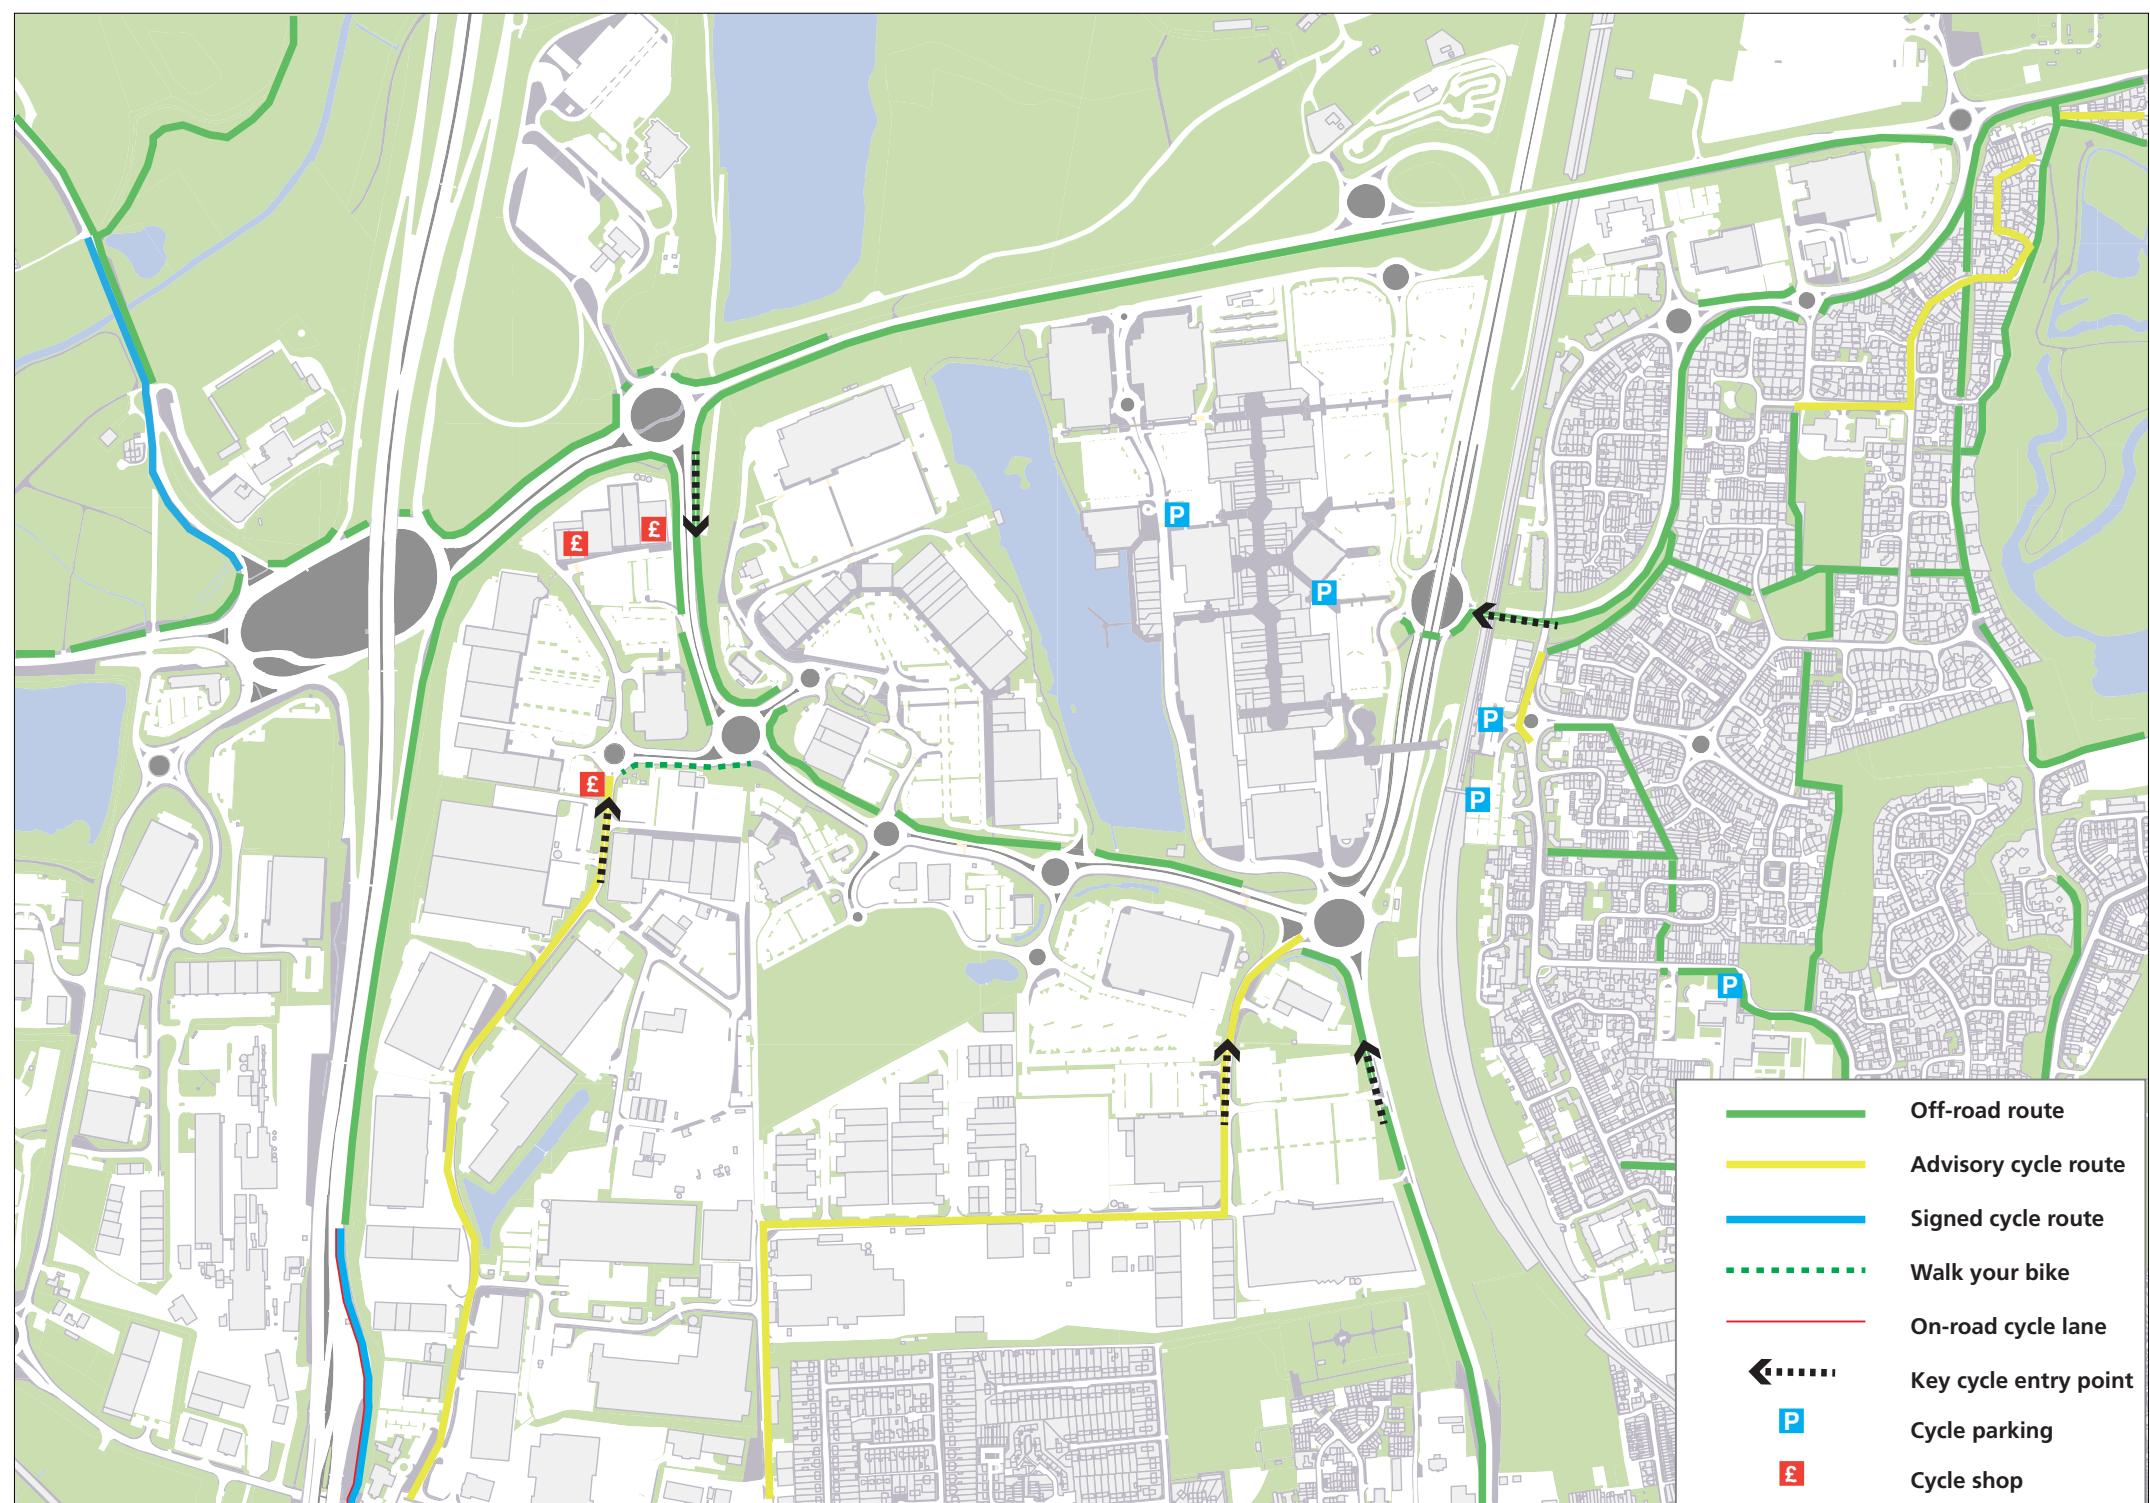
Figure 9 Existing cycle infrastructure

West Thurrock Way presents a challenging environment for cyclists in terms of poor road crossing facilities and poor connections with strategic routes. Despite this staff working at some of the retail units were observed to be using their cycles albeit in low numbers.

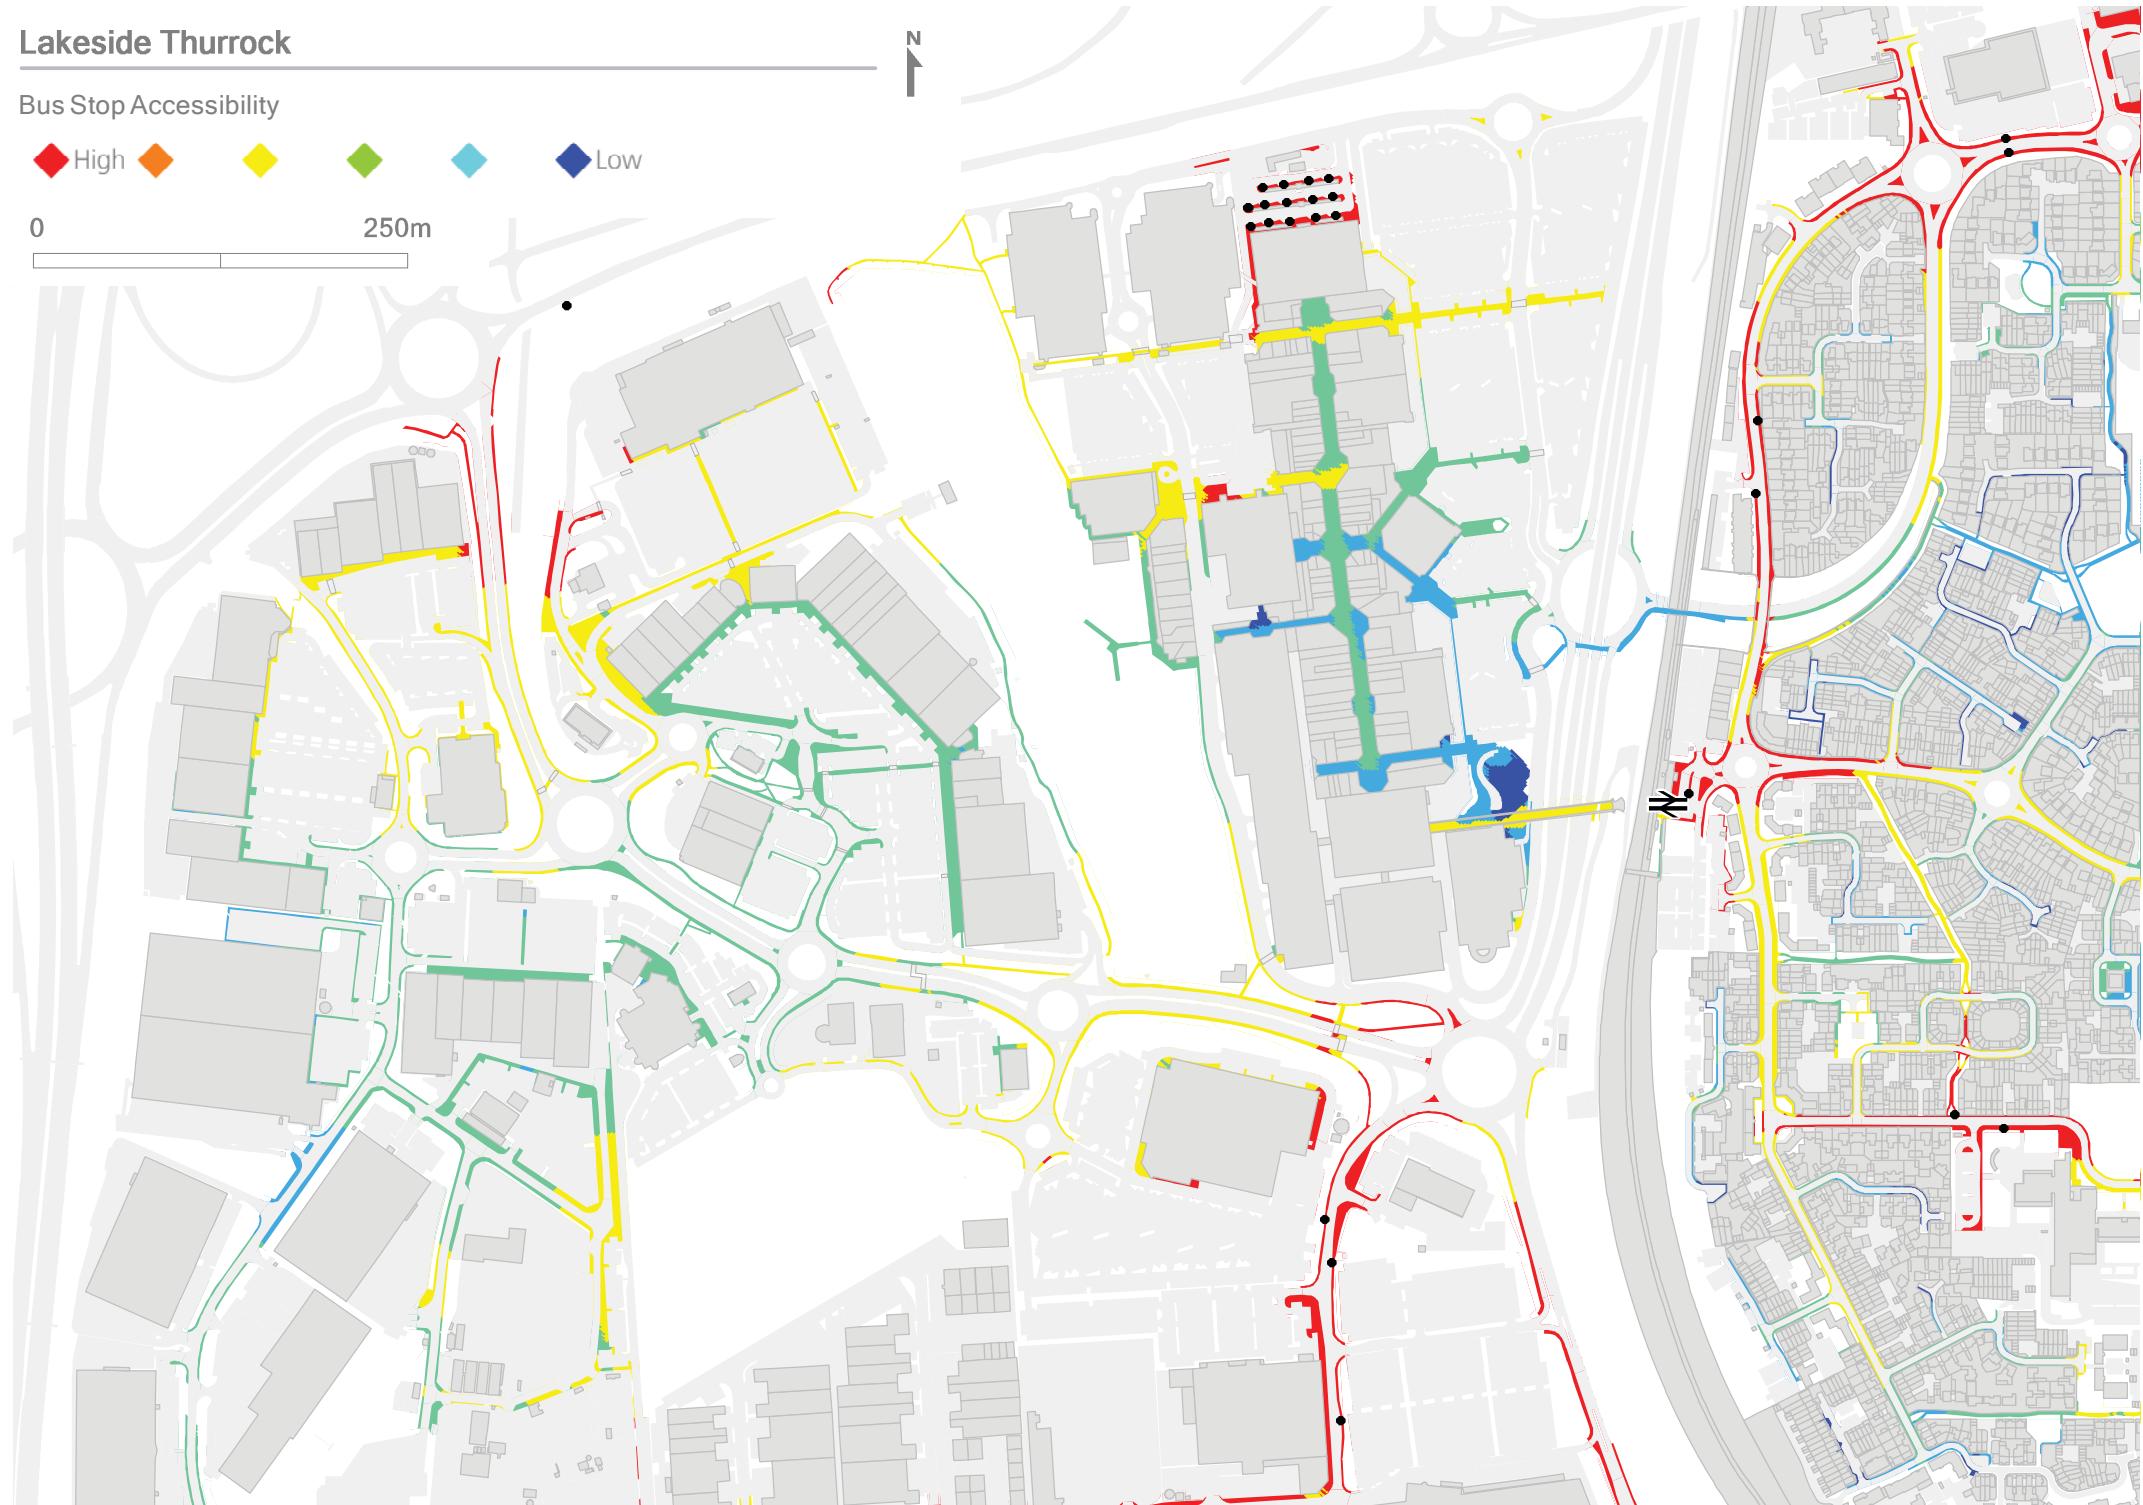
Figure 11 FATHOM model of bus accessibility

The ease of accessibility to the bus network was calculated using Visibility Graph Analysis software with a 3m grid. This enables the proximity to an operational bus stop to be shown based on how many changes of direction are required: low accessibility is the result of numerous changes of direction from a particular location.

Chafford Hundred is served by the 33 and X80, both of which terminate at the Lakeside Centre. This suggests that the shopping centre is well integrated with the wider area but that the specific location of the bus station is not especially accessible for the retail park as a whole.

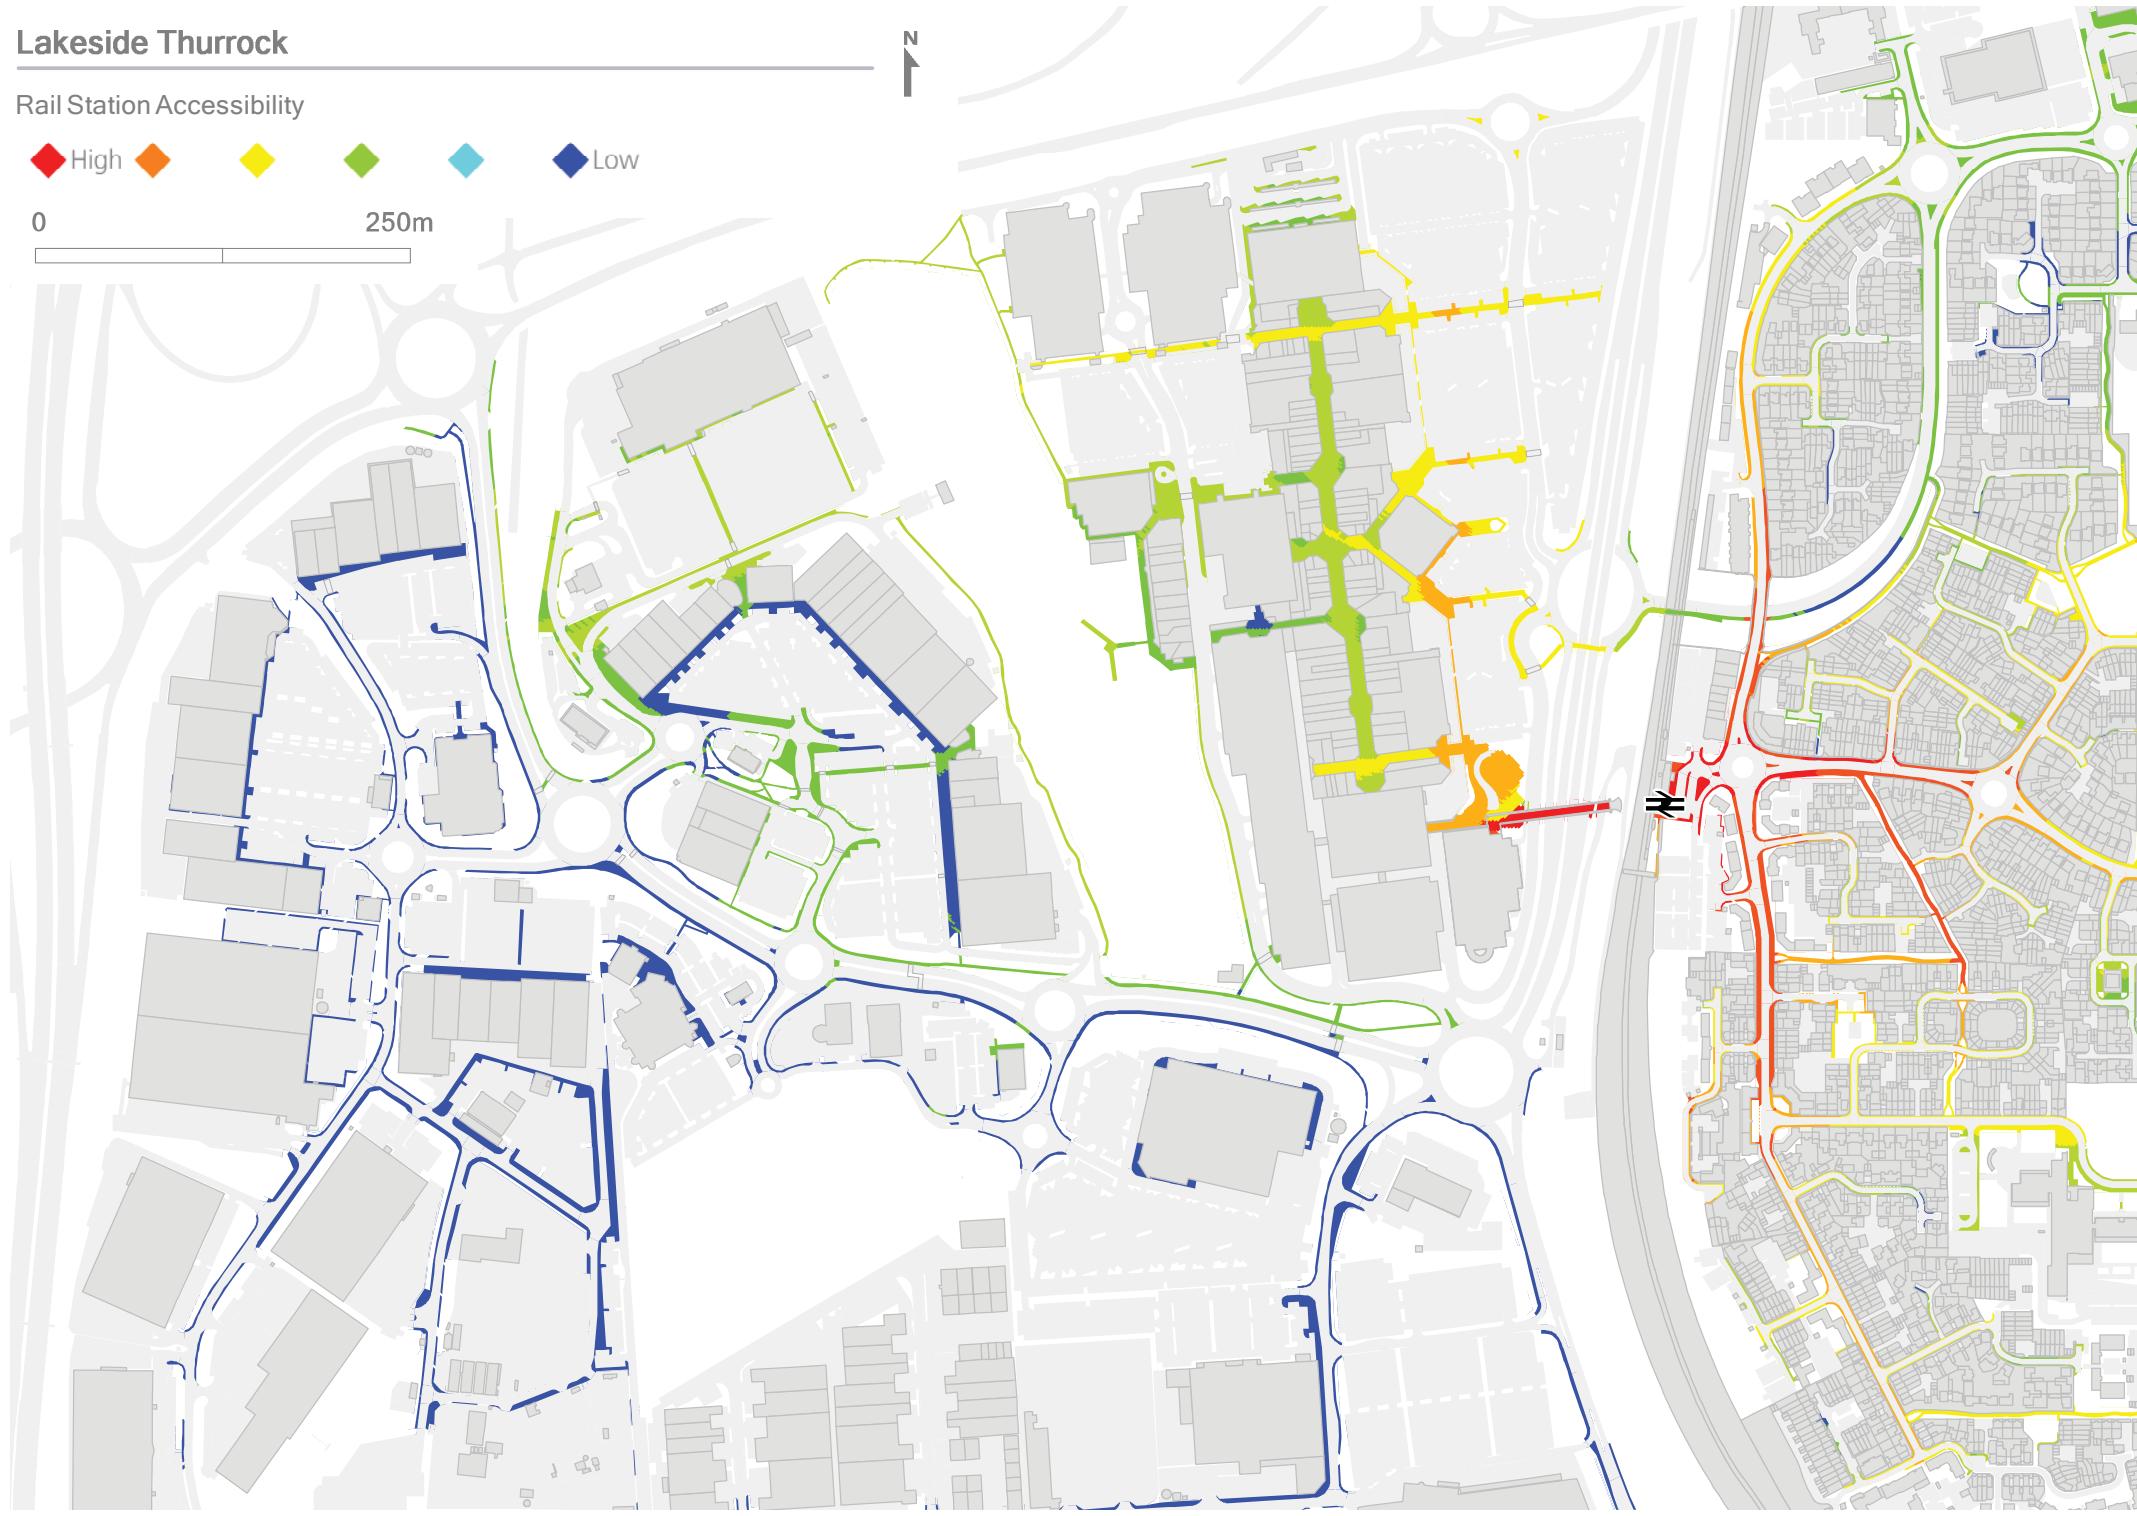
Figure 12 FATHOM model of rail accessibility

Visibility Graph Analysis was conducted at 3m intervals to assess the accessibility of rail infrastructure.

The accessibility results show that the radiating street network eastwards towards the town of Chafford Hundred provides relatively good accessibility to the station. However rail accessibility to the study area is severed by the A126, with low values shown immediately beyond the footbridge. Despite this well connected pedestrian link at the station side, the internal retail complex is spatially detached from the station, as a number of changes in direction are required. The only other pedestrian access across the A126 requires a convoluted route north and then back on the B186.

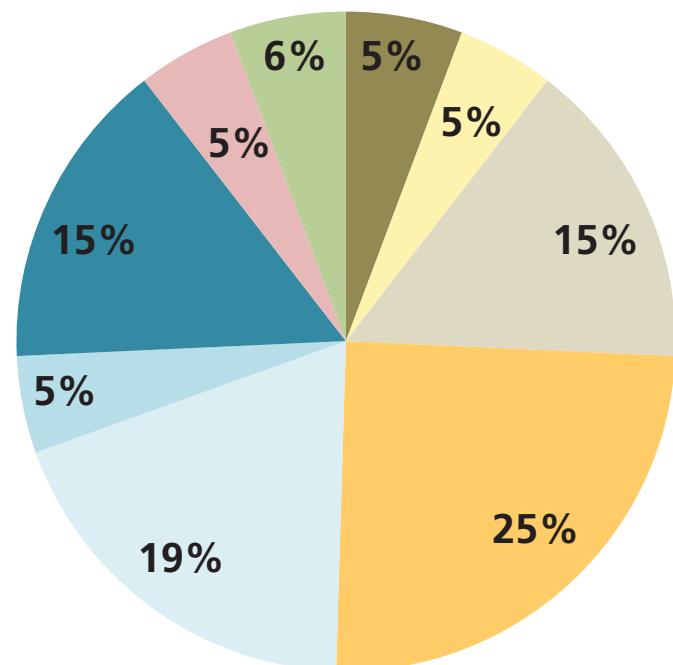
Figure 15 Accident causes (where 5 or more accidents have recorded the cause)

The pie chart opposite shows the most common causes of accidents where more than 5 instances have occurred. 50% of causes relate to "poor judgement, poor manoeuvre, or poor observation" highlighting that more can be done to improve conditions and user behaviour. The data form used by police officers is shown opposite.

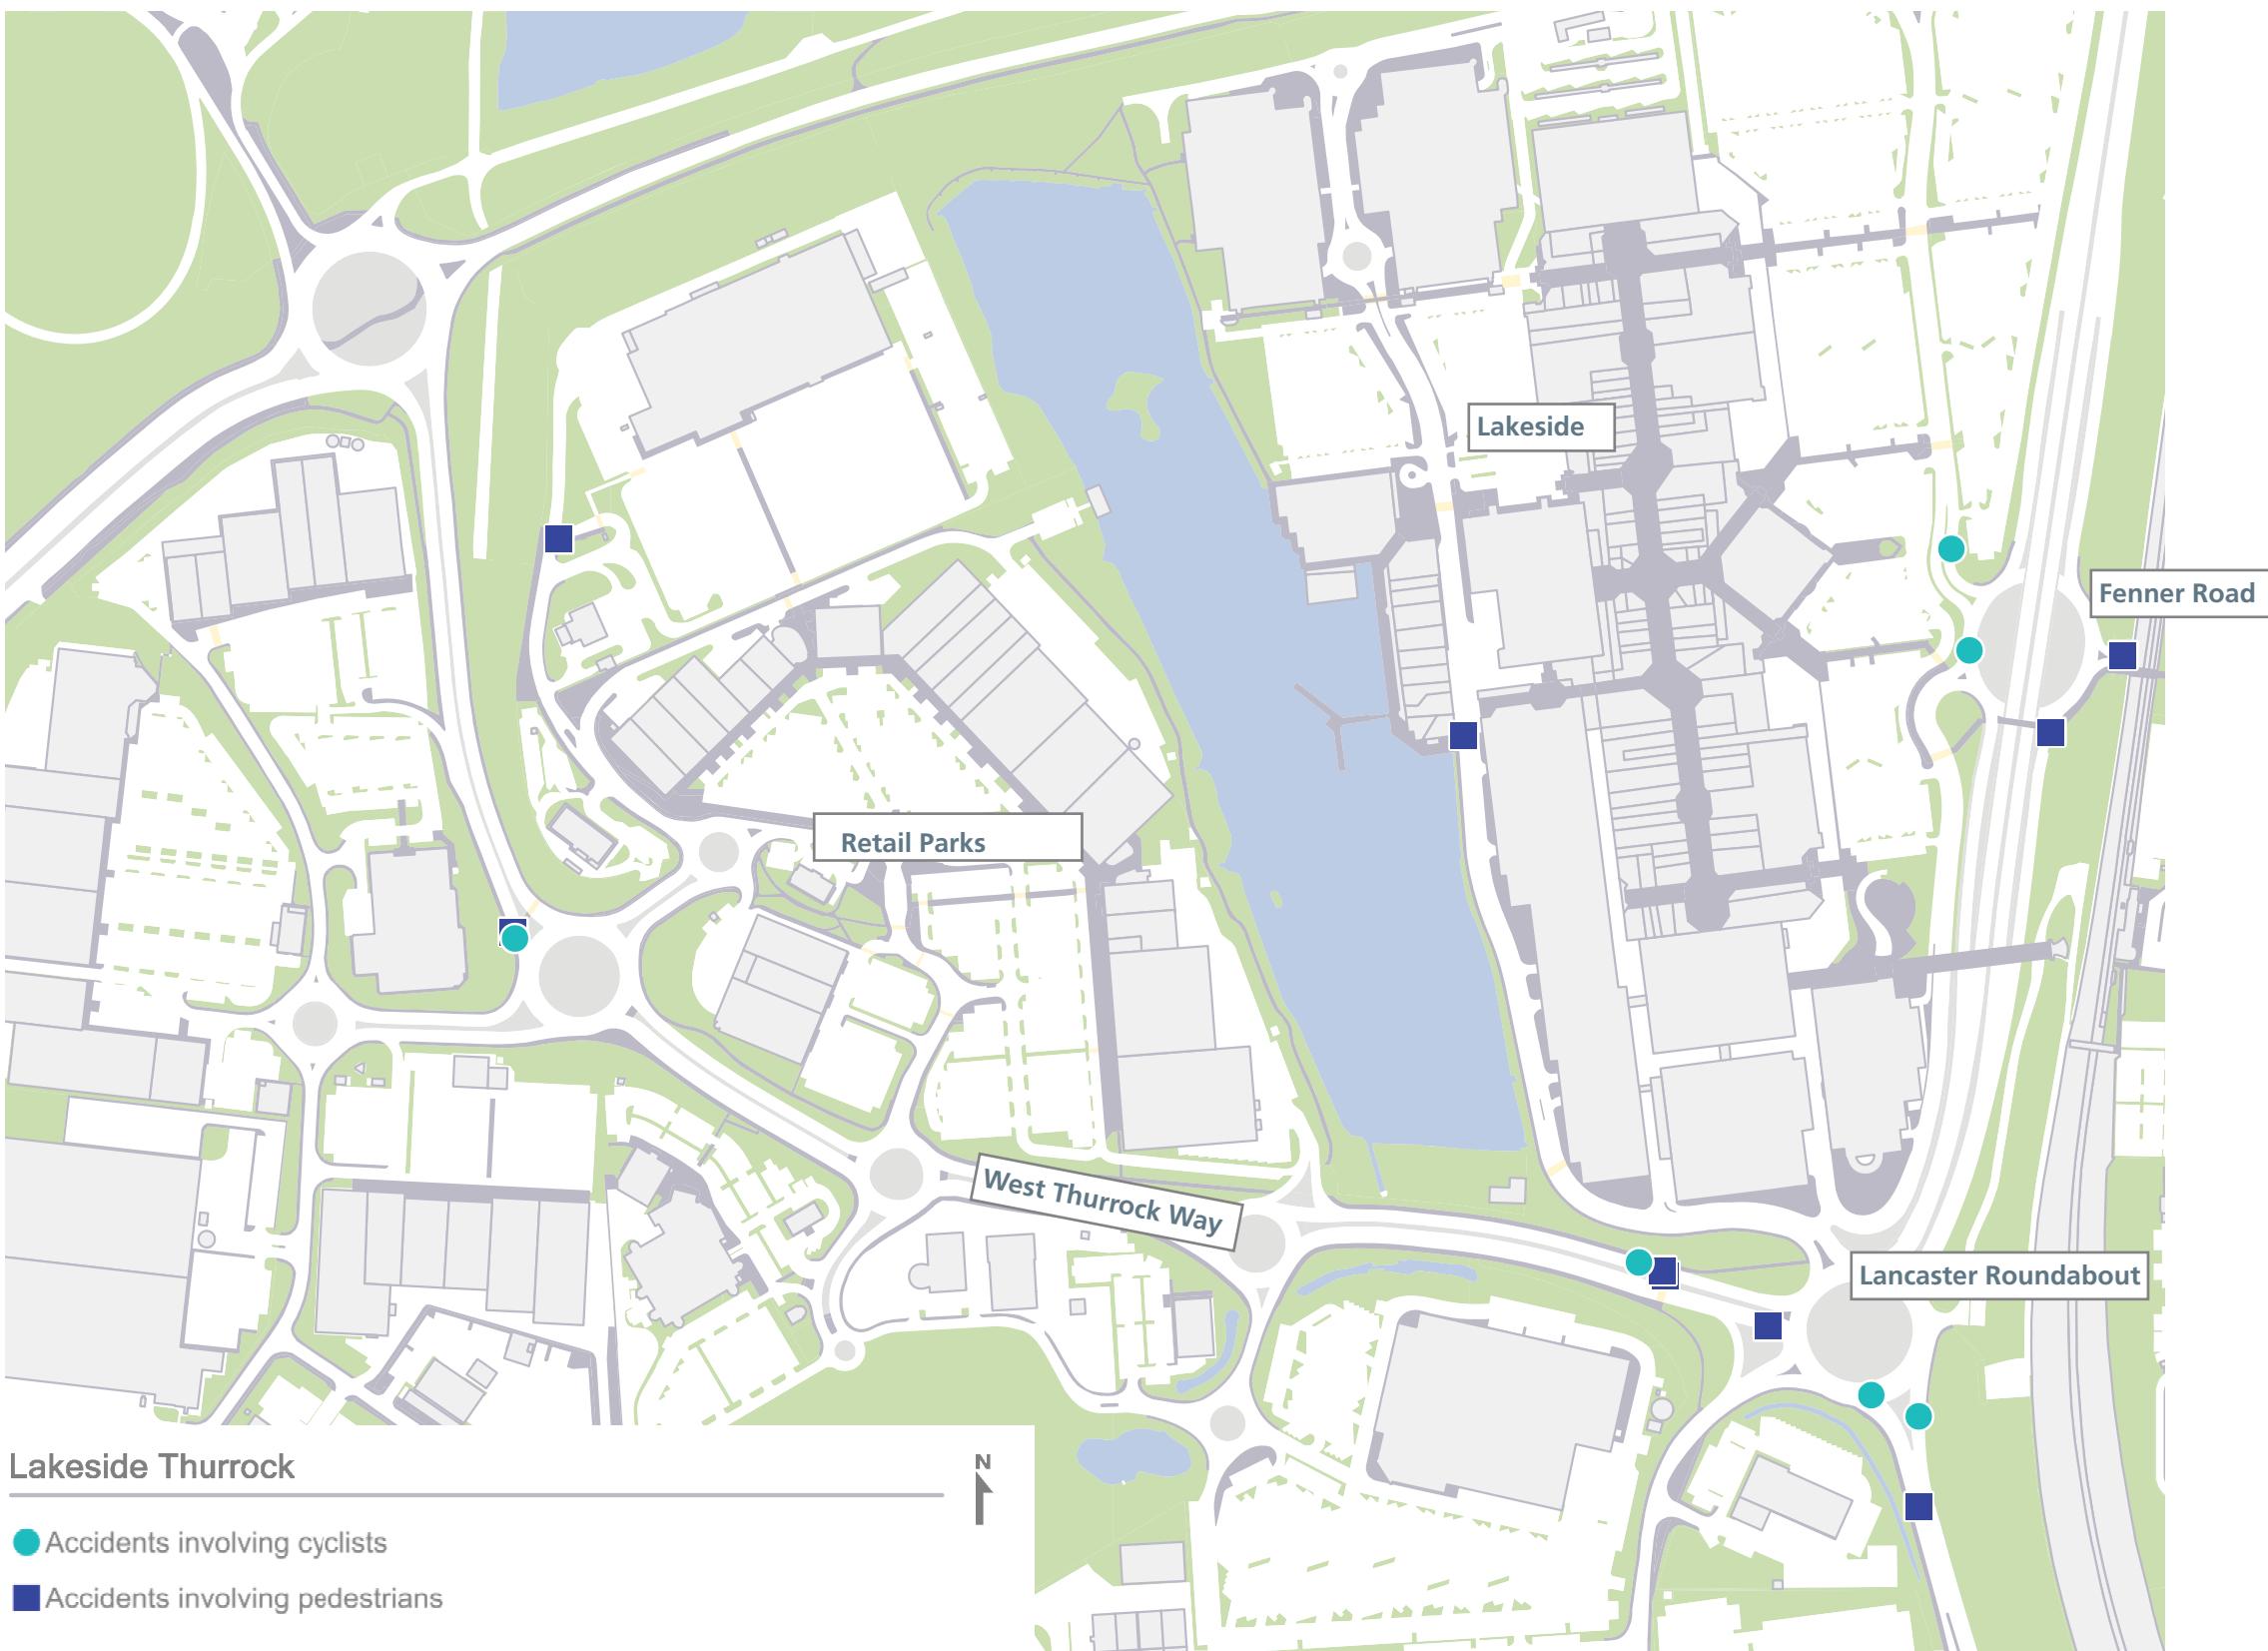
Figure 19 Reported pedestrian and cycle accidents (2008-2012)

To the North West, there are some accidents involving pedestrian or cyclists on the roundabouts on West Thurrock Way and close to the retail parks.

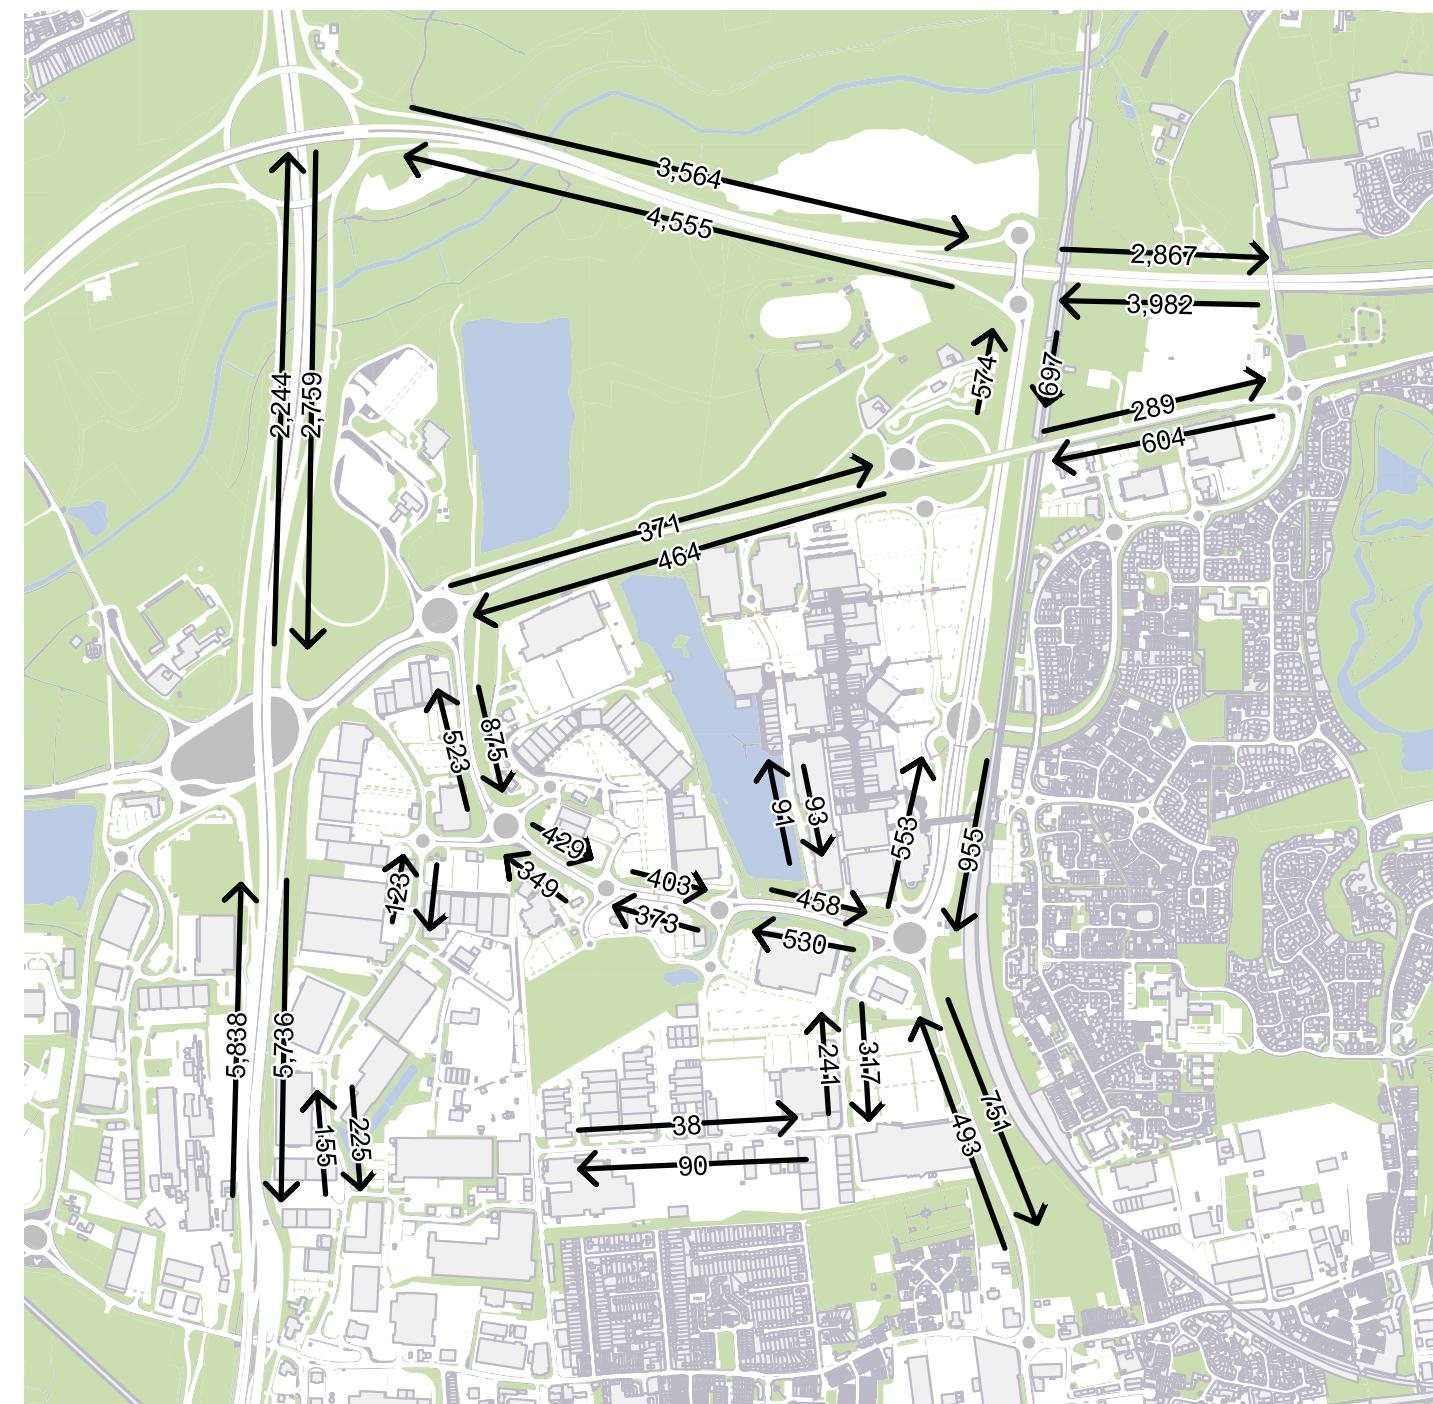
Figure 22 Peak hour AM observed flows in Lakeside area taken from Lakeside Traffic Modelling Report, 2012, SKM

The SKM 2012 Lakeside modelling report indicates that West Thurrock Way along its entire length is currently operating below capacity, with the model estimate at below 70% of available capacity in both the AM and PM peaks. From our observations traffic flow on West Thurrock Way is currently generally good at all times and in this respect our observations are consistent with those noted by SKM in their work. However it should also be noted that there can be considerable queuing on the exits from the Lakeside Retail Park and Junction parks on the build up to the peak retail times at Christmas and during the New Year sales. The highway access and egress roads to / from Lakeside shopping Centre are also heavily congested during these times.

Figure 22 shows AM peak hour two way flows on key links throughout the wider study area taken from the Lakeside Traffic model.

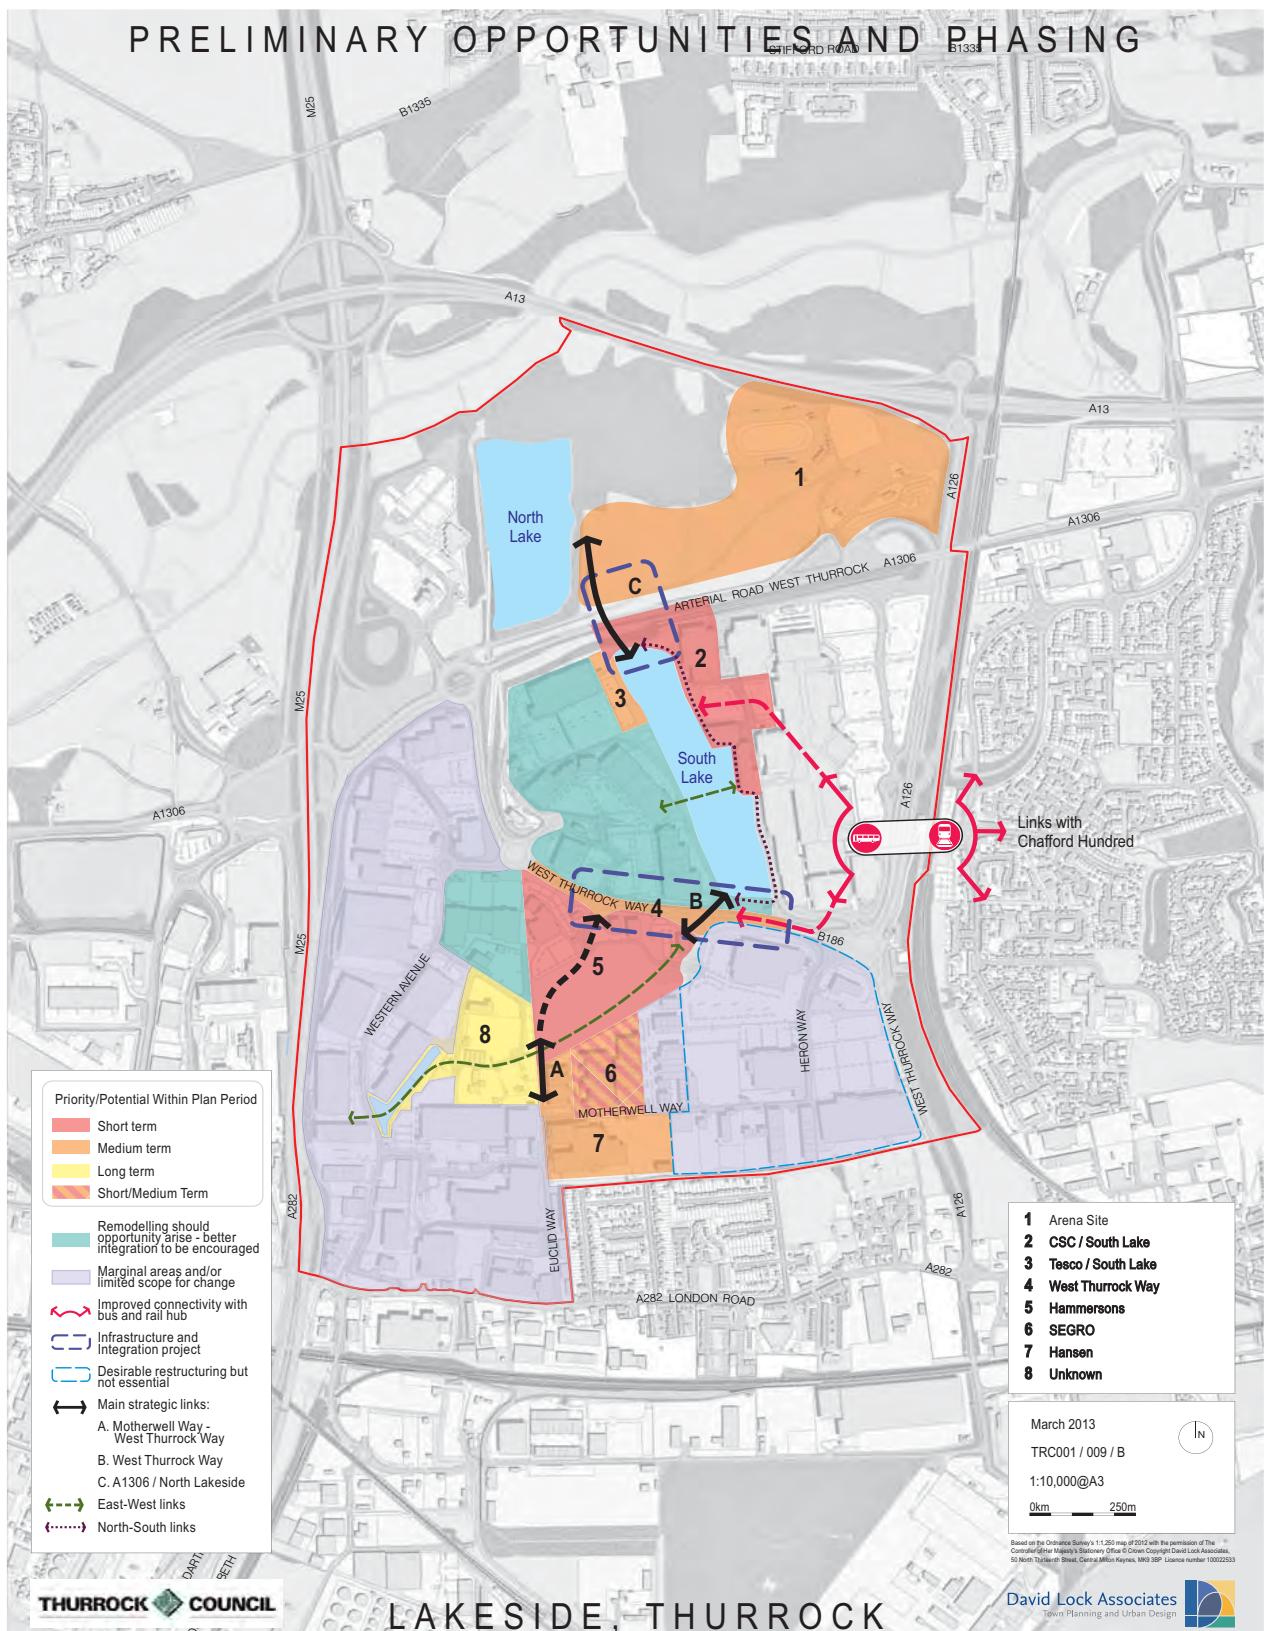
Fig. 24 - March 2013: Preliminary Opportunities and Phasing Plan centred on West Thurrock Way. Courtesy of DLA

The section of the Lakeside Masterplan which focuses on West Thurrock Way looks in the long term to change the existing character of the road by reorientating active frontages and by building new commercial and residential units which provide a more cohesive built line onto the street. More consistent and regular massing of buildings has the opportunity to provide an urban environment which functions at a more human scale than the existing conditions, which currently have buildings spread out thinly across the length of the road. This urban densification in turn contributes towards improved navigability for pedestrians and vehicle drivers, as there are more buildings as wayfinding reference points. Good urban design will also help in orientating people along key paths or towards active frontages. The overall aim is to provide a sense of space, scale and activity on West Thurrock Way more aligned to that of a typical high street, with greater opportunities for social transaction and an increased sense
