SECTION 19 FLOOD AND WATER MANAGEMENT ACT

FLOOD INVESTIGATION REPORT

QUEBEC ROAD, TILBURY

NOVEMBER 2013

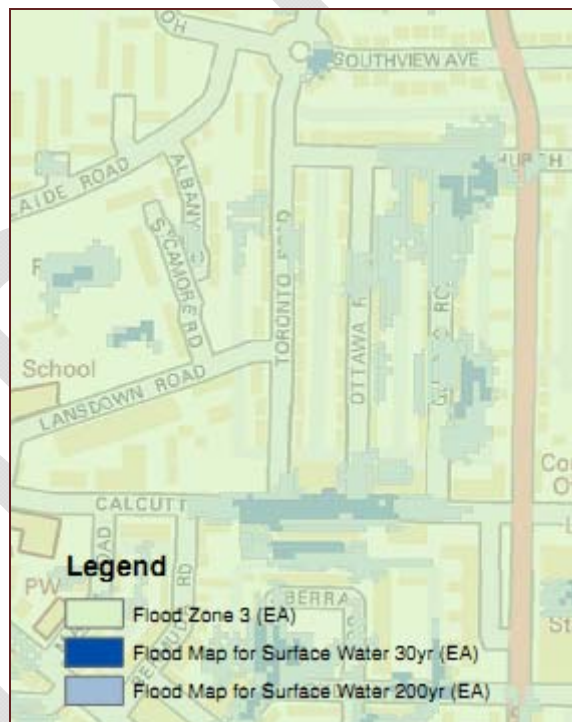
FIGURE 2: FLOOD RISK MAP

The area under investigation is situated in EA tidal flood zone 3 (see Figure 1), representing land with a 1 in 200 years (0.5%) chance of flooding from tidal sources in any one year, as shown in figure 2.
