the play inspection company

Annual Inspection

Thurrock Council

Corringham Town Park

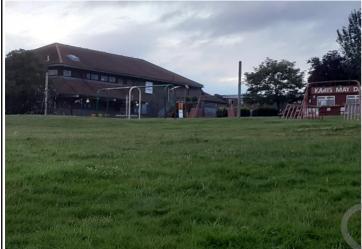
Item: Ancillary Items - Site General Risk Level: L - Low Risk

6 - Low Risk (Finding 14)

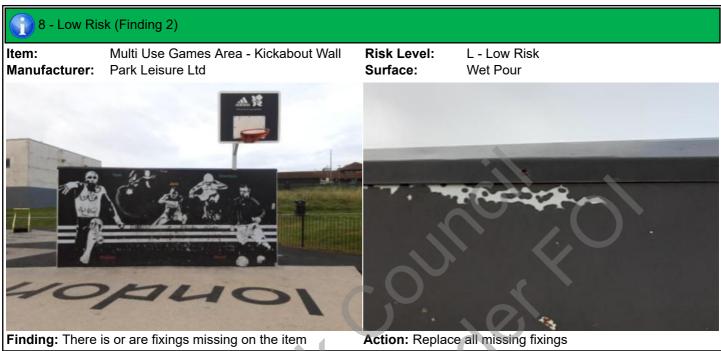
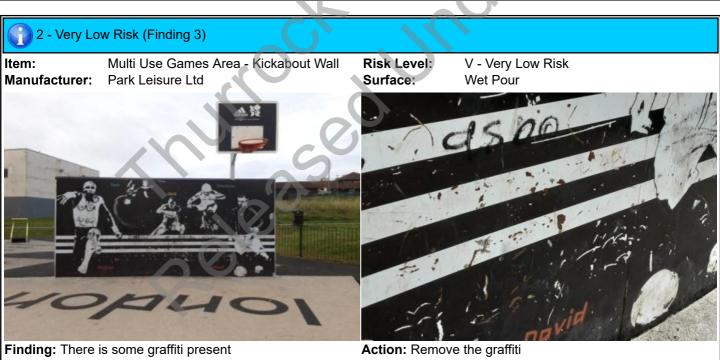
Finding: A clearly visible facility sign should be provided in a prominent position with the wording as detailed BS EN 15312- the equipment is not intended for children less than 3 years old- the warning - Do not climb on the framework or nets- the warning - Do not hang on the ring (if provided)- the warning - Do not wear rings or other jewellery- name and telephone number of the administrator- number to call in case of accident
