## Annual Inspection

Thurrock Council

Corringham Town Park

Springhouse Road, Corringham, Essex, SS17 7NB

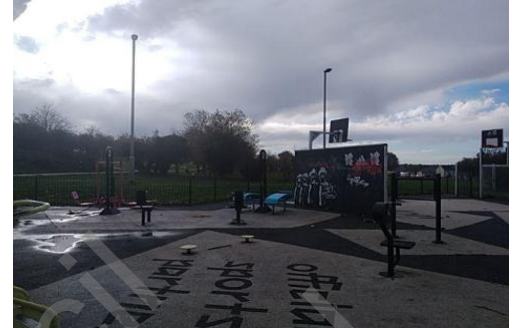
**Item:** Site General  
**Manufacturer:** Owner/Operator  
**Surface Type:** N/A  
**Item Quantity:** 1  
**Equipment Compliance:** N/A  
**Surface Area Compliance:** N/A

Signage should be provided for the outdoor fitness equipment in accordance with the requirements of BS EN 16630, key requirements of the sign include, but are not limited to, intended users, medical safety and emergency contact details - Provide appropriate signage

The wetpour is crumbling in areas - Monitor for any further deterioration and repair as required

The surfacing in the fitness area is damaged - Repair the damaged areas of surfacing

There are areas or parts of the timber edgings that have rotted or are missing - Replace all affected timbers

There are significant gaps (over 30mm) between the surface and the edging or between the joints in the surface; these are large enough for a small foot to enter - Repair surfacing

The surface is damaged and is lifting at the edges and creating trip points - Repair perimeter of surfacing to remove trip points

There are sleepers missing from the timber retaining wall - Replace the missing sleepers

There are trip hazards at the edges of the surface - Reinstall surrounding surface levels to remove the trip points

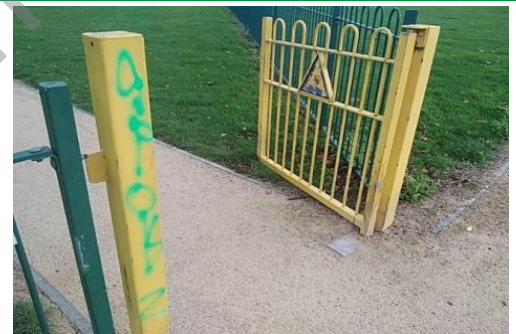
**Item:** Gate - Self Closing  
**Manufacturer:** Not Identified  
**Surface Type:** Grass  
**Item Quantity:** 1  
**Equipment Compliance:** N/A  
**Surface Area Compliance:** N/A

The gate is not operating correctly - Take effective action to ensure the gate closes between 4 and 8 seconds

The weld(s) on this item have failed - Repair item

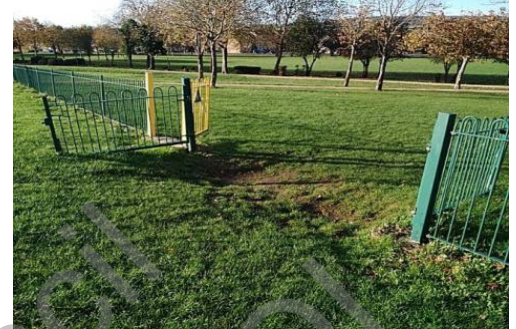
**Item:** Gate - Maintenance  
**Manufacturer:** Not Identified  
**Surface Type:** Grass  
**Item Quantity:** 1  
**Equipment Compliance:** N/A  
**Surface Area Compliance:** N/A

The area around the item has eroded and may become slippery - Reinstall eroded area

The item is loose in its foundations - Reinstall item to secure

The surface has eroded and the foundations are exposed - Reinstall surrounding surfaces to cover the foundations

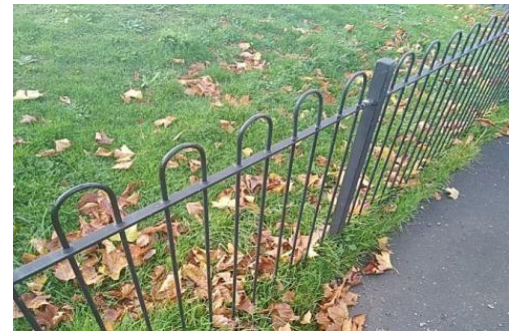
**Item:** Fence - Bow Top  
**Manufacturer:** Not Identified  
**Surface Type:** Grass  
**Item Quantity:** 1  
**Equipment Compliance:** N/A  
**Surface Area Compliance:** N/A

There is some damage to the fence sections - Monitor for any further deterioration and repair as required

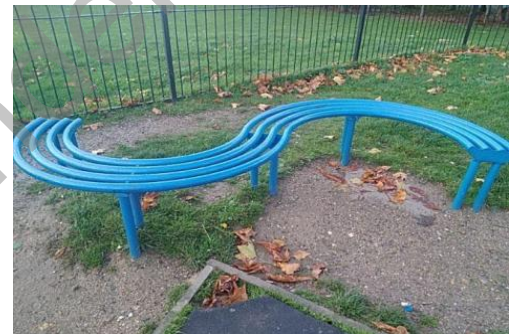
**Item:** Bench  
**Manufacturer:** Not Identified  
**Surface Type:** Grass  
**Item Quantity:** 2  
**Equipment Compliance:** N/A  
**Surface Area Compliance:** N/A

The area around the item has eroded and may become slippery - Reinstate eroded area

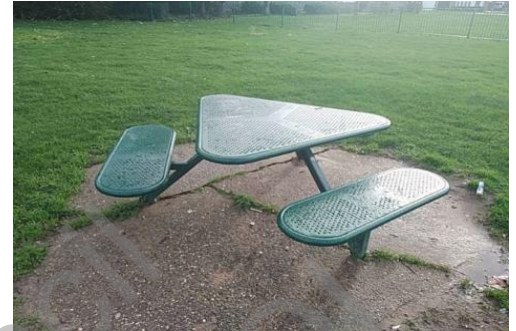
**Item:** Picnic Table  
**Manufacturer:** Not Identified  
**Surface Type:** Concrete  
**Item Quantity:** 3  
**Equipment Compliance:** N/A  
**Surface Area Compliance:** N/A

There is moderate damage to the surface - Repair the damaged areas of surfacing

There are trip hazards at the edges of the surface - Reinstate surrounding surface levels to remove the trip points

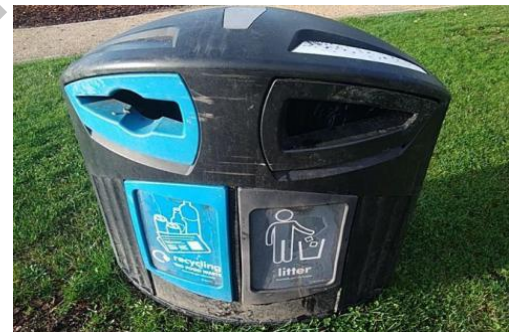
**Item:** Litter Bin  
**Manufacturer:** Not Identified  
**Surface Type:** Grass  
**Item Quantity:** 2  
**Equipment Compliance:** N/A  
**Surface Area Compliance:** N/A

The bin is not securely fixed to the surface and there is some possibility of the item tipping or rolling over - Secure the bin to the ground

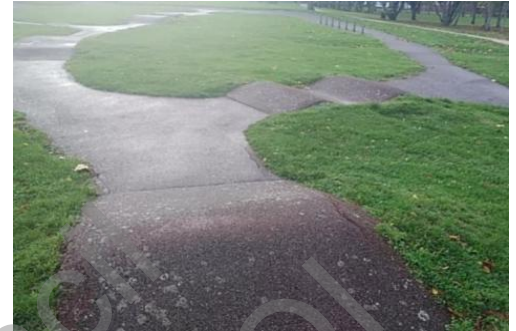
**Item:** BMX Track  
**Manufacturer:** Owner/Operator  
**Surface Type:** Tarmac  
**Item Quantity:** 1  
**Equipment Compliance:** N/A  
**Surface Area Compliance:** N/A

There are minor stress fractures in the tarmac surface - Monitor and repair if required

There is algae, silt or moss growth on the surface resulting in slippery conditions - Clean and treat appropriately

The edges of the tarmac jump ramps has subsided - Repair the damaged ramps

There is some evidence of rot in the timber - Monitor for any further deterioration and replace as required

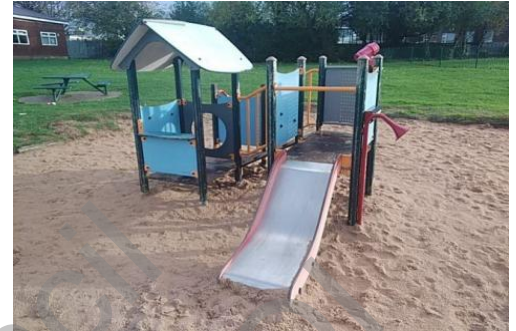
**Item:** Multi Play (Toddler)  
**Manufacturer:** Hags  
**Surface Type:** Sand  
**Item Quantity:** 1  
**Equipment Compliance:** Yes  
**Surface Area Compliance:** Yes  
**Life Expectancy:** 5 -10 Years  
**Total Findings:** 7

The plywood has delaminated in some places - Remove all rough or splintered edges.

There are post / end caps missing from the item - Replace missing post caps

There is some evidence of rot in the timber - Monitor for any further deterioration and replace as required

The paintwork on this item has been damaged or worn exposing the metal underneath which is rusting - Treat any rusting components and repaint

The timber stain is in poor condition - Prepare all affected parts and re-stain with an appropriate preservative

There are a number of dents in the slide surface - Monitor for any further deterioration and repair as required

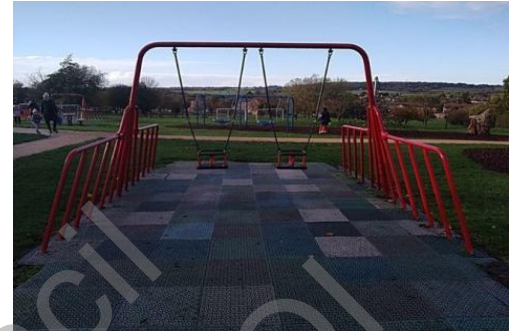
**Item:** 1 Bay 2 Seat (Cradle)  
**Manufacturer:** Wicksteed Playgrounds  
**Surface Type:** Matta  
**Item Quantity:** 1  
**Equipment Compliance:** Yes  
**Surface Area Compliance:** Yes  
**Life Expectancy:** 5 -10 Years  
**Total Findings:** 4

There are gaps opening in between the tiles - Monitor for any further deterioration and repair as required

The connecting lugs are showing signs of wear - Monitor for any further deterioration and repair as required

The seat has minor damage or wear - Monitor for any further deterioration and replace as required

The surface has subsided in some areas - Monitor for any further deterioration and repair as required

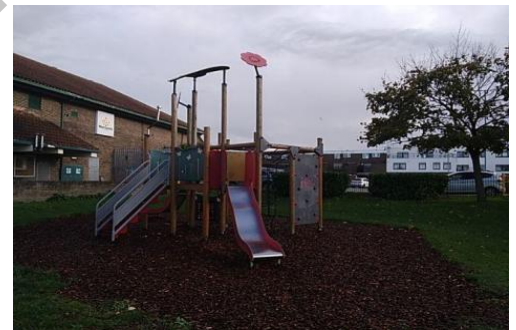
**Item:** Multi Play (Junior)  
**Manufacturer:** Hags  
**Surface Type:** Woodchip  
**Item Quantity:** 1  
**Equipment Compliance:** Yes  
**Surface Area Compliance:** Yes  
**Life Expectancy:** 5 -10 Years  
**Total Findings:** 4

There is some graffiti present - Remove the graffiti

There are a number of dents in the slide surface - Monitor for any further deterioration and repair as required

There is some evidence of fire damage to the item - Monitor for any further deterioration and repair as required

There are post / end caps missing from the item - Replace missing post caps

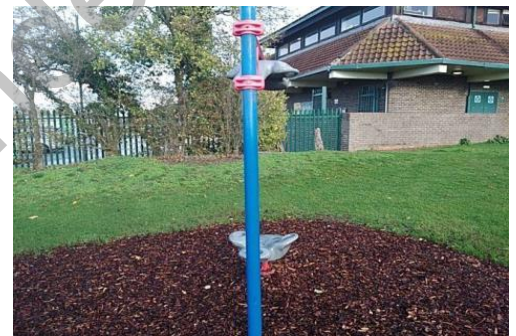
**Item:** Misc Item  
**Manufacturer:** Playworld Systems (Europe) Ltd  
**Surface Type:** Woodchip  
**Item Quantity:** 1  
**Equipment Compliance:** Yes  
**Surface Area Compliance:** Yes  
**Life Expectancy:** 1 - 3 Years  
**Total Findings:** 2

The item has missing component(s) - Consider replacing missing components

The bearing is not operating correctly - Repair or replace the bearing as required

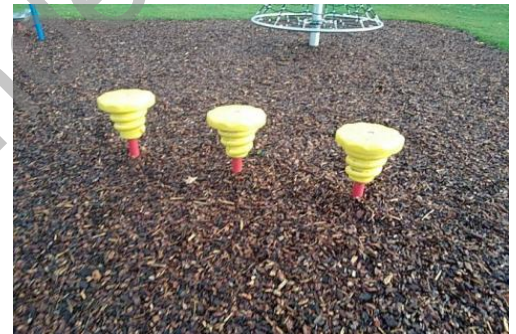
**Item:** Stepping Stones  
**Manufacturer:** Playworld Systems (Europe) Ltd  
**Surface Type:** Woodchip  
**Item Quantity:** 1  
**Equipment Compliance:** Yes  
**Surface Area Compliance:** Yes  
**Life Expectancy:** 3 - 5 Years  
**Total Findings:** 1

The item has been damaged - Monitor for any further deterioration and replace as required

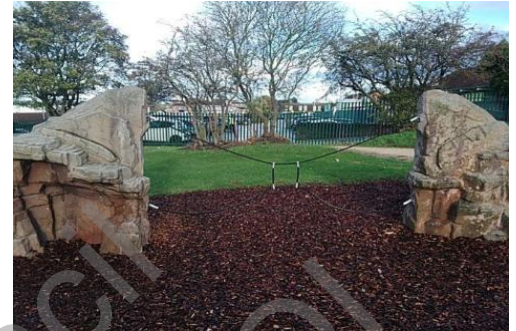
**Item:** Climbing Wall  
**Manufacturer:** Not Identified  
**Surface Type:** Woodchip  
**Item Quantity:** 1  
**Equipment Compliance:** Yes  
**Surface Area Compliance:** Yes  
**Life Expectancy:** 5 -10 Years  
**Total Findings:** 1

The rope has worn and wire strands are exposed - Replace rope or net

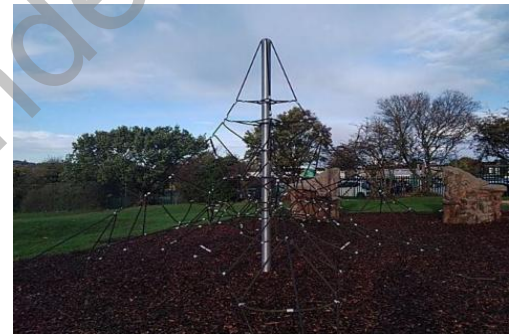
**Item:** Space Net  
**Manufacturer:** Kompan Ltd  
**Surface Type:** Woodchip  
**Item Quantity:** 1  
**Equipment Compliance:** No  
**Surface Area Compliance:** Yes  
**Life Expectancy:** 5 -10 Years  
**Total Findings:** 1

There is a potential crushing point between the rope and the central post in contravention of BS EN 1176 Part 1 - Retention ropes to ensure the rope is spaced evenly around the post

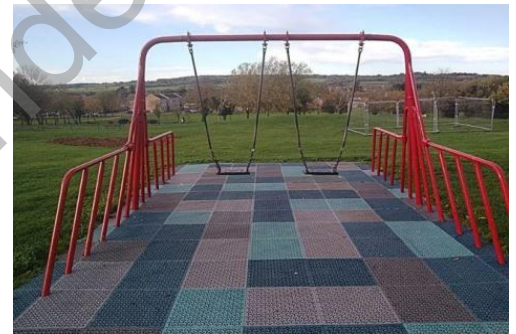
**Item:** 1 Bay 2 Seat (Flat)  
**Manufacturer:** Wicksteed Playgrounds  
**Surface Type:** Wet Pour  
**Item Quantity:** 1  
**Equipment Compliance:** No  
**Surface Area Compliance:** Yes  
**Life Expectancy:** 5 -10 Years  
**Total Findings:** 3

The connecting links are in excess of 8.6mm and less than 12mm and fail the requirements of BS EN 1176 Part 1; clause 4.2.13, Chains - Monitor use and replace with compliant links at the next maintenance cycle

The chain openings are in excess of the 8.6mm as recommended by BS EN 1176 - Monitor - No remedial work recommended

There is some notable evidence of chain wear - Monitor for any further deterioration and replace when 40% worn

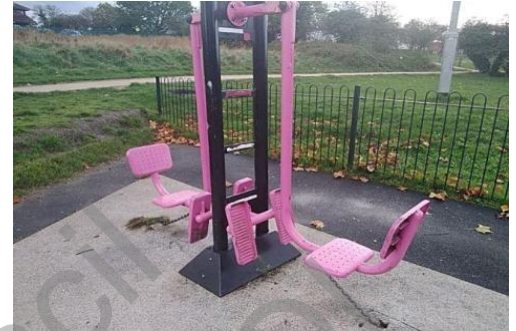
**Item:** Leg Press  
**Manufacturer:** The Great Outdoor Gym Company  
**Surface Type:** Wet Pour  
**Item Quantity:** 1  
**Equipment Compliance:** No  
**Surface Area Compliance:** Yes  
**Life Expectancy:** 3 - 5 Years  
**Total Findings:** 5

The connecting lugs are showing signs of wear - Monitor for any further deterioration and repair as required

There is some wear to the shackles - Monitor for any further deterioration and replace when 40% worn

There is some notable evidence of chain wear - Monitor for any further deterioration and replace when 40% worn

There is/are bolt cap covers missing or damaged on the item - Replace missing or damaged bolt cap covers

There is or are fixings missing on the item - Replace all missing fixings

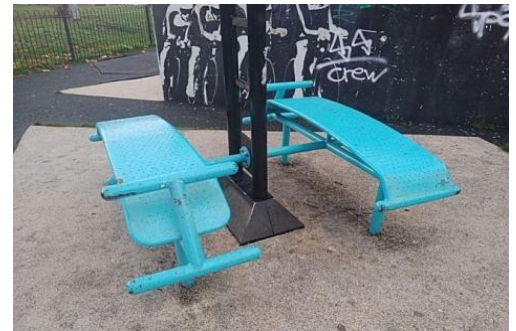
**Item:** Ab Station  
**Manufacturer:** The Great Outdoor Gym Company  
**Surface Type:** Wet Pour  
**Item Quantity:** 1  
**Equipment Compliance:** No  
**Surface Area Compliance:** Yes  
**Life Expectancy:** 5 - 10 Years  
**Total Findings:** 3

The paintwork on this item has been damaged or worn exposing the metal underneath which is rusting - Treat any rusting components and repaint

There is/are bolt cap covers missing or damaged on the item - Replace missing or damaged bolt cap covers

There is minor distortion damage to the bench - Monitor and repair if required

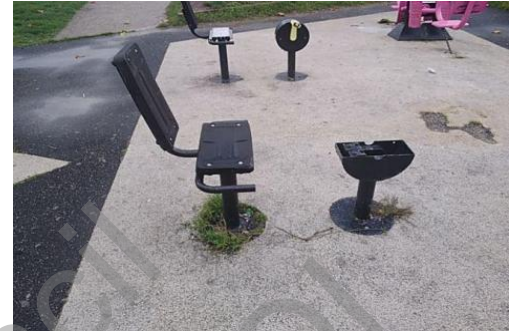
**Item:** Cycle  
**Manufacturer:** The Great Outdoor Gym Company  
**Surface Type:** Wet Pour  
**Item Quantity:** 2  
**Equipment Compliance:** No  
**Surface Area Compliance:** Yes  
**Life Expectancy:** 1 - 3 Years  
**Total Findings:** 2

The mechanism has been removed from one item - Replace the missing components or remove the item completely

There is minor damage to the seat - Monitor and replace if required

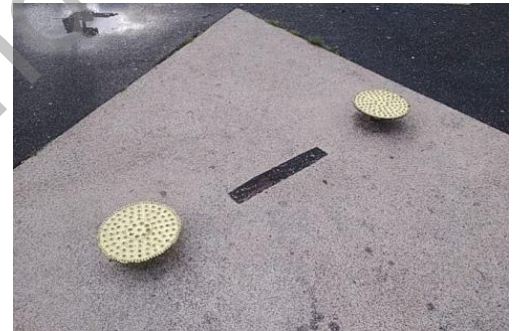
**Item:** Hip Twister  
**Manufacturer:** The Great Outdoor Gym Company  
**Surface Type:** Wet Pour  
**Item Quantity:** 1  
**Equipment Compliance:** No  
**Surface Area Compliance:** Yes  
**Life Expectancy:** <12 Months  
**Total Findings:** 3

The deflection of the rotating user station exceeds the maximum 105 degrees required by BS EN 16630 - Monitor - No remedial work recommended

The rotating user station is not appropriately marked with a guideline of user direction and/or the original position as required by BS EN 16630 - Monitor - No remedial work recommended

The frame has been removed - Consider replacing missing components

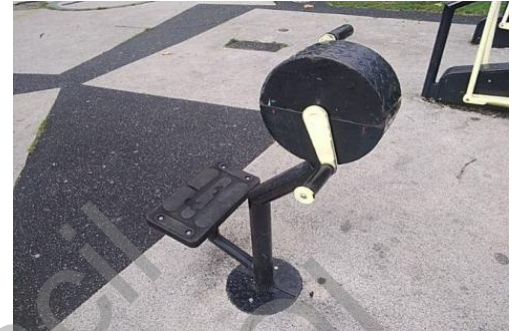
**Item:** Hand Bike  
**Manufacturer:** The Great Outdoor Gym Company  
**Surface Type:** Wet Pour  
**Item Quantity:** 1  
**Equipment Compliance:** No  
**Surface Area Compliance:** Yes  
**Life Expectancy:** 3 - 5 Years  
**Total Findings:** 3

There is some evidence of fire damage to the item - Monitor for any further deterioration and repair as required

The paintwork on this item has been damaged or worn exposing the metal underneath which is rusting - Treat any rusting components and repaint

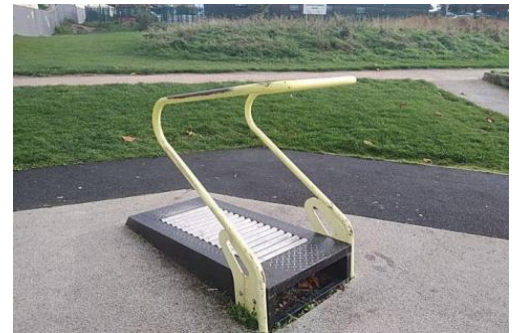
**Item:** Treadmill  
**Manufacturer:** The Great Outdoor Gym Company  
**Surface Type:** Wet Pour  
**Item Quantity:** 1  
**Equipment Compliance:** No  
**Surface Area Compliance:** Yes  
**Life Expectancy:** 5 -10 Years  
**Total Findings:** 2

The paintwork on this item has been damaged or worn exposing the metal underneath which is rusting - Treat any rusting components and repaint

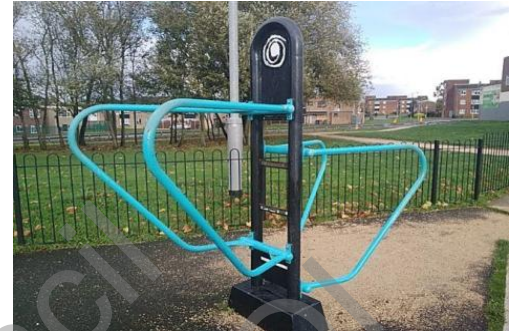
**Item:** Dip Station  
**Manufacturer:** The Great Outdoor Gym Company  
**Surface Type:** Wet Pour  
**Item Quantity:** 1  
**Equipment Compliance:** No  
**Surface Area Compliance:** Yes  
**Life Expectancy:** 5 -10 Years  
**Total Findings:** 1

The paintwork on this item has been damaged or worn exposing the metal underneath which is rusting - Treat any rusting components and repaint

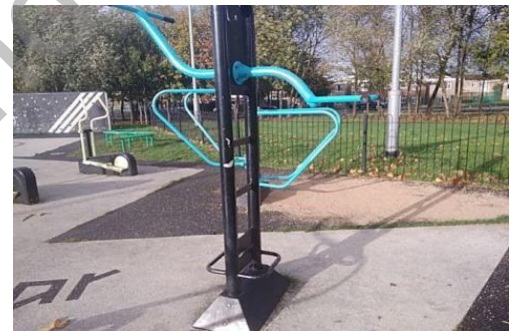
**Item:** Pull Up Station  
**Manufacturer:** The Great Outdoor Gym Company  
**Surface Type:** Wet Pour  
**Item Quantity:** 1  
**Equipment Compliance:** No  
**Surface Area Compliance:** Yes  
**Life Expectancy:** 5 -10 Years  
**Total Findings:** 1

There is/are bolt cap covers missing or damaged on the item - Replace missing or damaged bolt cap covers

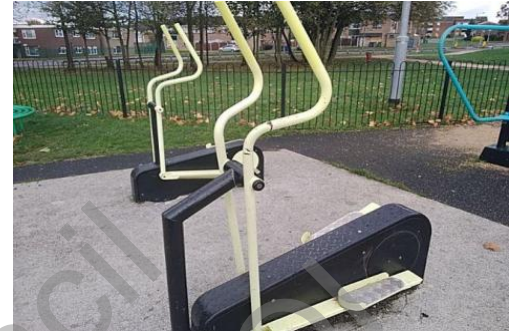
**Item:** Cross Trainer  
**Manufacturer:** The Great Outdoor Gym Company  
**Surface Type:** Wet Pour  
**Item Quantity:** 2  
**Equipment Compliance:** No  
**Surface Area Compliance:** Yes  
**Life Expectancy:** 3 - 5 Years  
**Total Findings:** 2

The bushes are worn or missing - Replace worn or missing bushes

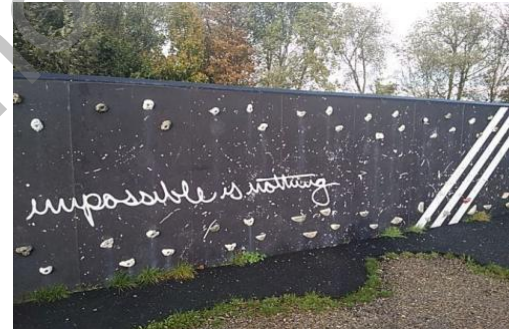
**Item:** Traverse Wall  
**Manufacturer:** Park Leisure Ltd  
**Surface Type:** Wet Pour  
**Item Quantity:** 1  
**Equipment Compliance:** Yes  
**Surface Area Compliance:** Yes  
**Life Expectancy:** 5 - 10 Years  
**Total Findings:** 3

The surfacing is severely damaged - Repair damaged areas of surfacing

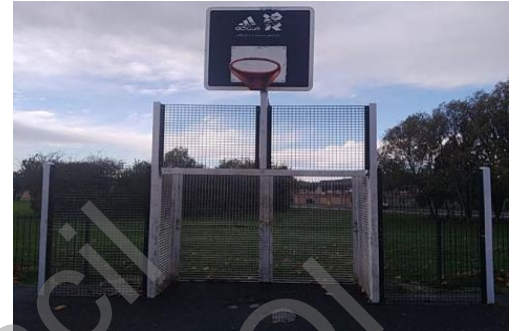
**Item:** Goalmouth and Basketball Post  
**Manufacturer:** Park Leisure Ltd  
**Surface Type:** Wet Pour  
**Item Quantity:** 1  
**Equipment Compliance:** No  
**Surface Area Compliance:** N/A  
**Life Expectancy:** 5 -10 Years  
**Total Findings:** 3

There is moderate damage to the surface - Repair the damaged areas of surfacing

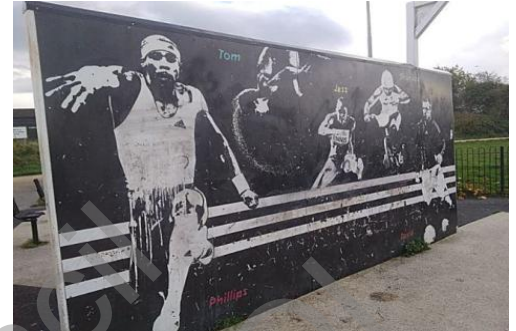
**Item:** Kickabout Wall  
**Manufacturer:** Park Leisure Ltd  
**Surface Type:** Wet Pour  
**Item Quantity:** 1  
**Equipment Compliance:** Yes  
**Surface Area Compliance:** Yes  
**Life Expectancy:** 5 -10 Years  
**Total Findings:** 3

The paintwork on this item has been damaged or worn exposing the metal underneath which is rusting - Treat any rusting components and repaint

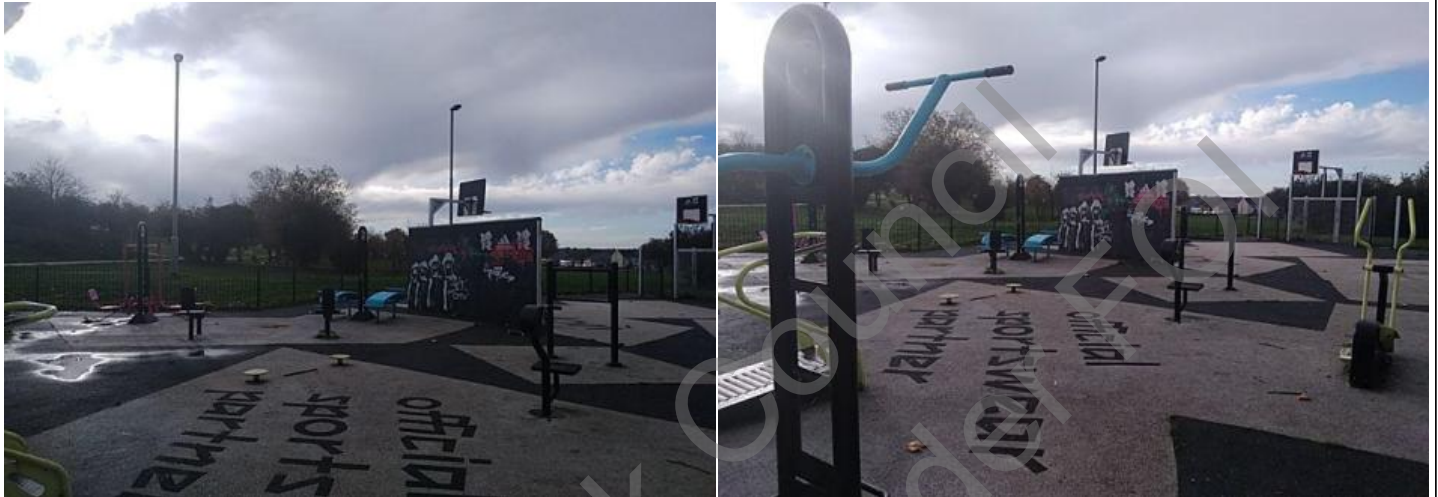
**Item:** Ancillary Items - Site General  
**Manufacturer:** Owner/Operator

**Finding:** Signage should be provided for the outdoor fitness equipment in accordance with the requirements of BS EN 16630, key requirements of the sign include, but are not limited to, intended users, medical safety and emergency contact details

**Action:** Provide appropriate signage

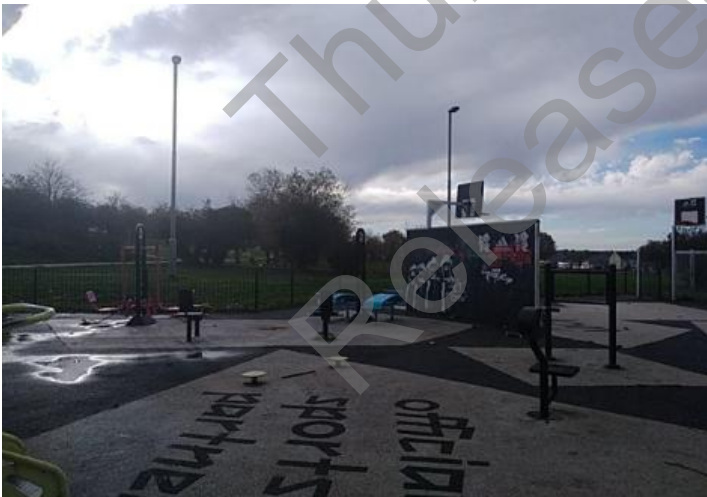
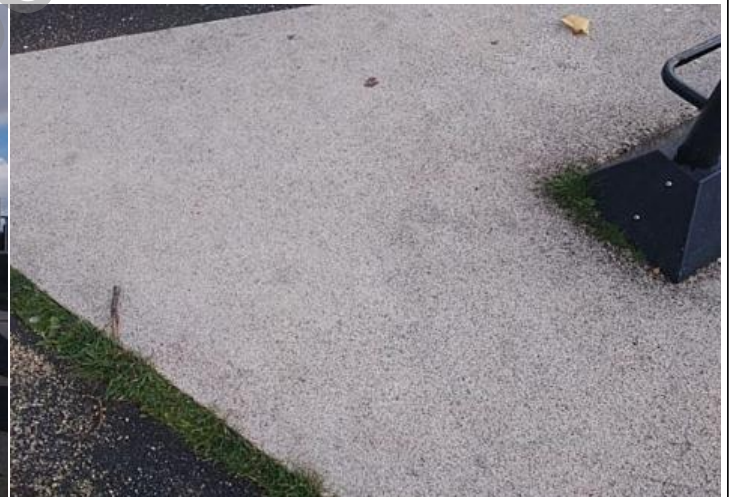
**Finding:** There is weed / vegetation growth on, between, or around the edges of the surfacing

**Action:** Remove weed / vegetation growth

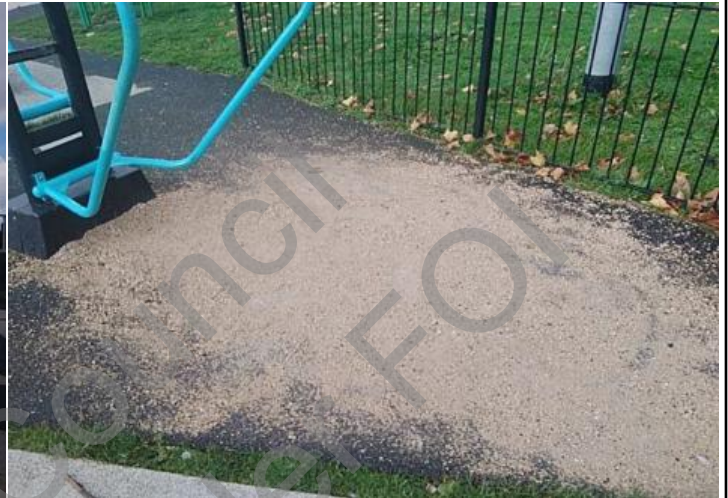
**Finding:** There is a large amount of gravel on the surface

**Action:** Remove from area

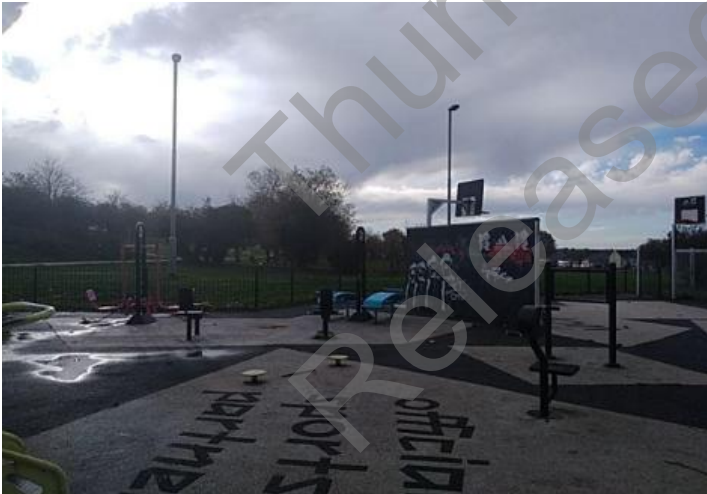
**Finding:** The wetpour is crumbling in areas

**Action:** Monitor for any further deterioration and repair as required

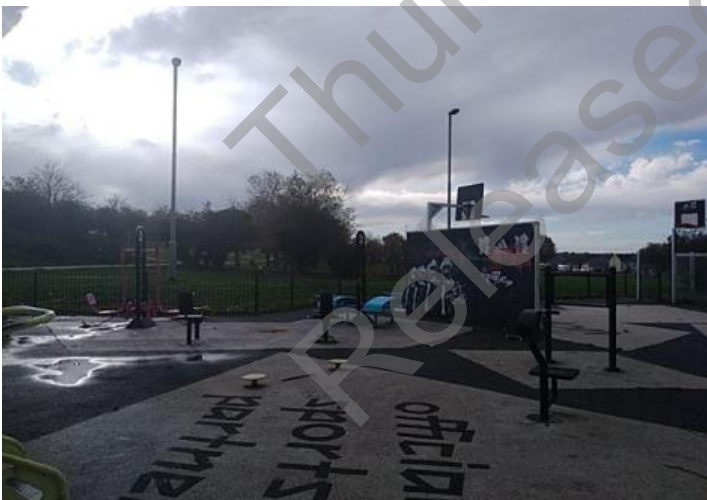
**Finding:** The surfacing in the fitness area is damaged  
**Action:** Repair the damaged areas of surfacing

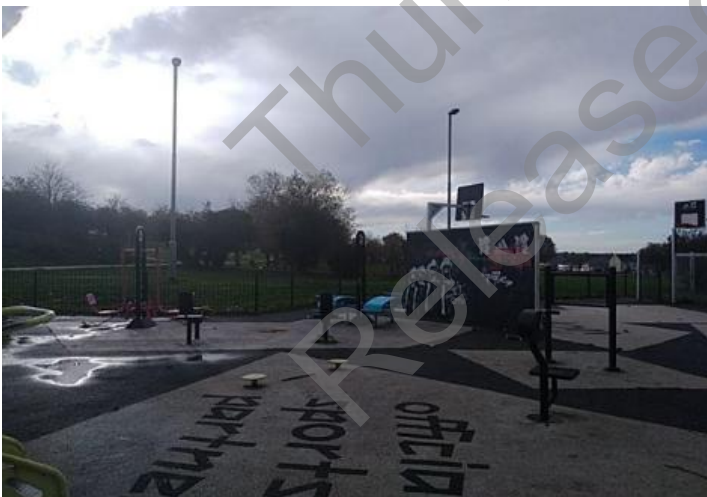
**Finding:** There are areas or parts of the timber edgings that have rotted or are missing

**Action:** Replace all affected timbers

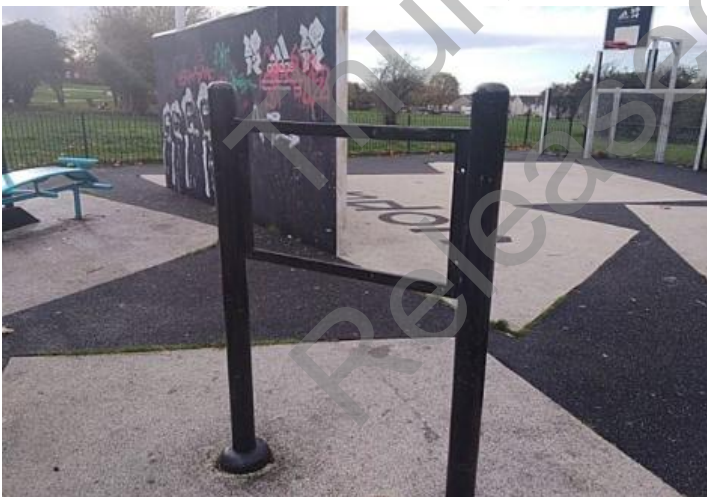
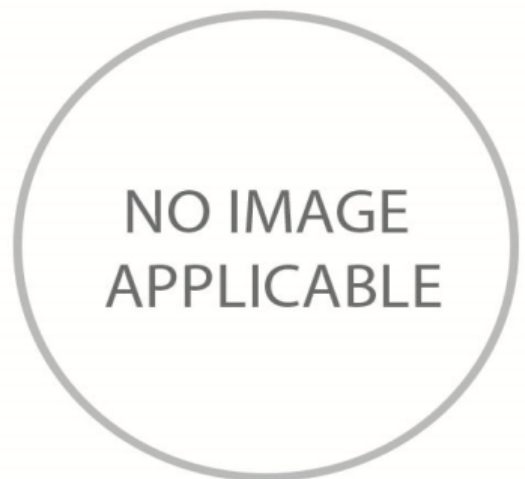
**Finding:** It is recommended that signage, with information including the site address, contact information for maintenance issues and emergency contact details are provided for the facility **Action:** Provide in accordance with the recommendations

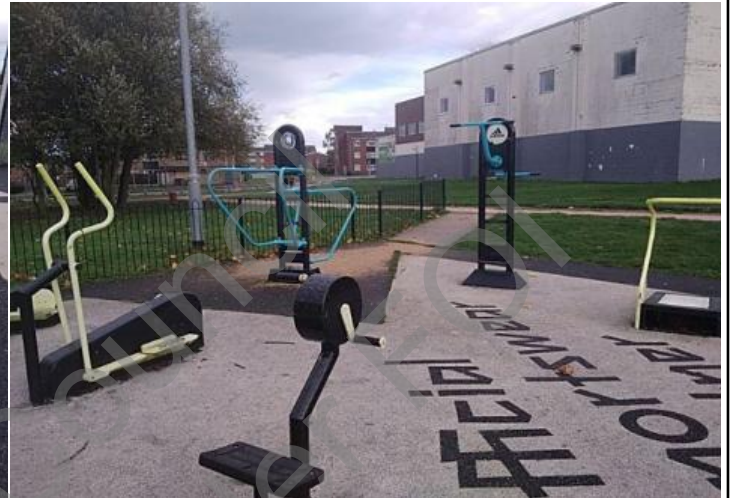
**Finding:** There are no instruction labels provided on the fitness equipment; an instruction label should be provided with each item of equipment in accordance with the requirements of BS EN 16630

**Action:** Provide appropriate instruction label/s

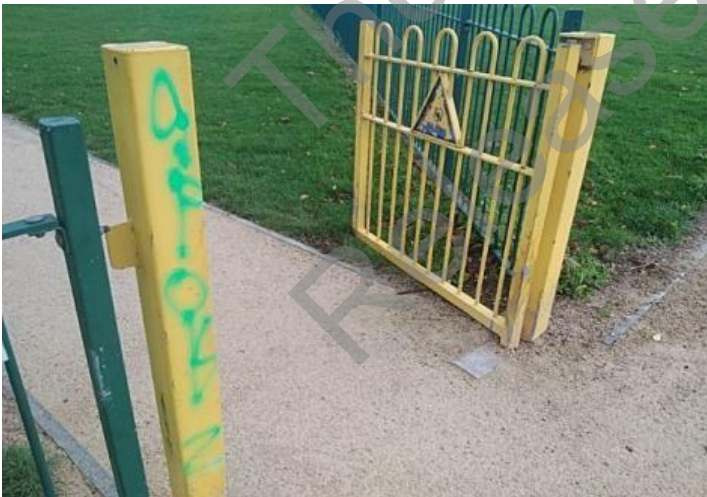
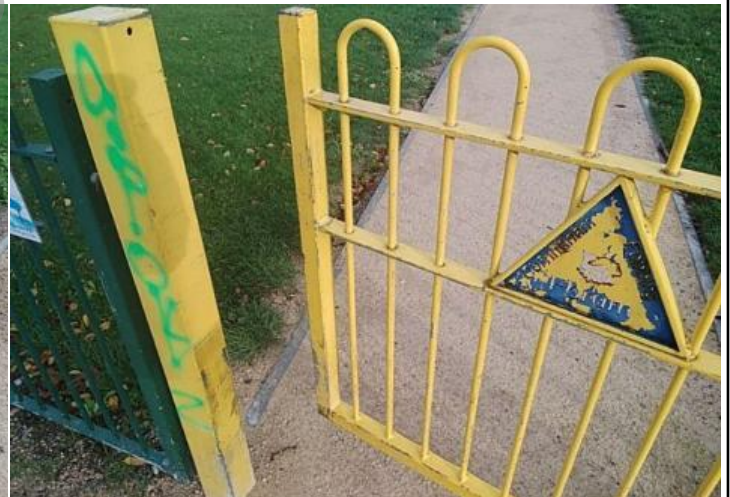
**Finding:** The gate is not operating correctly

**Action:** Take effective action to ensure the gate closes between 4 and 8 seconds

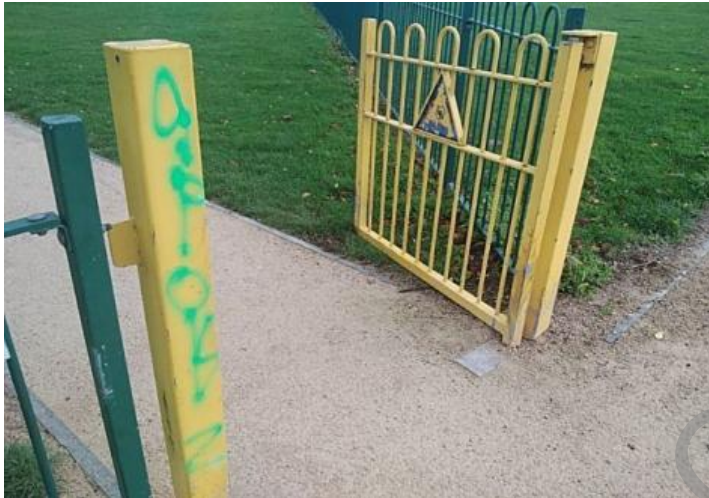
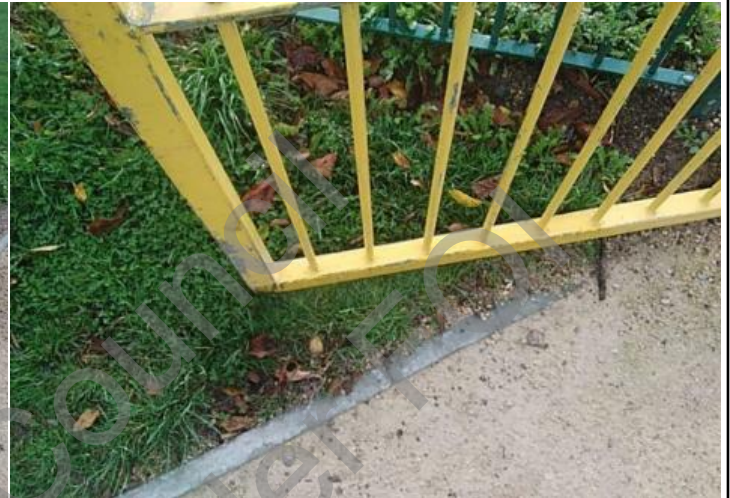
**Finding:** The gate is snagging on the surrounding surface preventing it from closing correctly

**Action:** Carry out remedial works to ensure the gate closes correctly

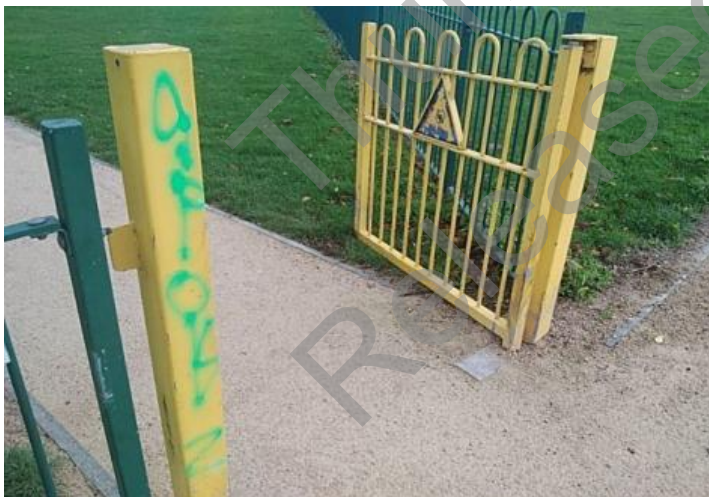
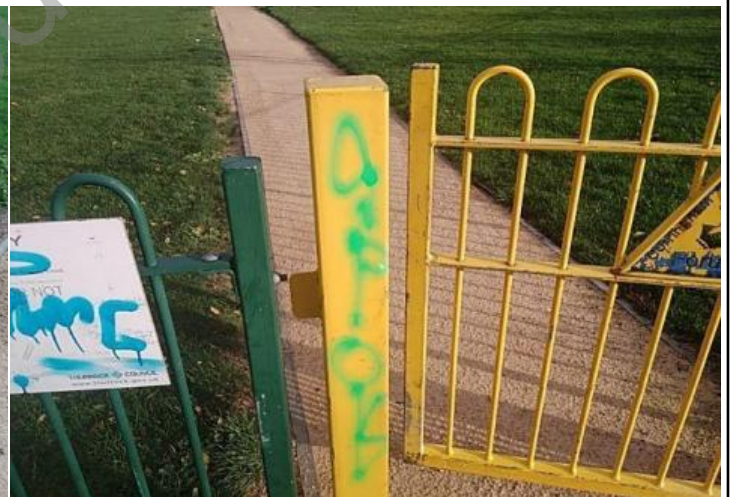
**Finding:** No slamming plate has been fitted to the gates and the gate leaves pass the slamming posts

**Action:** Provide slamming plates

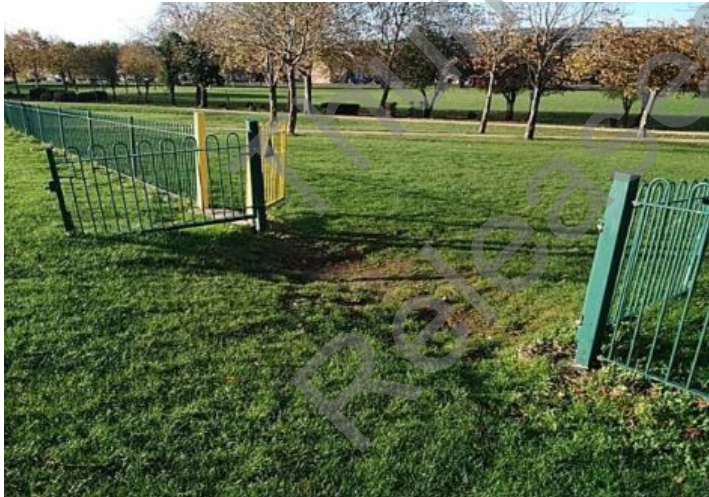
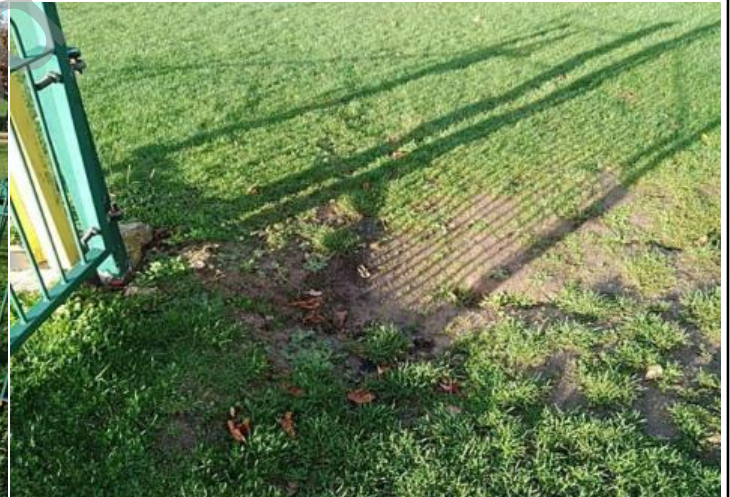
**Finding:** The area around the item has eroded and may become slippery

**Action:** Reinstate eroded area

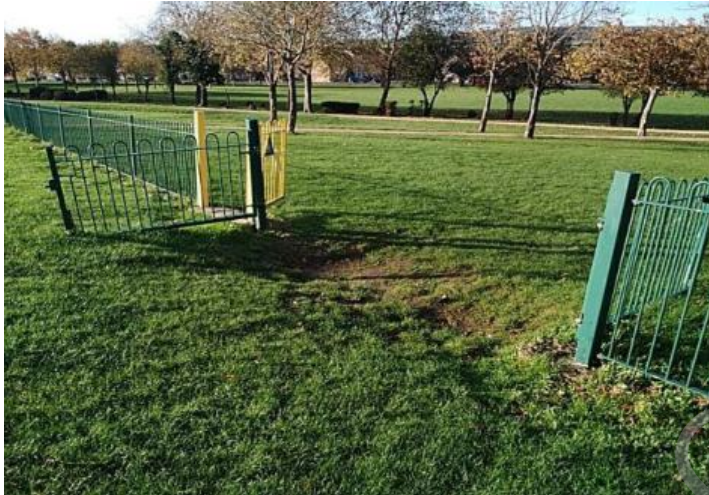
**Finding:** The item is loose in its foundations

**Action:** Reinstall item to secure

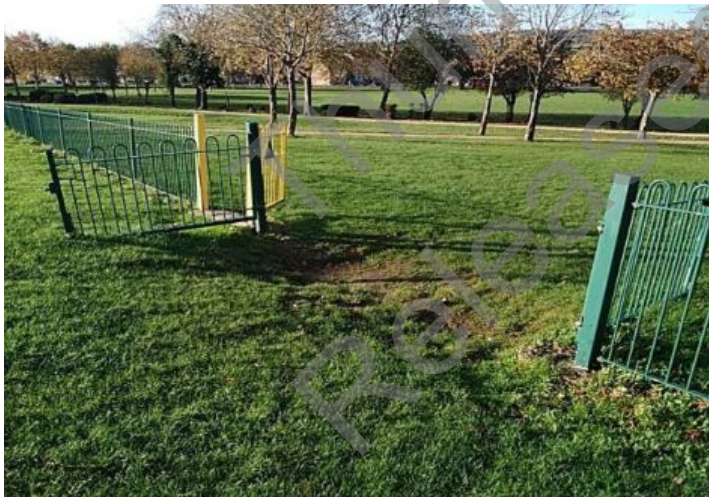
**Finding:** The surface has eroded and the foundations are exposed

**Action:** Reinstall surrounding surfaces to cover the foundations

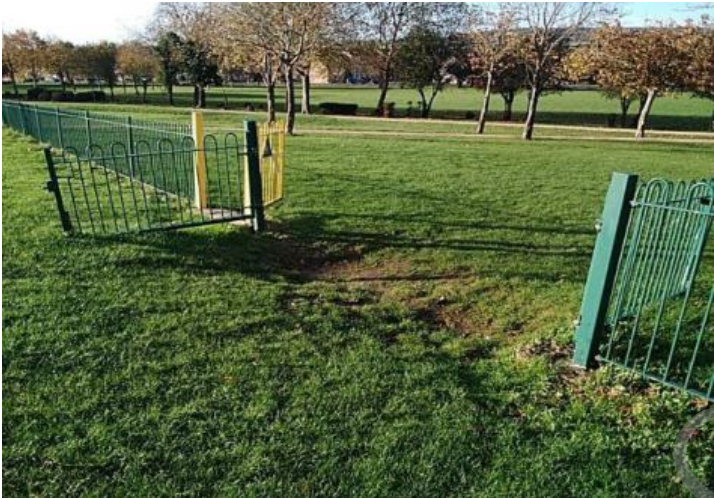
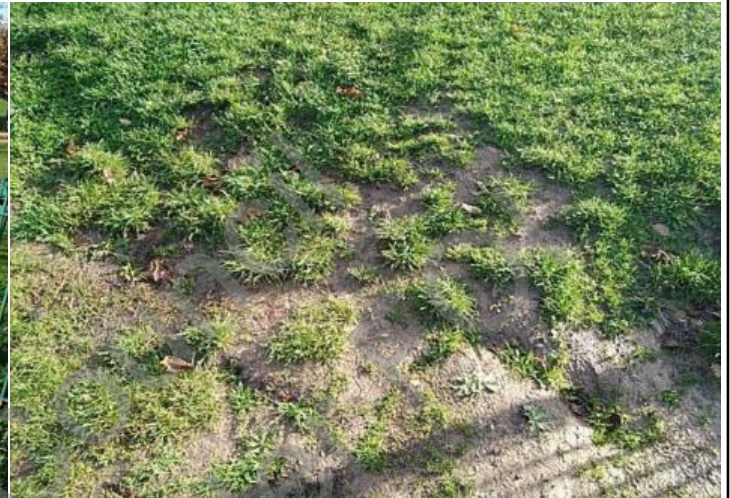
**Finding:** The gate has no drop bolt sleeves and/or drop bolts fitted

**Action:** Provide drop bolt sleeves and/or drop bolts

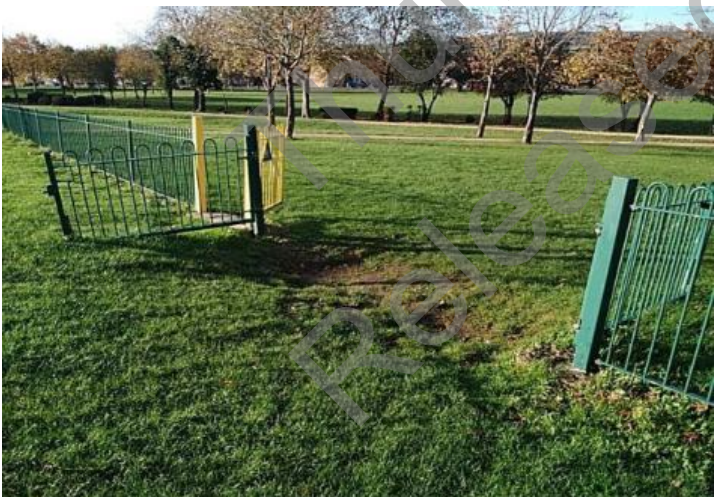
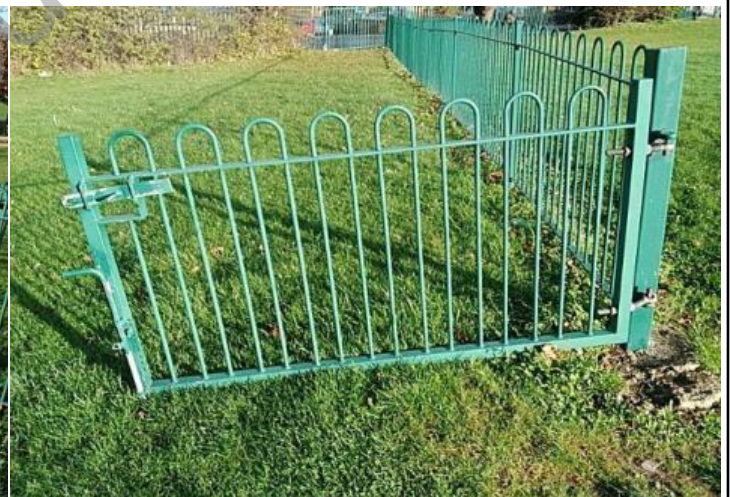
**Finding:** There is no padlock on the maintenance gate

**Action:** Provide a padlock to secure the gate

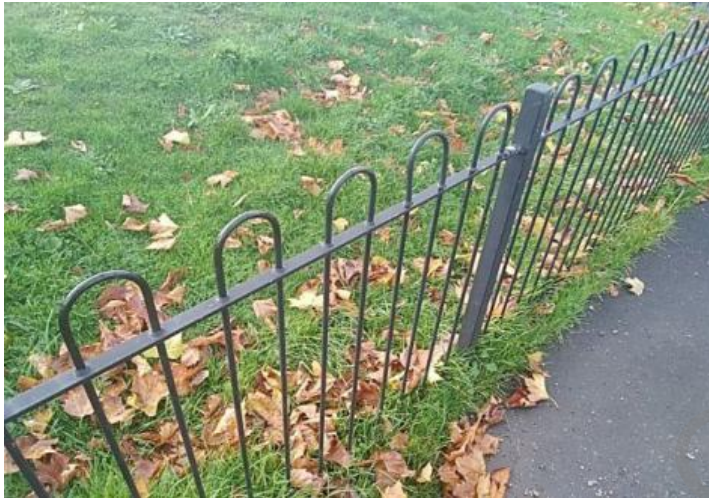
**Finding:** There is some damage to the fence sections

**Action:** Monitor for any further deterioration and repair as required

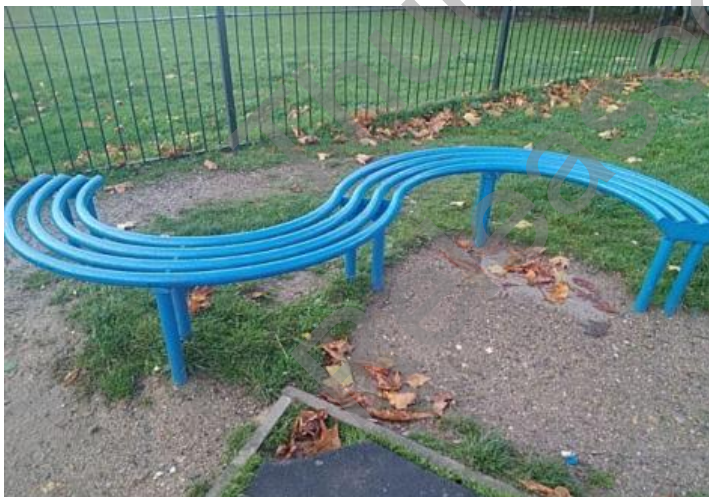
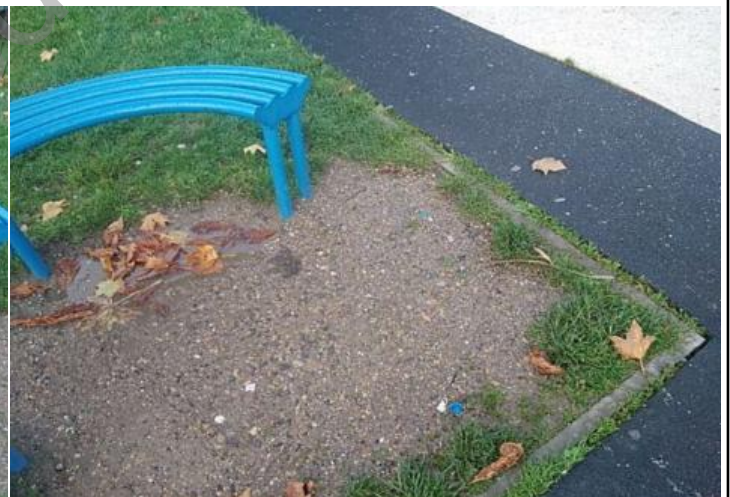
**Finding:** The area around the item has eroded and may become slippery

**Action:** Reinstate eroded area

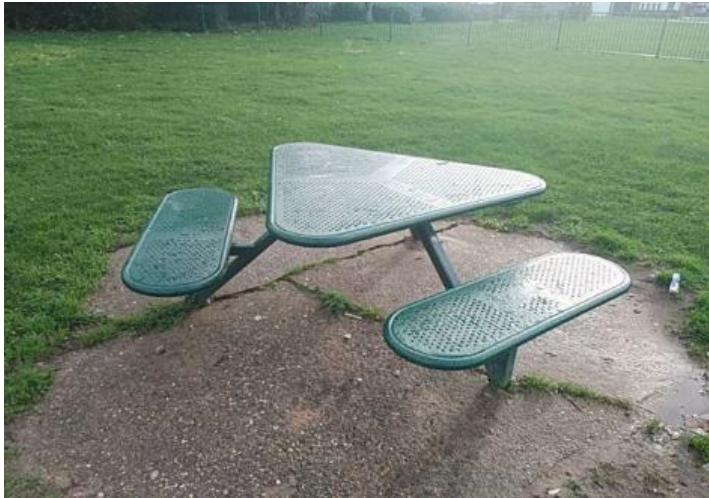
**Finding:** There is moderate damage to the surface

**Action:** Repair the damaged areas of surfacing

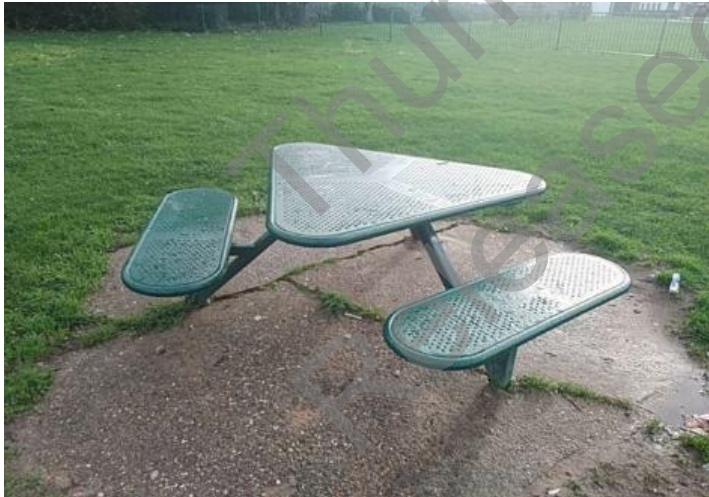
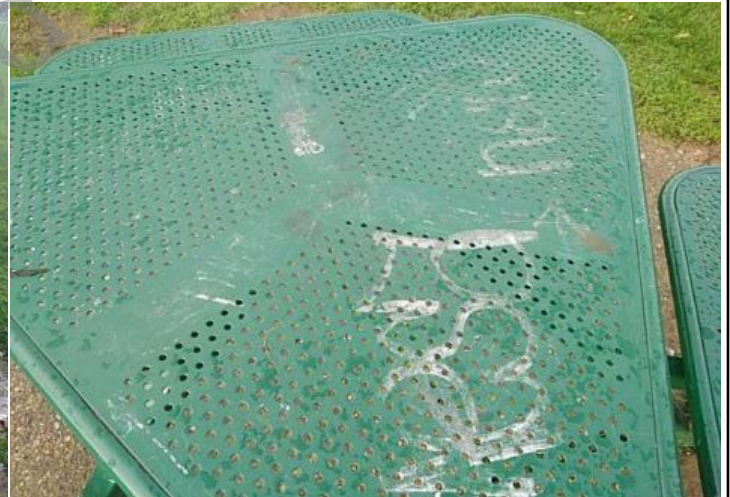
**Finding:** There is some graffiti present

**Action:** Remove the graffiti

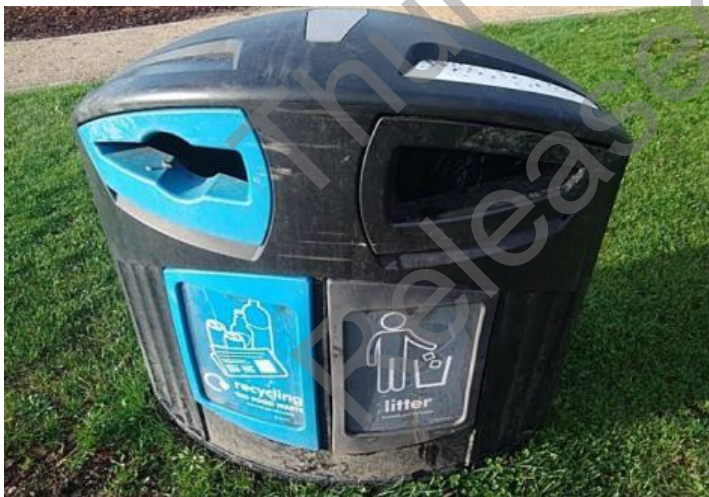
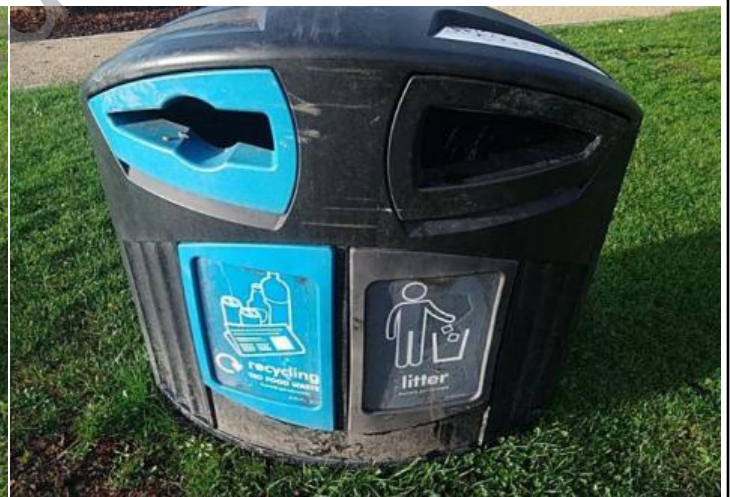
**Finding:** The bin is not securely fixed to the surface and there is some possibility of the item tipping or rolling over

**Action:** Secure the bin to the ground

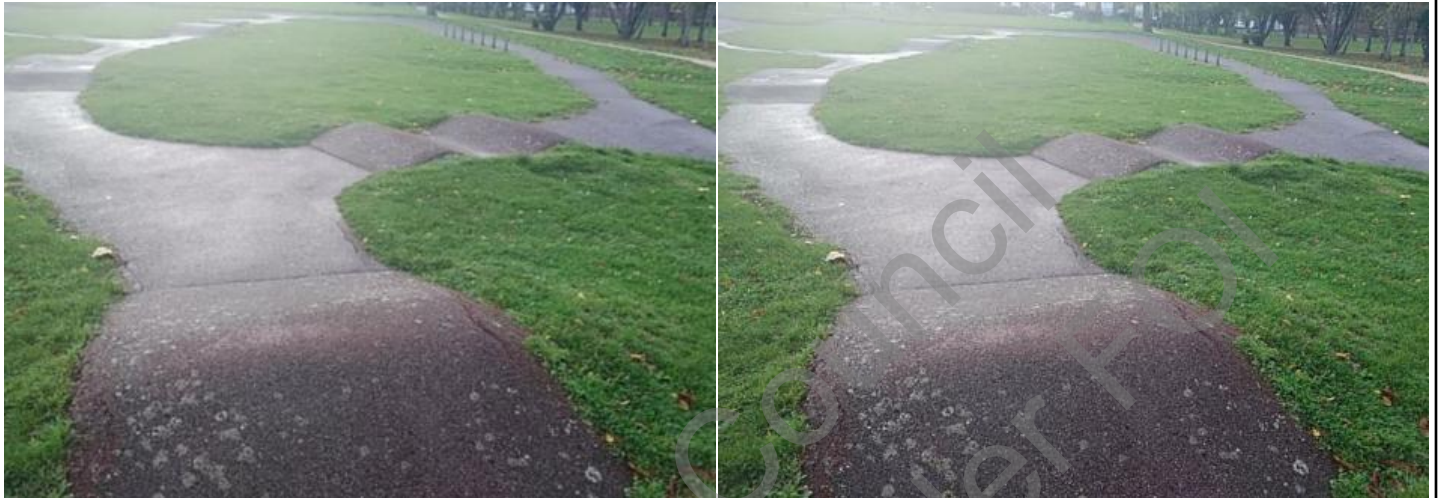
**Finding:** BMX tracks are not currently covered by any British or European Standard; comments made in the report are based on the application of our knowledge and understanding of the Wheeled Sports Standard (BS EN 14974) and their maintenance and the area has been risk assessed accordingly

**Action:** Monitor use and review risk assessment regularly

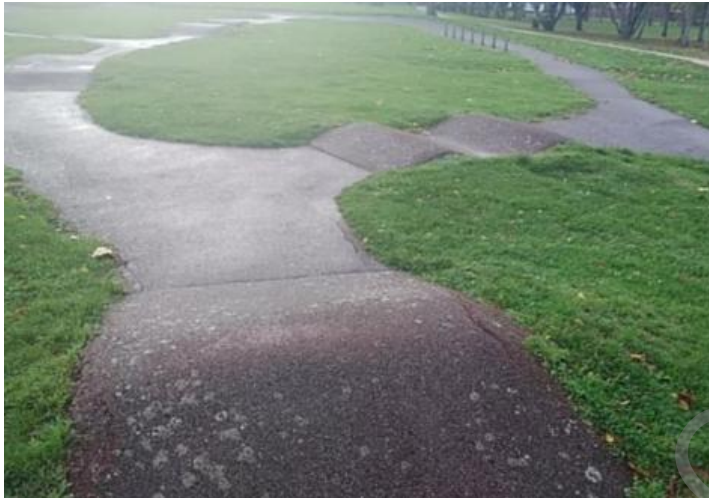
**Finding:** There are minor stress fractures in the tarmac surface

**Action:** Monitor and repair if required
