## Annual Inspection

Thurrock Council

Corringham Town Park

Springhouse Road, Corringham, Essex, SS17 7NB

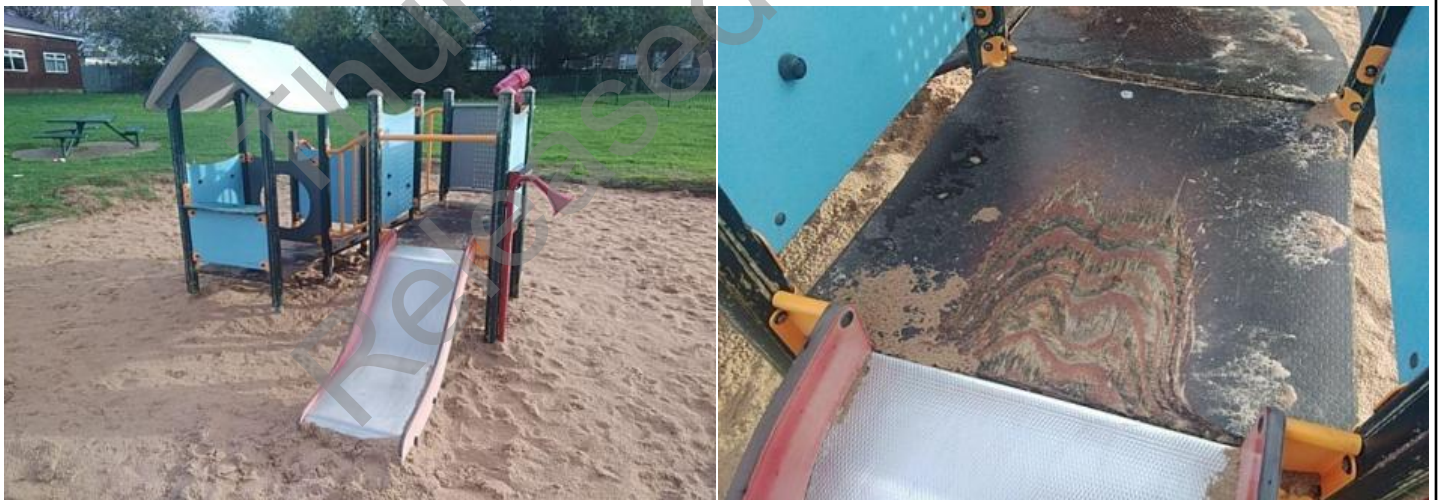
**Finding:** The plywood has delaminated in some places

**Action:** Remove all rough or splintered edges.

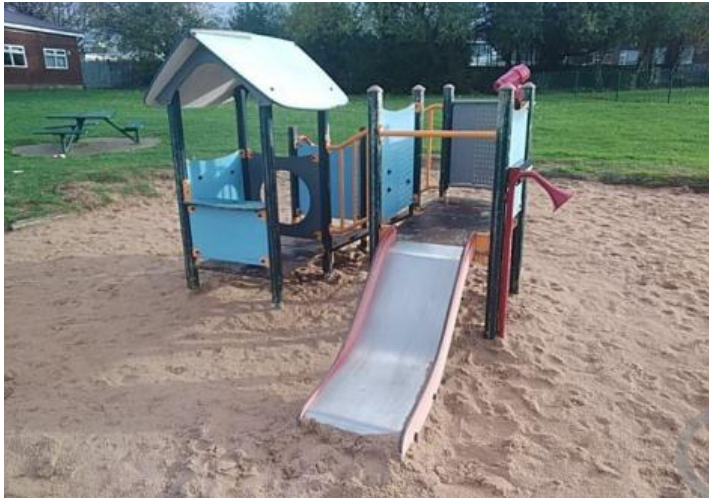
**Finding:** The paintwork on this item has been damaged or worn exposing the metal underneath which is rusting

**Action:** Treat any rusting components and repaint

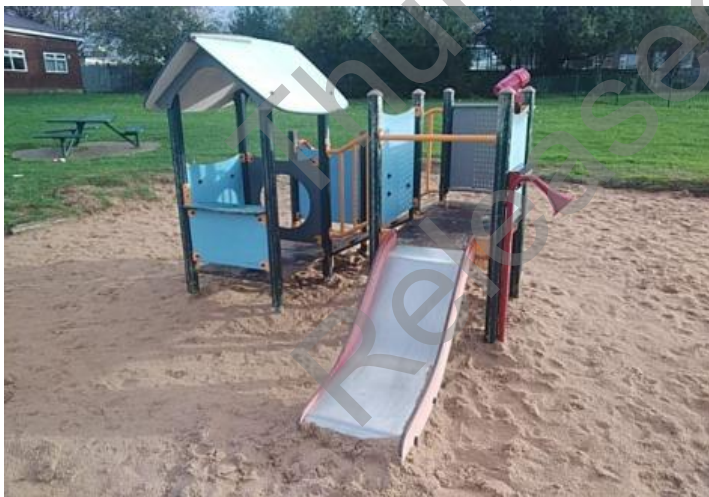
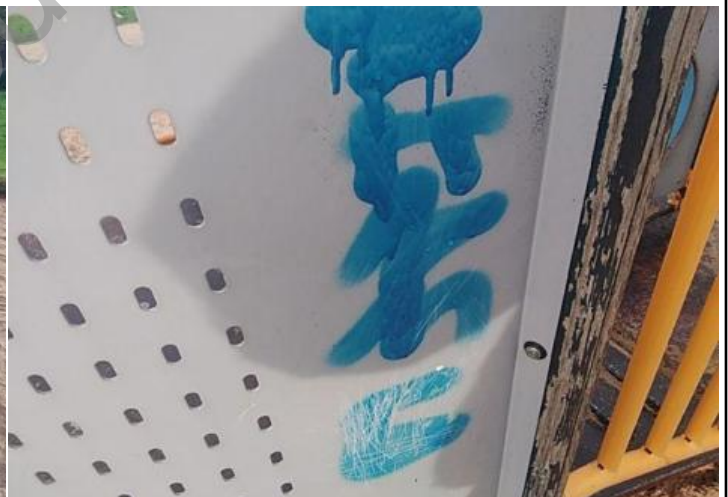
**Finding:** There is some graffiti present

**Action:** Remove the graffiti

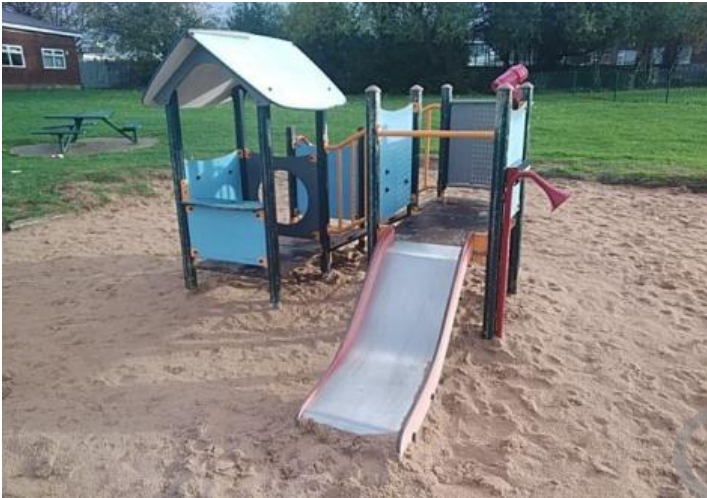
**Item:** Activity Equipment - Multi Play (Toddler)  
**Manufacturer:** Hags

**Finding:** There are post / end caps missing from the item

**Action:** Replace missing post caps

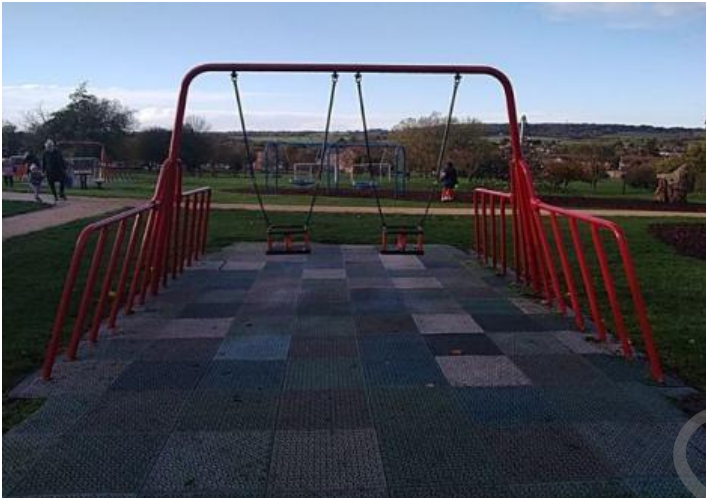
**Item:** Swings - 1 Bay 2 Seat (Cradle)  
**Manufacturer:** Wicksteed Playgrounds

**Finding:** There are gaps opening in between the tiles

**Action:** Monitor for any further deterioration and repair as required

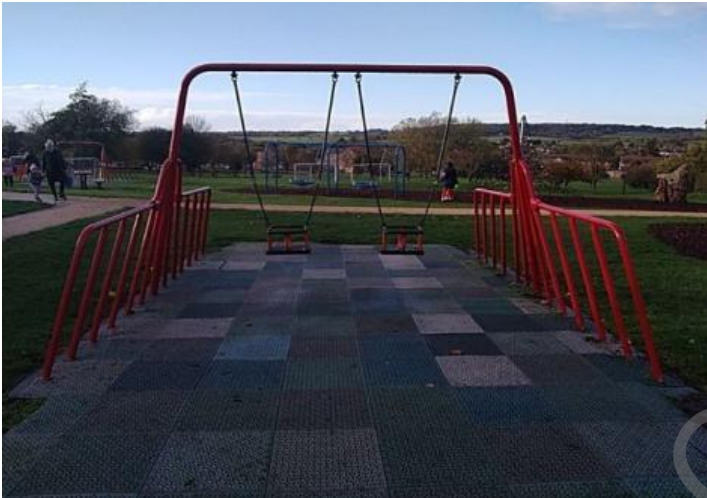
**Item:** Swings - 1 Bay 2 Seat (Cradle)  
**Manufacturer:** Wicksteed Playgrounds

The connecting lugs are showing signs of wear - Monitor for any further deterioration and repair as required

**Finding:** The connecting lugs are showing signs of wear

**Action:** Monitor for any further deterioration and repair as required

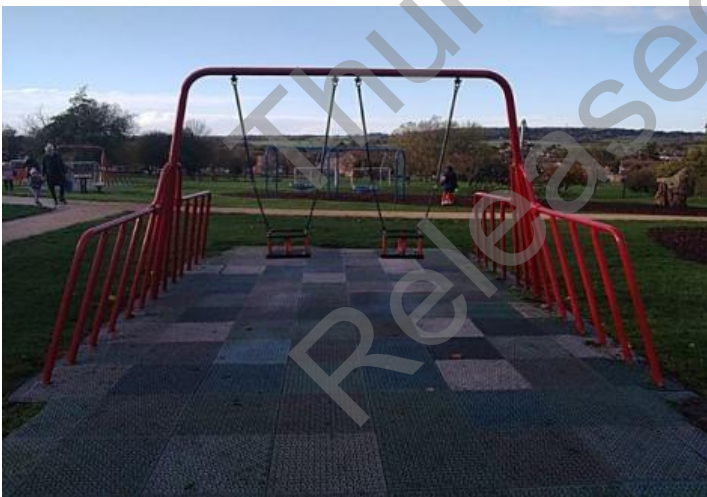
**Item:** Swings - 1 Bay 2 Seat (Cradle)  
**Manufacturer:** Wicksteed Playgrounds

The surface has subsided in some areas - Monitor for any further deterioration and repair as required

**Finding:** The surface has subsided in some areas

**Action:** Monitor for any further deterioration and repair as required

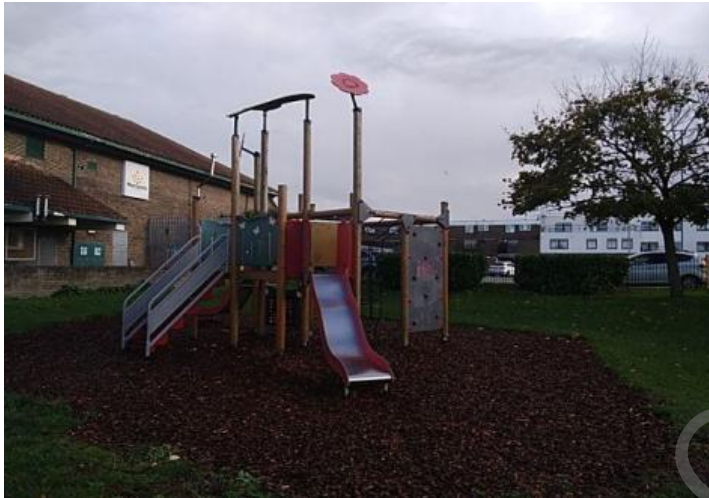
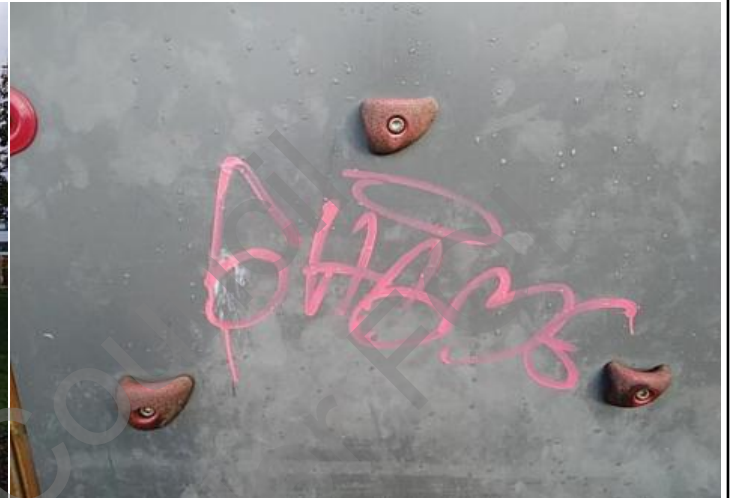
**Item:** Activity Equipment - Multi Play (Junior)  
**Manufacturer:** Hags

**Finding:** There is some graffiti present

**Action:** Remove the graffiti

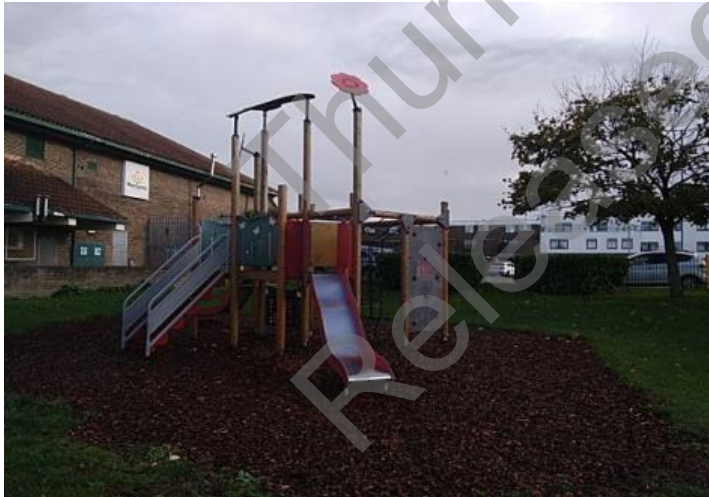
**Item:** Activity Equipment - Multi Play (Junior)  
**Manufacturer:** Hags

There are a number of dents in the slide surface - Monitor for any further deterioration and repair as required

**Finding:** There are a number of dents in the slide surface

**Action:** Monitor for any further deterioration and repair as required

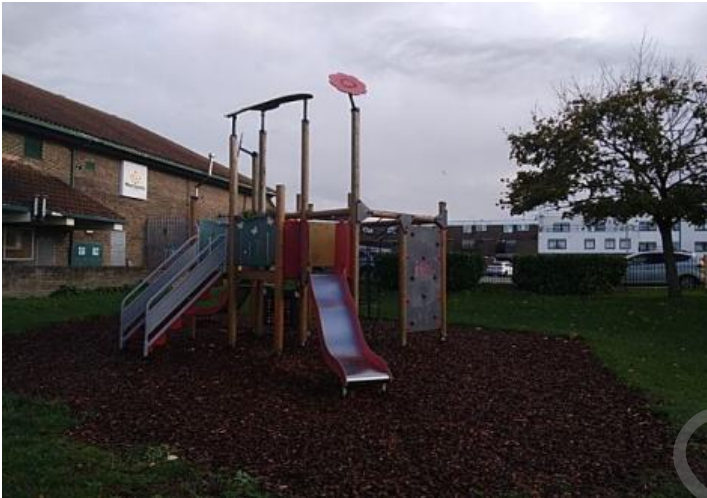
**Item:** Activity Equipment - Multi Play (Junior)  
**Manufacturer:** Hags

There is some evidence of fire damage to the item - Monitor for any further deterioration and repair as required

**Finding:** There is some evidence of fire damage to the item **Action:** Monitor for any further deterioration and repair as required

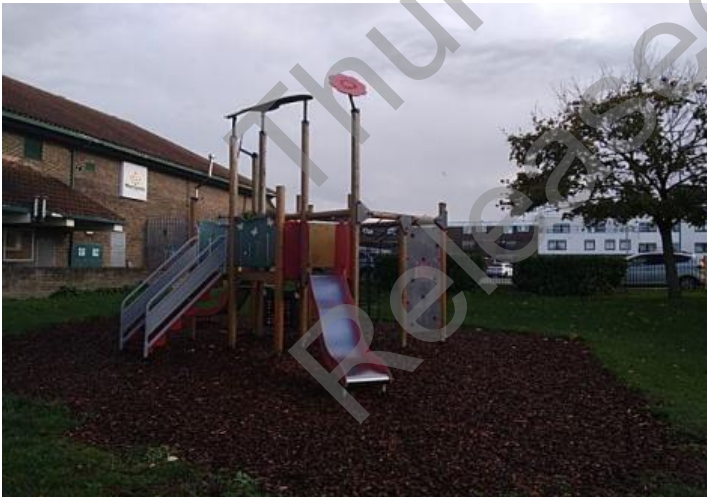
**Item:** Activity Equipment - Multi Play (Junior)  
**Manufacturer:** Hags

There are post / end caps missing from the item - Replace missing post caps

**Finding:** There are post / end caps missing from the item **Action:** Replace missing post caps

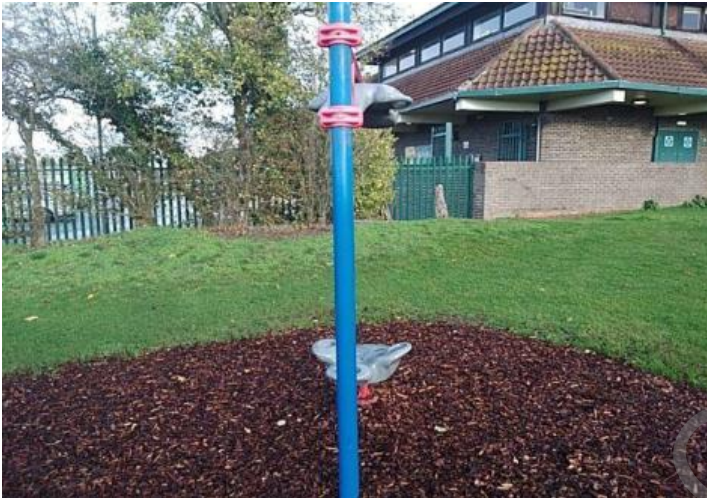
**Item:** Rotor Play - Misc Item  
**Manufacturer:** Playworld Systems (Europe) Ltd

The item has missing component(s) - Consider replacing missing components

**Finding:** The item has missing component(s)

**Action:** Consider replacing missing components

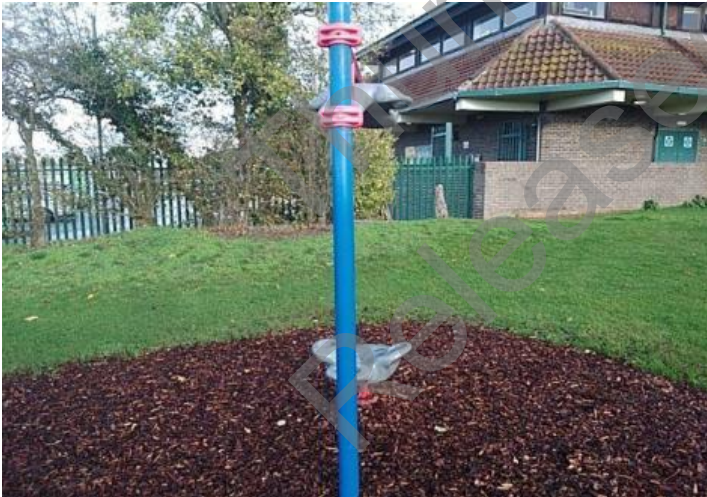
**Item:** Rotor Play - Misc Item  
**Manufacturer:** Playworld Systems (Europe) Ltd

The bearing is not operating correctly - Repair or replace the bearing as required

**Finding:** The bearing is not operating correctly

**Action:** Repair or replace the bearing as required

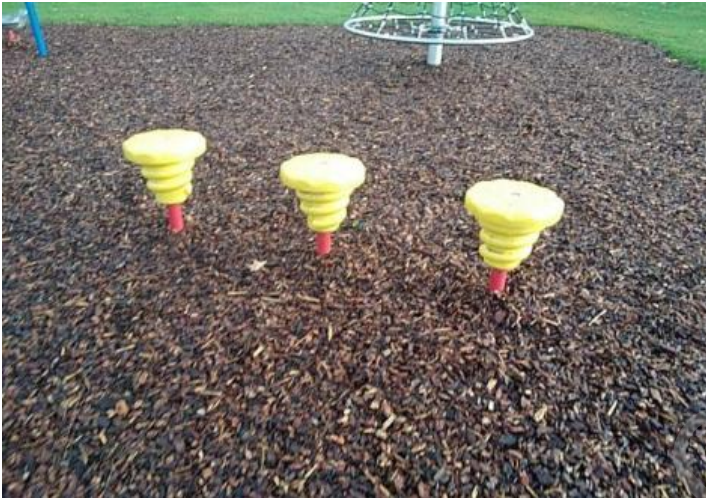
**Item:** Activity Equipment - Stepping Stones  
**Manufacturer:** Playworld Systems (Europe) Ltd

**Finding:** The item has been damaged

**Action:** Monitor for any further deterioration and replace as required

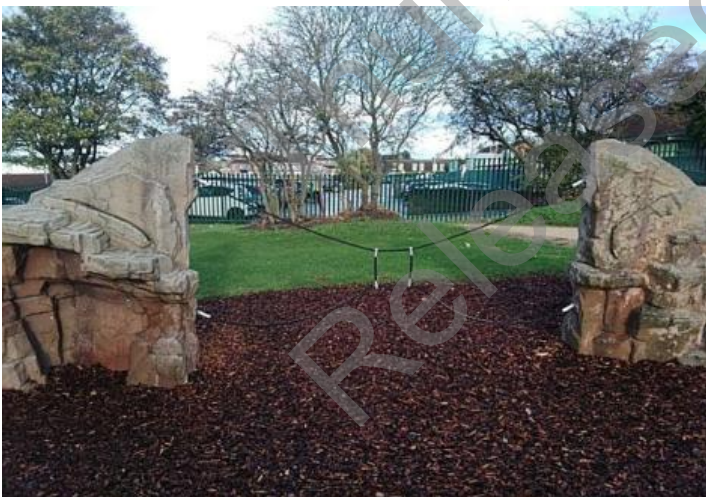
**Item:** Activity Equipment - Climbing Wall  
**Manufacturer:** Not Identified

The rope has worn and wire strands are exposed - Replace rope or net

**Finding:** The rope has worn and wire strands are exposed

**Action:** Replace rope or net

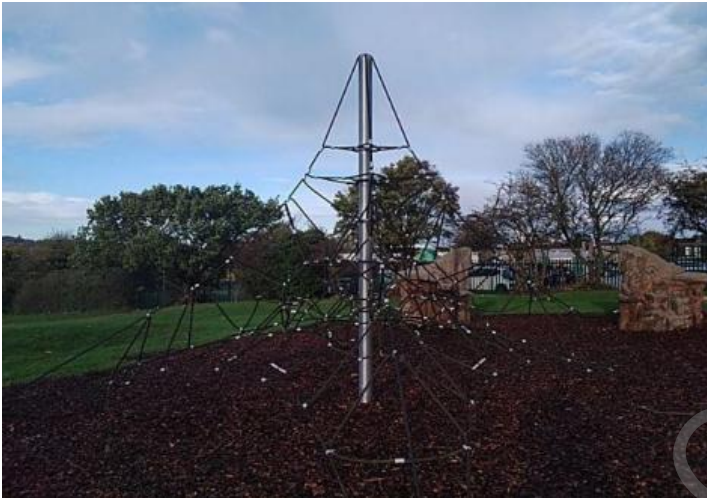
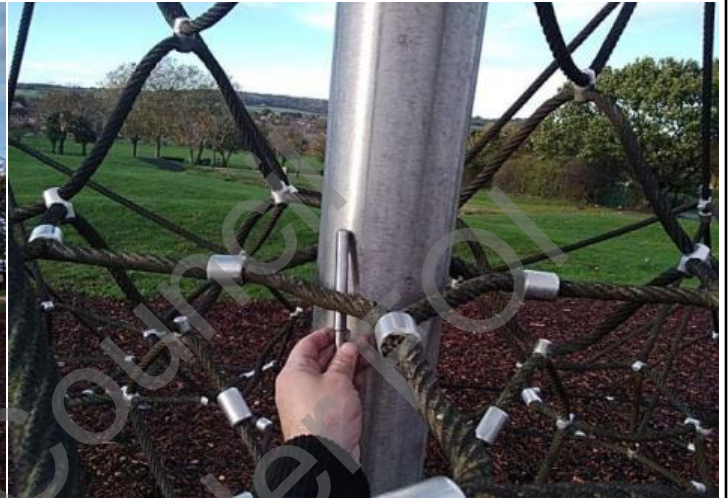
**Item:** Activity Equipment - Space Net  
**Manufacturer:** Kompan Ltd

**Finding:** There is a potential crushing point between the rope and the central post in contravention of BS EN 1176 Part 1

**Action:** Re-tension ropes to ensure the rope is spaced evenly around the post

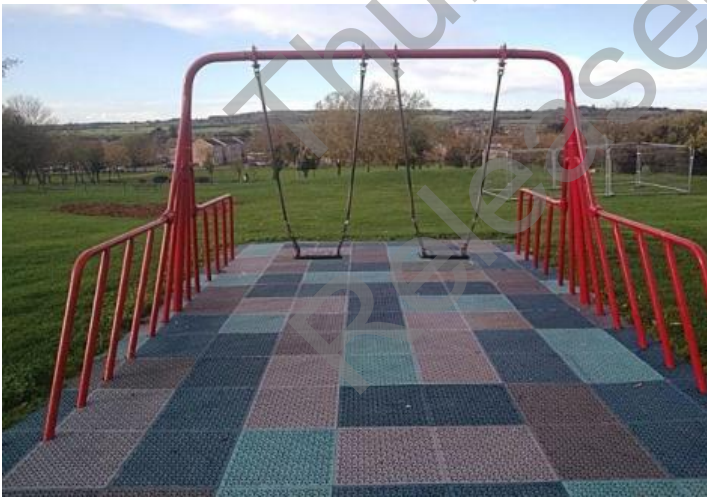
**Item:** Swings - 1 Bay 2 Seat (Flat)  
**Manufacturer:** Wicksteed Playgrounds

The connecting links are in excess of 8.6mm and less than 12mm and fail the requirements of BS EN 1176 Part 1; clause 4.2.13, Chains - Monitor use and replace with compliant links at the next maintenance cycle

**Finding:** The connecting links are in excess of 8.6mm and less than 12mm and fail the requirements of BS EN 1176 Part 1; clause 4.2.13, Chains

**Action:** Monitor use and replace with compliant links at the next maintenance cycle

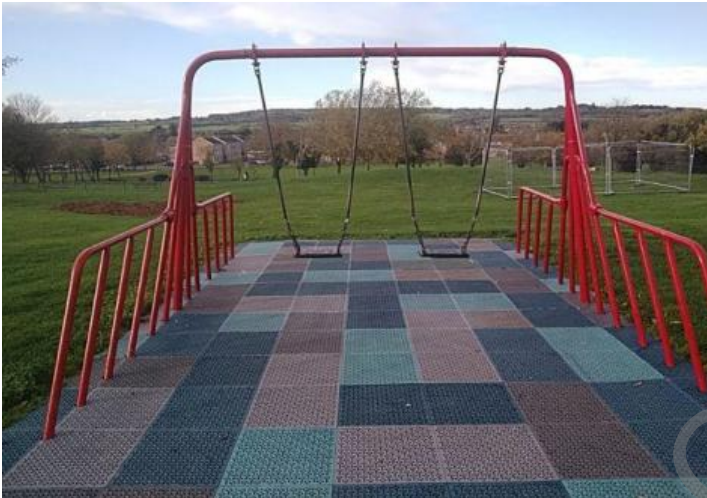
**Item:** Swings - 1 Bay 2 Seat (Flat)  
**Manufacturer:** Wicksteed Playgrounds

**Finding:** There is some notable evidence of chain wear

**Action:** Monitor for any further deterioration and replace when 40% worn

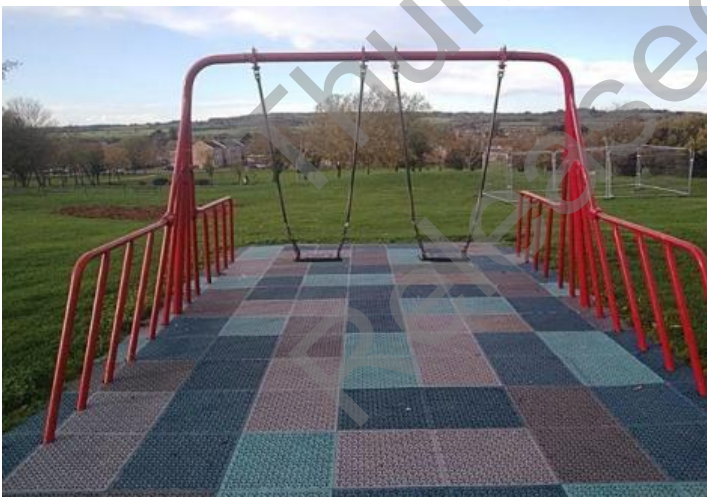
**Item:** Swings - 1 Bay 2 Seat (Flat)  
**Manufacturer:** Wicksteed Playgrounds

The chain openings are in excess of the 8.6mm as recommended by BS EN 1176 - Monitor - No remedial work recommended

**Finding:** The chain openings are in excess of the 8.6mm as recommended by BS EN 1176

**Action:** Monitor - No remedial work recommended

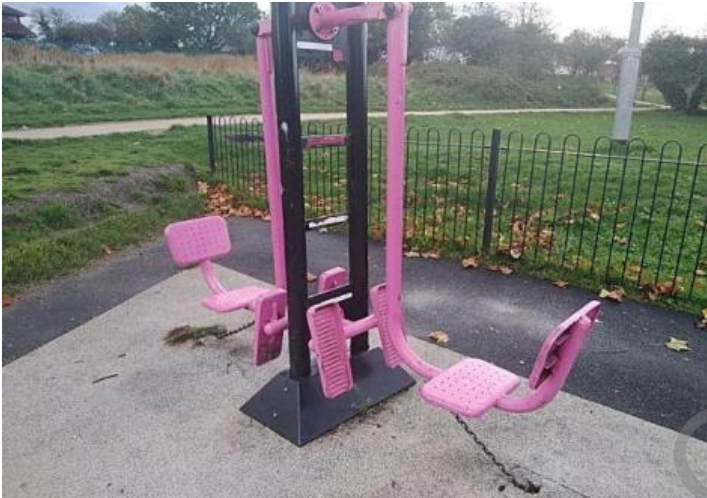
**Item:** Outdoor Fitness Equipment - Leg Press  
**Manufacturer:** The Great Outdoor Gym Company

**Finding:** The connecting lugs are showing signs of wear

**Action:** Monitor for any further deterioration and repair as required

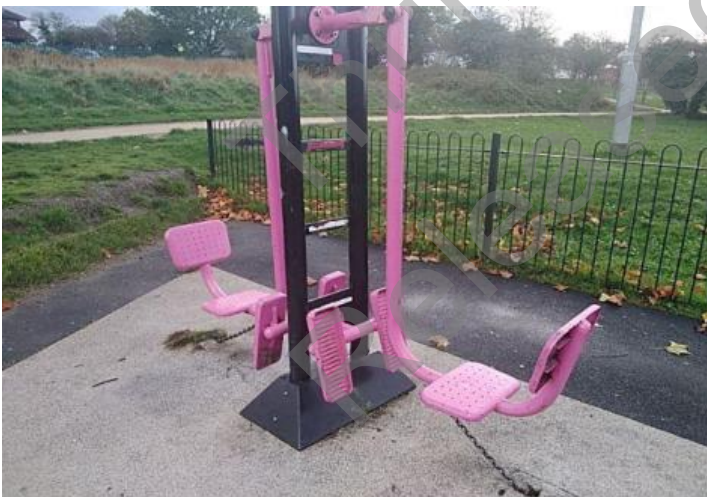
**Item:** Outdoor Fitness Equipment - Leg Press  
**Manufacturer:** The Great Outdoor Gym Company

There is some wear to the shackles - Monitor for any further deterioration and replace when 40% worn

**Finding:** There is some wear to the shackles

**Action:** Monitor for any further deterioration and replace when 40% worn

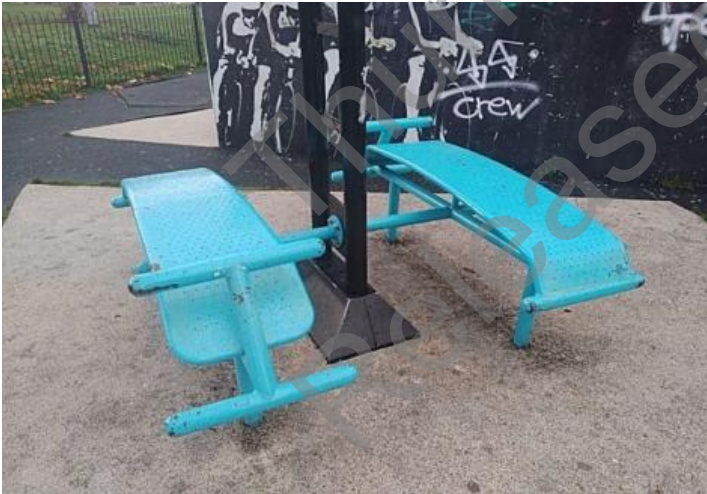
**Item:** Outdoor Fitness Equipment - Ab Station  
**Manufacturer:** The Great Outdoor Gym Company

**Finding:** The paintwork on this item has been damaged or worn exposing the metal underneath which is rusting

**Action:** Treat any rusting components and repaint

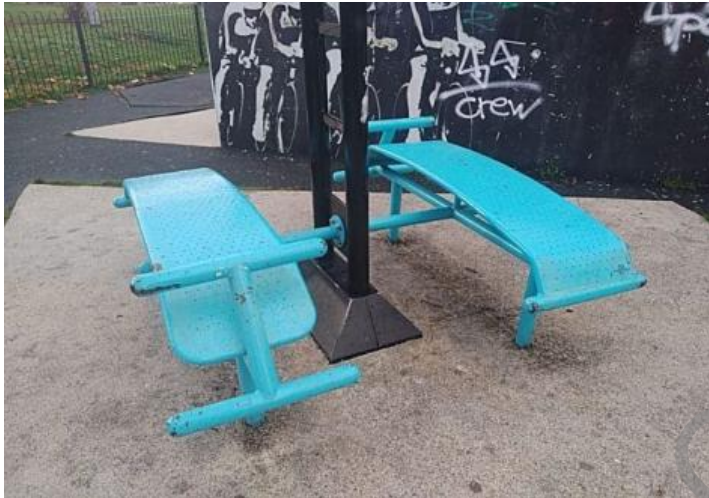
**Item:** Outdoor Fitness Equipment - Ab Station  
**Manufacturer:** The Great Outdoor Gym Company

**Finding:** There is/are bolt cap covers missing or damaged on the item

**Action:** Replace missing or damaged bolt cap covers

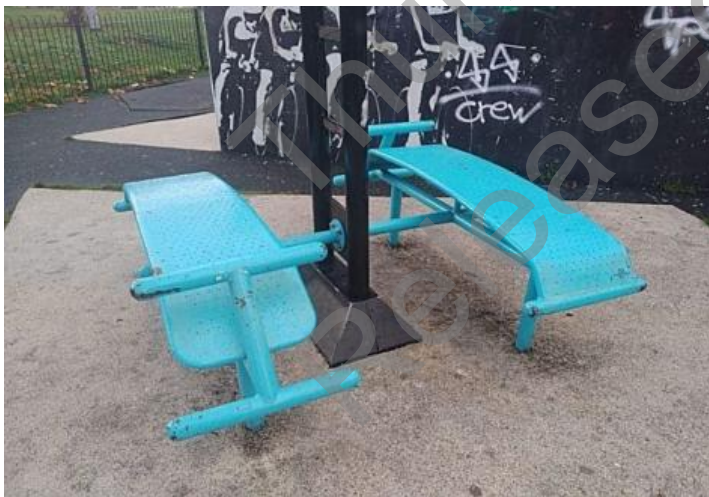
**Item:** Outdoor Fitness Equipment - Ab Station  
**Manufacturer:** The Great Outdoor Gym Company

There is minor distortion damage to the bench - Monitor and repair if required

**Finding:** There is minor distortion damage to the bench

**Action:** Monitor and repair if required

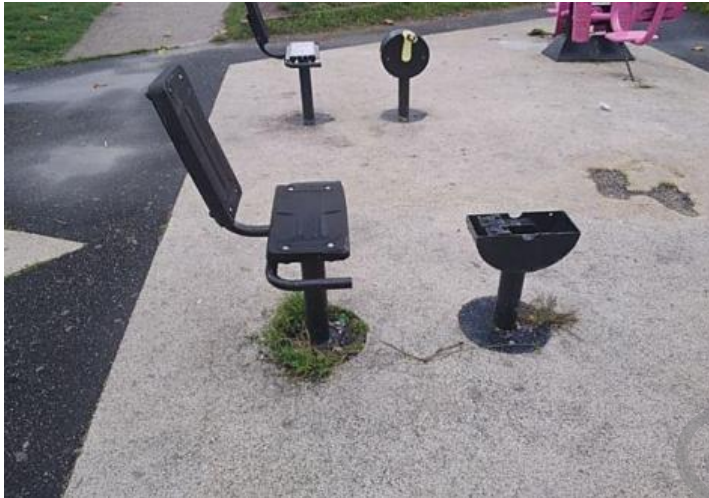
**Item:** Outdoor Fitness Equipment - Cycle  
**Manufacturer:** The Great Outdoor Gym Company

The mechanism has been removed from one item - Replace the missing components or remove the item completely

**Finding:** The mechanism has been removed from one item **Action:** Replace the missing components or remove the item completely

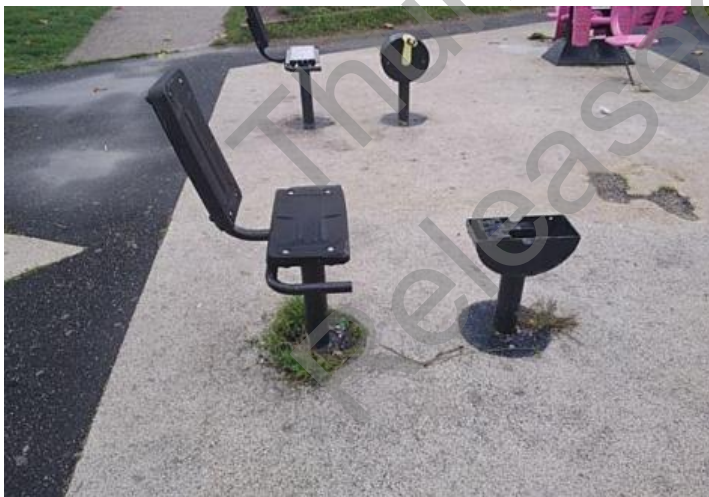
**Item:** Outdoor Fitness Equipment - Cycle  
**Manufacturer:** The Great Outdoor Gym Company

There is minor damage to the seat - Monitor and replace if required

**Finding:** There is minor damage to the seat **Action:** Monitor and replace if required

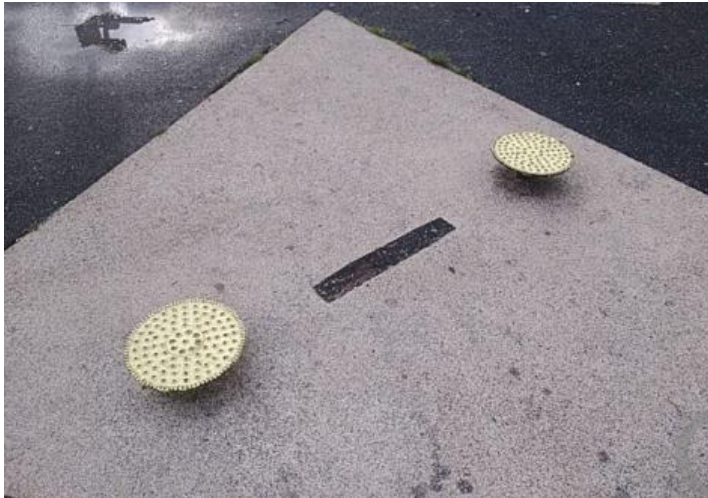
**Item:** Outdoor Fitness Equipment - Hip Twister  
**Manufacturer:** The Great Outdoor Gym Company

The deflection of the rotating user station exceeds the maximum 105 degrees required by BS EN 16630 - Monitor - No remedial work recommended

**Finding:** The deflection of the rotating user station exceeds the maximum 105 degrees required by BS EN 16630

**Action:** Monitor - No remedial work recommended

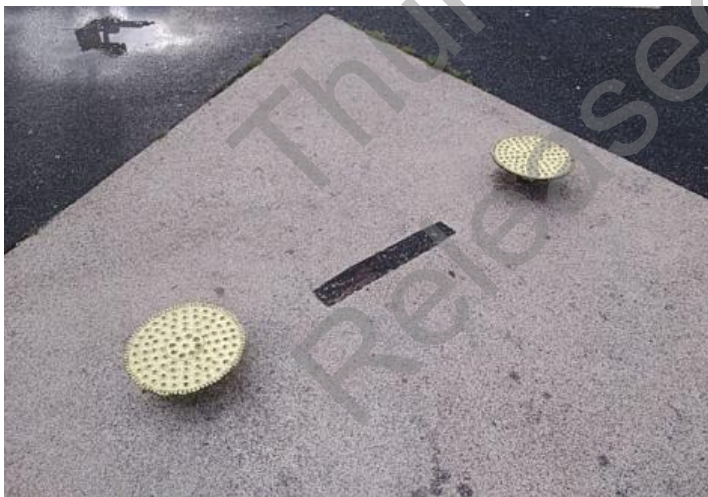
**Item:** Outdoor Fitness Equipment - Hip Twister  
**Manufacturer:** The Great Outdoor Gym Company

The rotating user station is not appropriately marked with a guideline of user direction and/or the original position as required by BS EN 16630 - Monitor - No remedial work recommended

**Finding:** The rotating user station is not appropriately marked with a guideline of user direction and/or the original position as required by BS EN 16630

**Action:** Monitor - No remedial work recommended

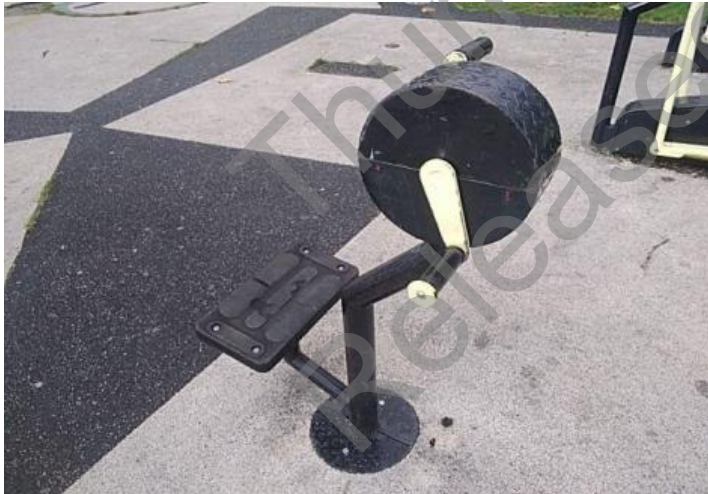
**Item:** Outdoor Fitness Equipment - Hand Bike  
**Manufacturer:** The Great Outdoor Gym Company

There is some evidence of fire damage to the item - Monitor for any further deterioration and repair as required

**Finding:** There is some evidence of fire damage to the item

**Action:** Monitor for any further deterioration and repair as required

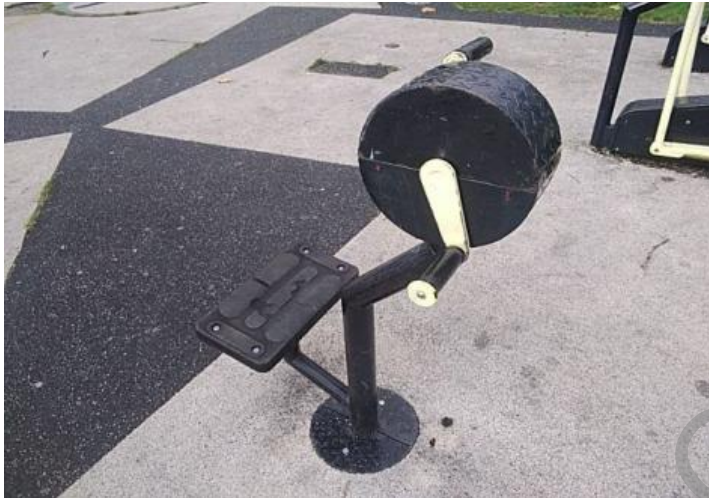
**Item:** Outdoor Fitness Equipment - Hand Bike  
**Manufacturer:** The Great Outdoor Gym Company

**Finding:** The paintwork on this item has been damaged or worn exposing the metal underneath which is rusting

**Action:** Treat any rusting components and repaint

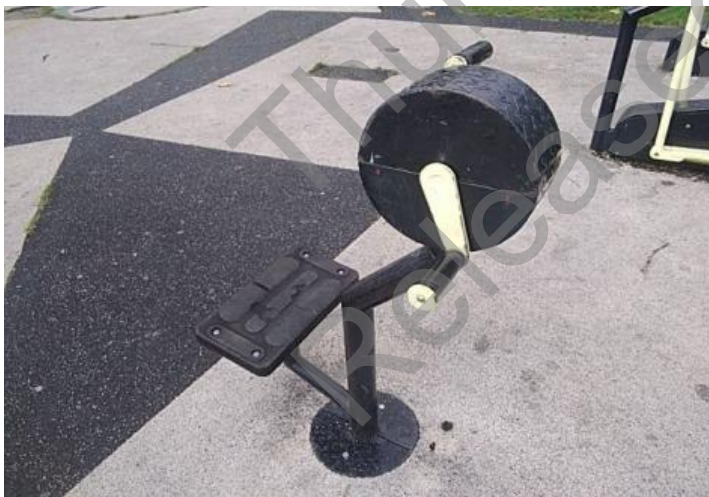
**Item:** Outdoor Fitness Equipment - Hand Bike  
**Manufacturer:** The Great Outdoor Gym Company

One or more handgrip(s) are damaged or missing. - Replace missing or damaged handgrips

**Finding:** One or more handgrip(s) are damaged or missing.

**Action:** Replace missing or damaged handgrips

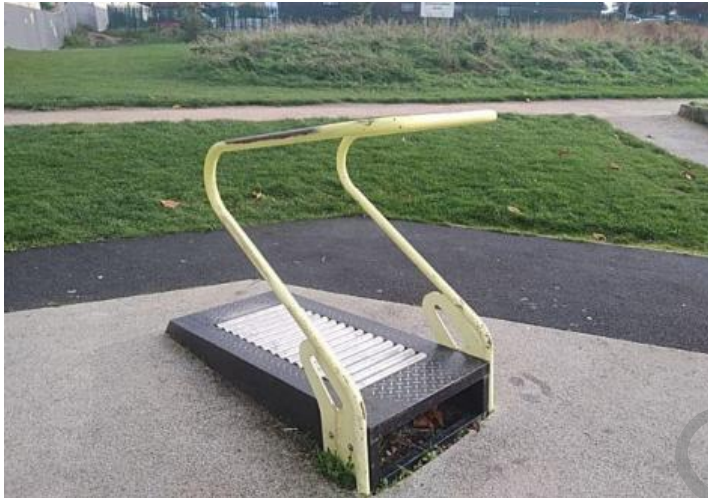
**Item:** Outdoor Fitness Equipment - Treadmill  
**Manufacturer:** The Great Outdoor Gym Company

**Finding:** The paintwork on this item has been damaged or worn exposing the metal underneath which is rusting

**Action:** Treat any rusting components and repaint

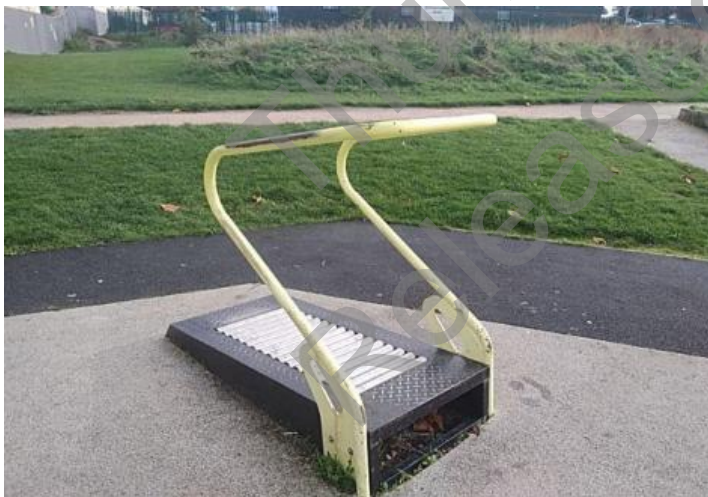
**Item:** Outdoor Fitness Equipment - Treadmill  
**Manufacturer:** The Great Outdoor Gym Company

The inspection plate has been removed - Replace the missing inspection plate

**Finding:** The inspection plate has been removed

**Action:** Replace the missing inspection plate

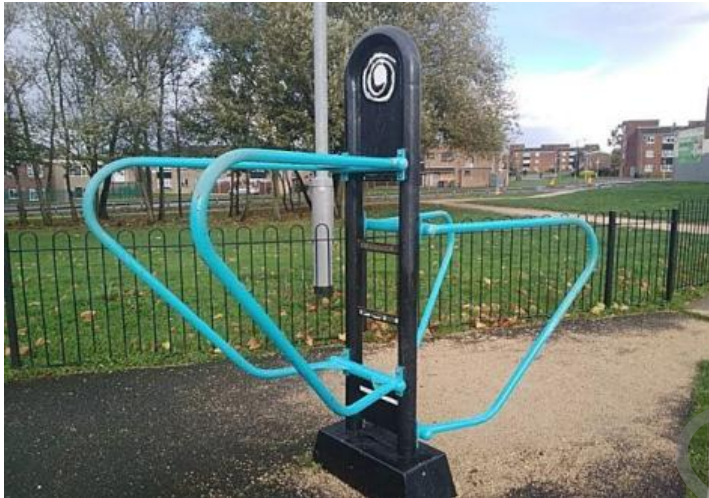
**Item:** Outdoor Fitness Equipment - Dip Station  
**Manufacturer:** The Great Outdoor Gym Company

**Finding:** The paintwork on this item has been damaged or worn exposing the metal underneath which is rusting

**Action:** Treat any rusting components and repaint

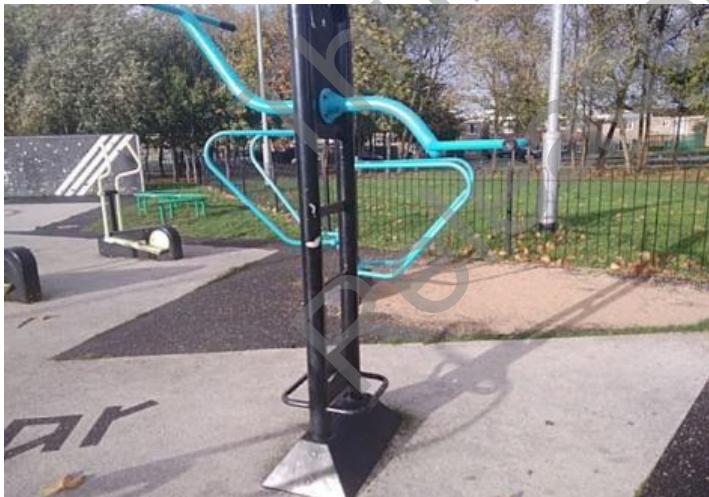
**Item:** Outdoor Fitness Equipment - Pull Up Station  
**Manufacturer:** The Great Outdoor Gym Company

**Finding:** There is/are bolt cap covers missing or damaged on the item

**Action:** Replace missing or damaged bolt cap covers

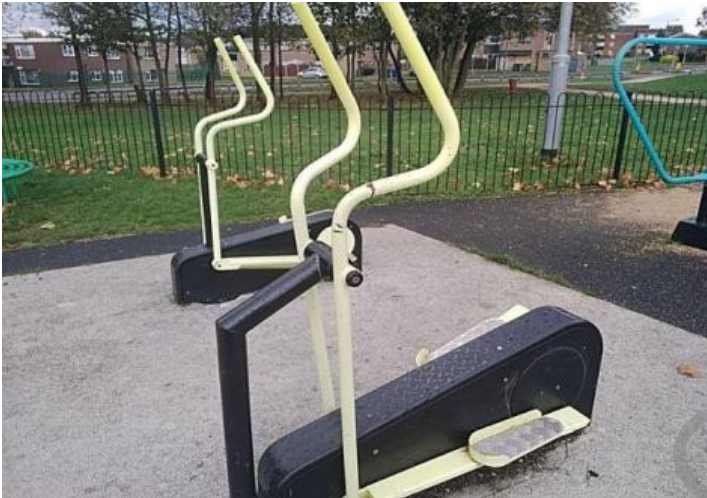
**Item:** Outdoor Fitness Equipment - Cross Trainer **Risk Level:** L - Low Risk  
**Manufacturer:** The Great Outdoor Gym Company **Surface:** Wet Pour

The bushes are worn or missing - Replace worn or missing bushes

**Finding:** The bushes are worn or missing

**Action:** Replace worn or missing bushes

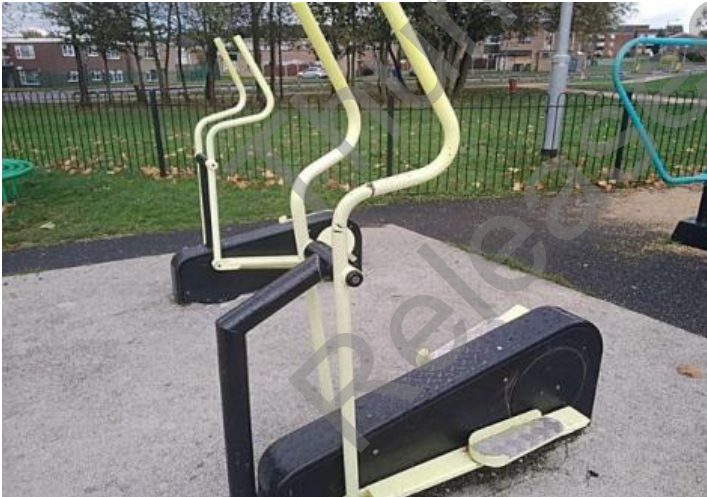
**Item:** Outdoor Fitness Equipment - Cross Trainer **Risk Level:** L - Low Risk  
**Manufacturer:** The Great Outdoor Gym Company **Surface:** Wet Pour

**Finding:** There is or are fixings missing on the item

**Action:** Replace all missing fixings

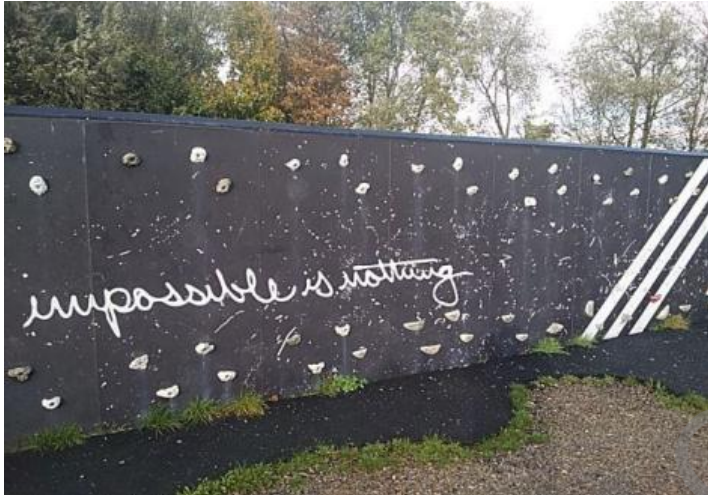
**Item:** Activity Equipment - Traverse Wall  
**Manufacturer:** Park Leisure Ltd

The surfacing is severely damaged - Repair damaged areas of surfacing

**Finding:** The surfacing is severely damaged

**Action:** Repair damaged areas of surfacing

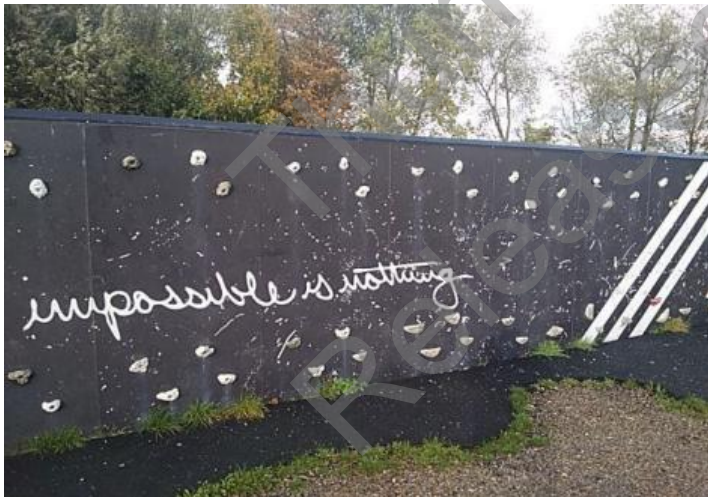
**Item:** Activity Equipment - Traverse Wall  
**Manufacturer:** Park Leisure Ltd

**Finding:** The item has been damaged

**Action:** Monitor for any further deterioration and replace as required

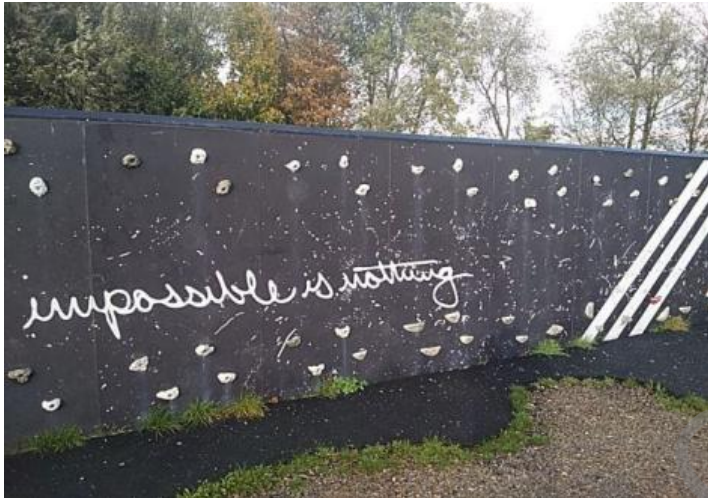
**Item:** Activity Equipment - Traverse Wall  
**Manufacturer:** Park Leisure Ltd

**Finding:** There is or are fixings missing on the item

**Action:** Replace all missing fixings

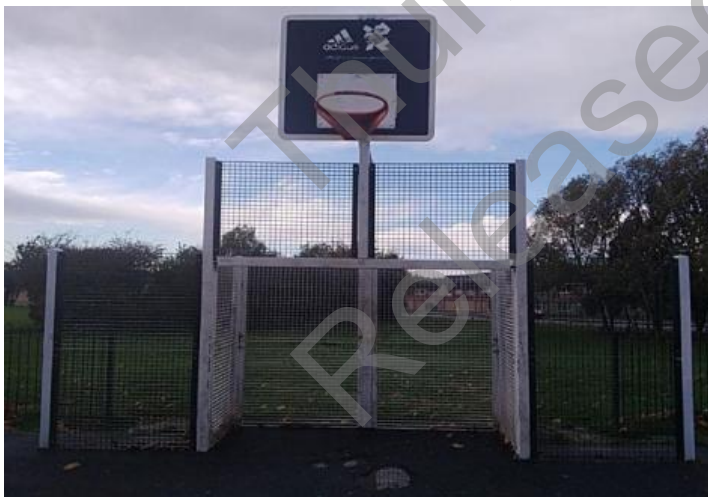
**Item:** Multi Use Games Area - Goalmouth and Basketball Post  
**Manufacturer:** Park Leisure Ltd

There is moderate damage to the surface - Repair the damaged areas of surfacing

**Finding:** There is moderate damage to the surface

**Action:** Repair the damaged areas of surfacing

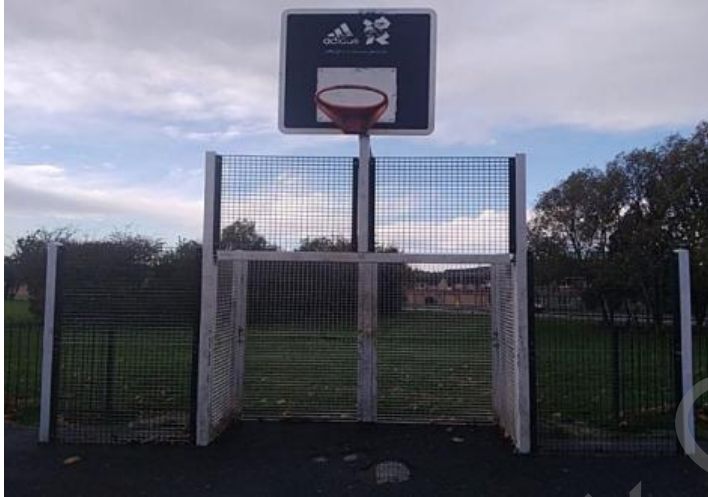
**Item:** Multi Use Games Area - Goalmouth and Basketball Post  
**Manufacturer:** Park Leisure Ltd

**Finding:** There is/are finger entrapments in the framework and the item fails to meet the requirements of BS EN 15312 Clause 4.4.2.2 Entrapment of fingers

**Action:** Monitor - No remedial work recommended

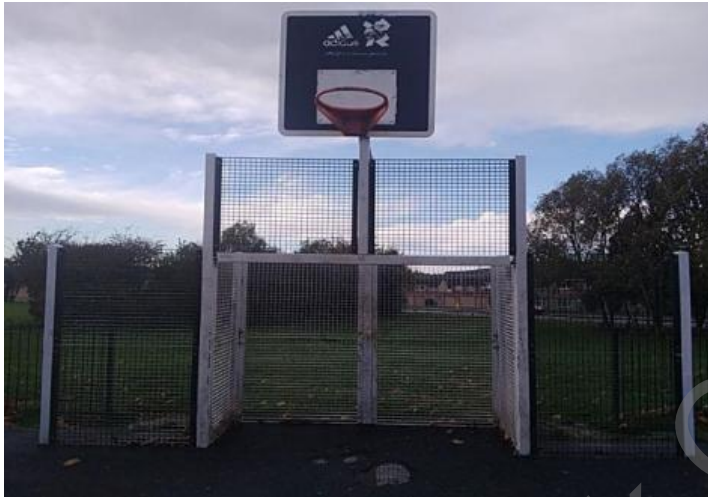
**Item:** Multi Use Games Area - Goalmouth and Basketball Post  
**Manufacturer:** Park Leisure Ltd

**Finding:** A clearly visible facility sign should be provided in a prominent position with the wording as detailed BS EN 15312- the equipment is not intended for children less than 3 years old- the warning - Do not climb on the framework or nets- the warning - Do not hang on the ring (if provided)- the warning - Do not wear rings or other jewellery- name and telephone number of the administrator- number to call in case of accident

**Action:** Provide signage to BS EN 15312

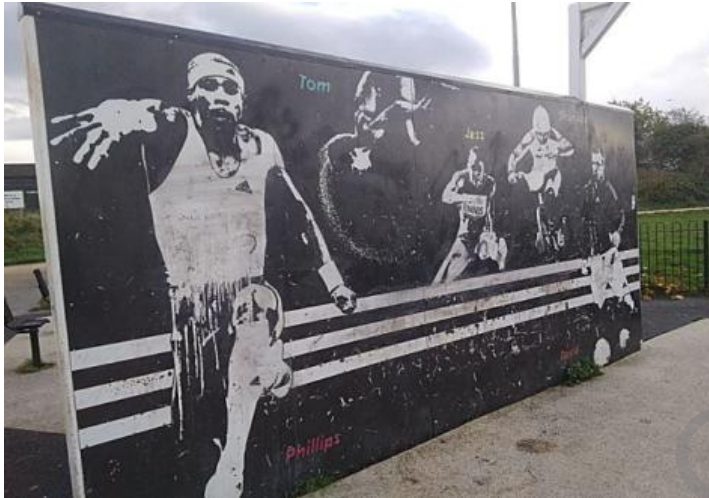
**Item:** Multi Use Games Area - Kickabout Wall  
**Manufacturer:** Park Leisure Ltd

**Finding:** The paintwork on this item has been damaged or worn exposing the metal underneath which is rusting

**Action:** Treat any rusting components and repaint

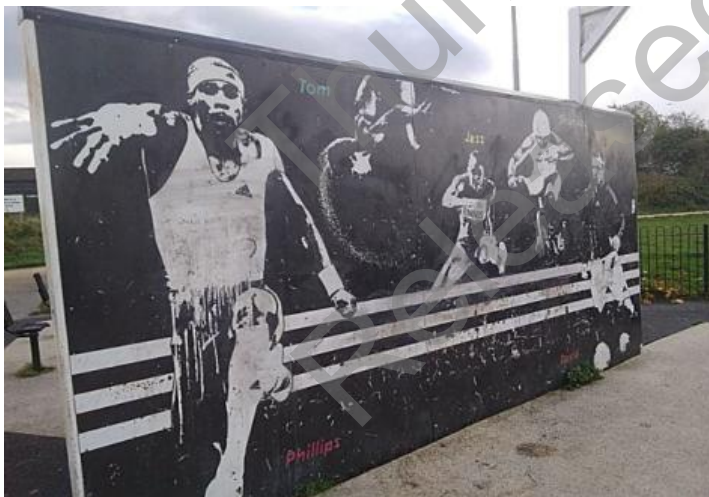
**Item:** Multi Use Games Area - Kickabout Wall  
**Manufacturer:** Park Leisure Ltd

**Finding:** There is or are fixings missing on the item

**Action:** Replace all missing fixings
