Annual Inspection

Thurrock Council

Corringham Town Park

Springhouse Road, Corringham, Essex, SS17 7NB

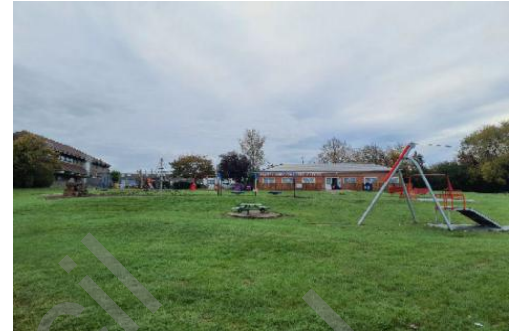
Item: Site General
Manufacturer: Owner/Operator
Surface Type: N/A
Item Quantity: 1
Equipment Compliance: N/A
Surface Area Compliance: N/A

There are trip hazards at the edges of the surface - Reinstate surrounding surface levels to remove the trip points

There is some evidence of fire damage to the surfacing - Monitor for any further deterioration and repair as required

There are redundant bases in the area due to the removal of equipment and there are foundations that are exposed causing trips - Consider removing bases and reinstating the surface to cover the exposed foundations

There are significant gaps (over 30mm) between the surface and the edging or between the joints in the surface; these are large enough for a small foot to enter - Repair surfacing

There are sleepers missing from the timber retaining wall - Replace the missing sleepers

There is moderate damage to the surface - Repair the damaged areas of surfacing

There is broken glass present on site - Remove the broken glass and maintain the area

The surface is lifting at the edges and creating trip points - Repair perimeter of surfacing to remove trip points

There are areas or parts of the timber edgings that have rotted or are missing - Replace all affected timbers

There is an exposed metal foundation present by the walkway - Remove

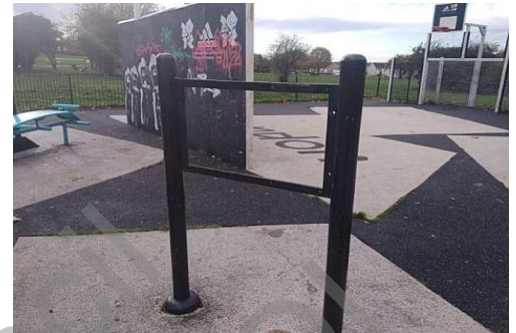
Item: Sign
Manufacturer: Owner/Operator
Surface Type: N/A
Item Quantity: 1
Equipment Compliance: N/A
Surface Area Compliance: N/A

It is recommended that signage, with information including the site address, contact information for maintenance issues and emergency contact details are provided for the facility - Provide in accordance with the recommendations

The signage is damaged or missing - Replace signage

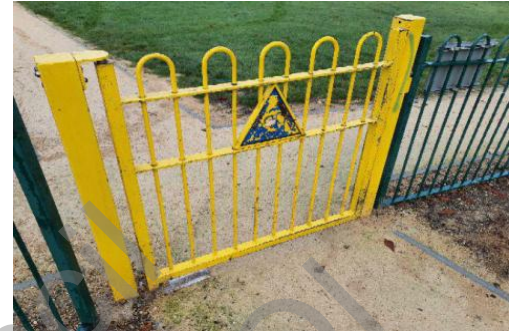
Item: Gate - Self Closing
Manufacturer: Not Identified
Surface Type: Grass
Item Quantity: 1
Equipment Compliance: N/A
Surface Area Compliance: N/A

No slamming plate has been fitted to the gates and the gate leaves pass the slamming posts - Provide slamming plates

The surface has eroded in some areas and may be slippery in wet conditions - Reinstate the surface

The area under the gate has eroded leaving uneven areas, or the concrete foundations exposed, resulting in trip hazards at the entrance/exit to the playground - Reinstate to level with surrounding surfaces

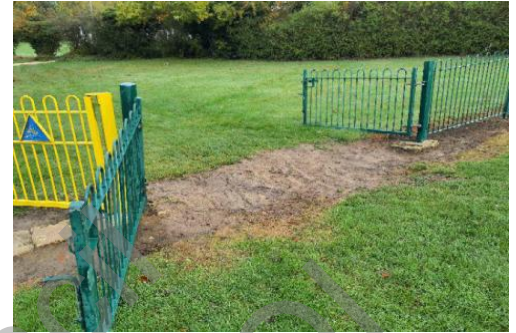
Item: Gate - Maintenance
Manufacturer: Not Identified
Surface Type: Grass
Item Quantity: 1
Equipment Compliance: N/A
Surface Area Compliance: N/A

The surface has eroded in some areas and may be slippery in wet conditions - Reinststate the surface

The item is loose in its foundations - Reinstall item to secure

The surface has eroded and the foundations are exposed - Reinststate surrounding surfaces to cover the foundations

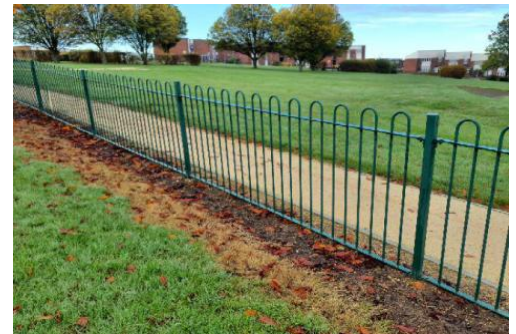
Item: Fence - Bow Top
Manufacturer: Not Identified
Surface Type: Grass
Item Quantity: 1
Equipment Compliance: N/A
Surface Area Compliance: N/A

There is some damage to the fence sections - Monitor for any further deterioration and repair as required

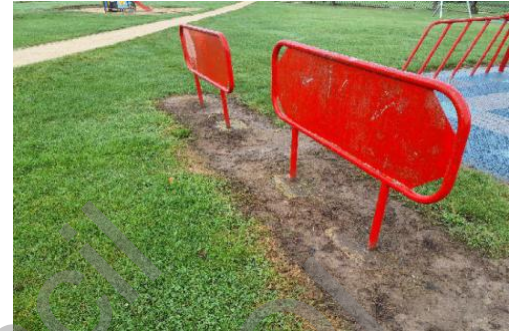
Item: Swing Barrier
Manufacturer: Not Identified
Surface Type: Grass
Item Quantity: 2
Equipment Compliance: N/A
Surface Area Compliance: N/A

The surface has eroded and the foundations are exposed - Reinstate surrounding surfaces to cover the foundations

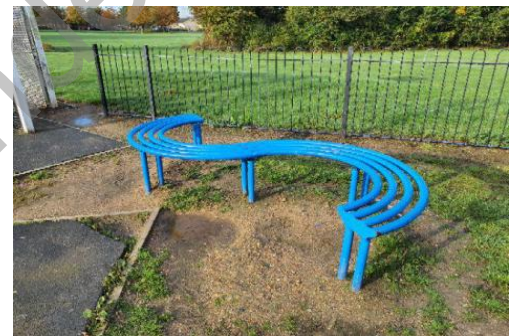
Item: Bench
Manufacturer: Not Identified
Surface Type: Grass
Item Quantity: 2
Equipment Compliance: N/A
Surface Area Compliance: N/A

The surface has eroded in some areas and may be slippery in wet conditions - Reinstate the surface

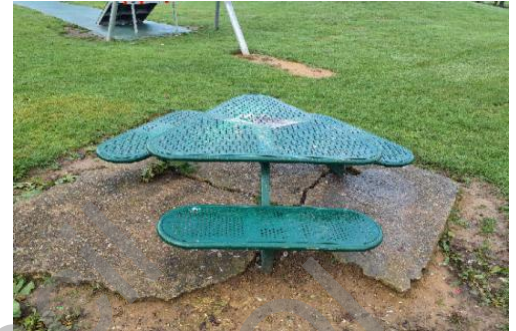
Item: Picnic Table
Manufacturer: Not Identified
Surface Type: Concrete
Item Quantity: 3
Equipment Compliance: N/A
Surface Area Compliance: N/A

The surfacing is severely damaged - Repair damaged areas of surfacing

There are trip hazards at the edges of the surface - Reinstate surrounding surface levels to remove the trip points

There is some evidence of fire damage to the item - Monitor for any further deterioration and repair as required

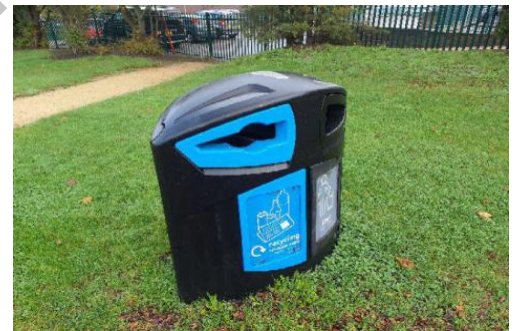
Item: Litter Bin
Manufacturer: Not Identified
Surface Type: Grass
Item Quantity: 2
Equipment Compliance: N/A
Surface Area Compliance: N/A

The bin is not securely fixed to the surface and there is some possibility of the item tipping or rolling over - Secure the bin to the ground

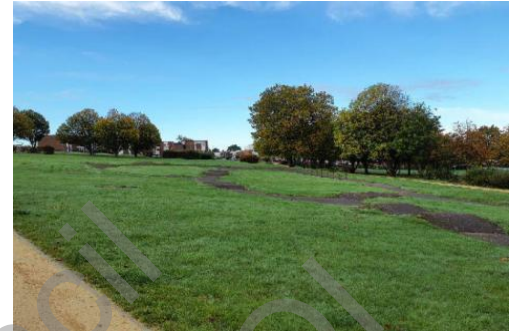
Item: BMX Track
Manufacturer: Owner/Operator
Surface Type: Tarmac
Item Quantity: 1
Equipment Compliance: N/A
Surface Area Compliance: N/A

BMX tracks are not currently covered by any British or European Standard; comments made in the report are based on the application of our knowledge and understanding of the Wheeled Sports Standard (BS EN 14974) and their maintenance and the area has been risk assessed accordingly - Monitor use and review risk assessment regularly

There are minor stress fractures in the tarmac surface - Monitor and repair if required

There is some evidence of fire damage to the surfacing - Monitor for any further deterioration and repair as required

There is algae, silt or moss growth on the surface resulting in slippery conditions - Clean and treat appropriately

There is some evidence of rot in the timber - Monitor for any further deterioration and replace as required

The riding surface of the ramp has some damage apparent - Monitor for any further deterioration and repair as required

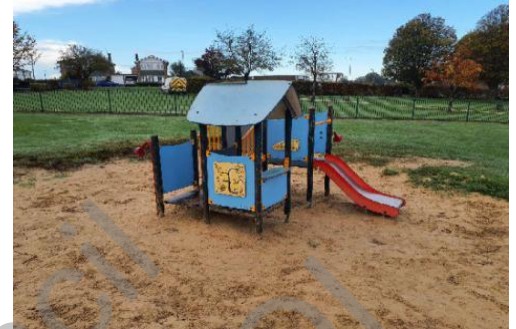
Item: Multi Play (Toddler)
Manufacturer: Hags
Surface Type: Sand
Item Quantity: 1
Equipment Compliance: No
Surface Area Compliance: Yes
Life Expectancy: 5 -10 Years
Total Findings: 10

Parts of the timber are rough or splintered - Remove all rough or sharp edges

There are post / end caps missing or damage on the item - Replace missing/damaged post caps

There is/are finger entrapment/s in the slide starting section and the item fails to meet the requirements of BS EN 1176 Part 1 4.2.7.6 Entrapment of fingers - Remove entrapment

There is some evidence of rot in the timber - Monitor for any further deterioration and replace as required

There are a number of dents in the slide surface - Monitor for any further deterioration and repair as required

The timber stain is in poor condition - Prepare all affected parts and re-stain with an appropriate preservative

The paintwork on this item has been damaged or worn exposing the metal underneath which is rusting / corroding - Treat affected areas and repaint

There are trip hazards at the edges of the surface - Reinststate surrounding surface levels to remove the trip points

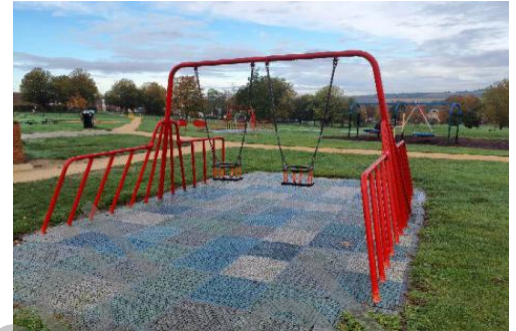
Item: 1 Bay 2 Seat (Cradle)
Manufacturer: Wicksteed Playgrounds
Surface Type: Matta
Item Quantity: 1
Equipment Compliance: Yes
Surface Area Compliance: Yes
Life Expectancy: 5 -10 Years
Total Findings: 5

There are gaps opening in between the tiles - Reinstate the surface

The seat has minor damage or wear - Monitor for any further deterioration and replace as required

The surface has subsided in some areas - Monitor for any further deterioration and repair as required

The connecting lugs are showing signs of wear - Monitor for any further deterioration and repair as required

There is some notable evidence of chain wear - Monitor for any further deterioration and replace when 40% worn

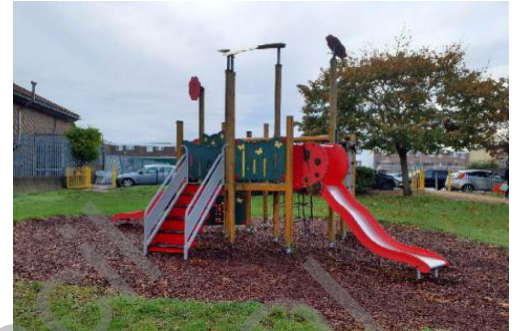
Item: Multi Play (Junior)
Manufacturer: Hags
Surface Type: Woodchip
Item Quantity: 1
Equipment Compliance: No
Surface Area Compliance: Yes
Life Expectancy: 5 -10 Years
Total Findings: 4

There are a number of dents in the slide surface - Monitor for any further deterioration and repair as required

There are post / end caps missing from the item - Replace missing post caps

There is some evidence of fire damage to the item - Monitor for any further deterioration and repair as required

There is/are finger entrapment/s in the platform due to fire damage and the item fails to meet the requirements of BS EN 1176 Part 1 4.2.7.6 Entrapment of fingers - Replace damaged slats to remove entrapment

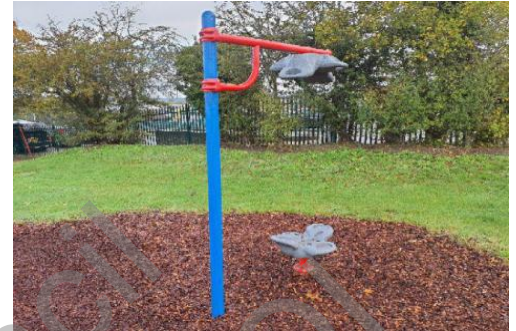
Item: Misc Item
Manufacturer: Playworld Systems (Europe) Ltd
Surface Type: Woodchip
Item Quantity: 1
Equipment Compliance: Yes
Surface Area Compliance: Yes
Life Expectancy: 1 - 3 Years
Total Findings: 2

The item has missing component(s) - Consider replacing missing components

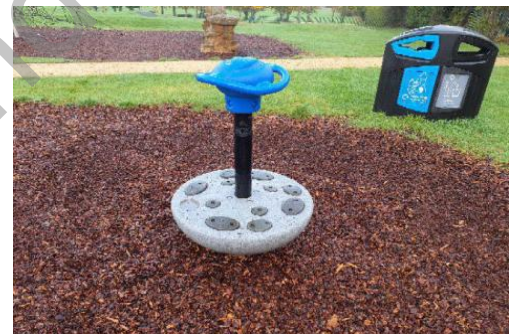
Item: Spinning Pole
Manufacturer: Playworld Systems (Europe) Ltd
Surface Type: Woodchip
Item Quantity: 1
Equipment Compliance: Yes
Surface Area Compliance: Yes
Life Expectancy: 3 - 5 Years
Total Findings: 1

The bearing is showing signs of wear - Monitor for any further deterioration and replace as required

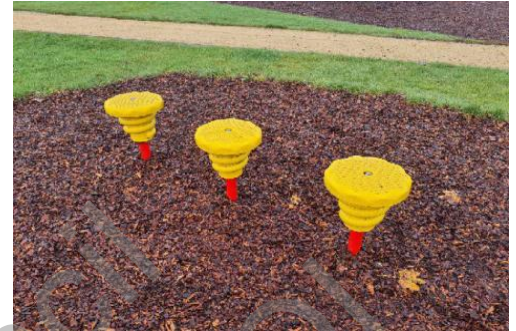
Item: Stepping Stones
Manufacturer: Playworld Systems (Europe) Ltd
Surface Type: Woodchip
Item Quantity: 1
Equipment Compliance: Yes
Surface Area Compliance: Yes
Life Expectancy: 3 - 5 Years
Total Findings: 1

The item has been damaged - Monitor for any further deterioration and replace as required

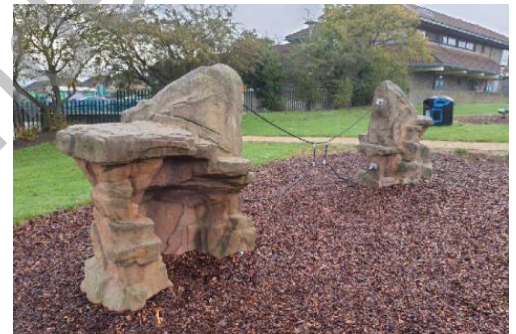
Item: Climbing Wall
Manufacturer: Not Identified
Surface Type: Woodchip
Item Quantity: 1
Equipment Compliance: Yes
Surface Area Compliance: Yes
Life Expectancy: 5 -10 Years
Total Findings: 1

The rope has worn and wire strands are exposed - Replace rope or net

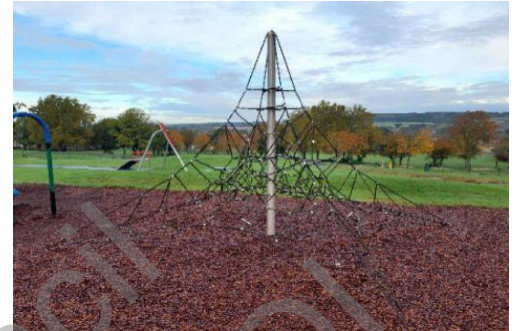
Item: Space Net
Manufacturer: Kompan Ltd
Surface Type: Woodchip
Item Quantity: 1
Equipment Compliance: No
Surface Area Compliance: Yes
Life Expectancy: 5 -10 Years
Total Findings: 1

There is a potential crushing point between the rope and the central post in contravention of BS EN 1176 Part 1 - Retention ropes to ensure the rope is spaced evenly around the post

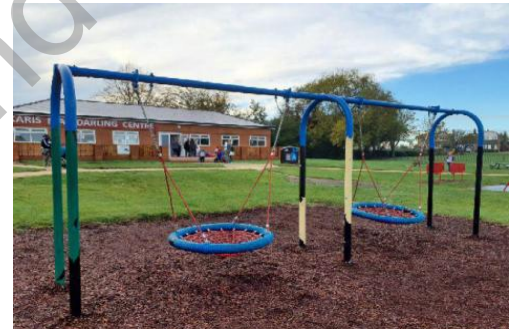
Item: 2 Bay Swing
Manufacturer: Playworld Systems (Europe) Ltd
Surface Type: Woodchip
Item Quantity: 1
Equipment Compliance: Yes
Surface Area Compliance: Yes
Life Expectancy: 5 -10 Years
Total Findings: 3

The bushes are showing signs of wear - Monitor for any further deterioration and replace as required

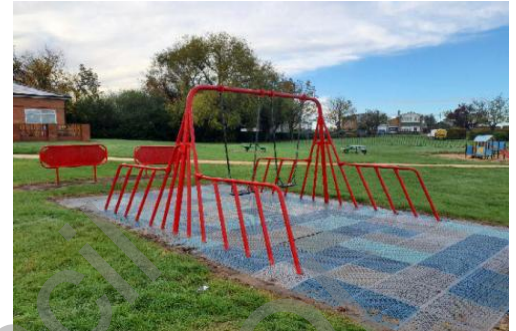
Item: 1 Bay 2 Seat (Flat)
Manufacturer: Wicksteed Playgrounds
Surface Type: Wet Pour
Item Quantity: 1
Equipment Compliance: No
Surface Area Compliance: Yes
Life Expectancy: 5 -10 Years
Total Findings: 4

There are gaps opening in between the tiles - Monitor for any further deterioration and repair as required

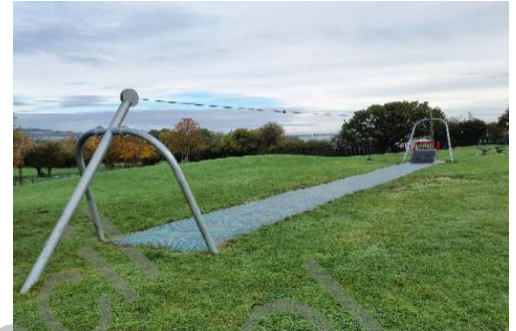
Item: Cable Runway
Manufacturer: Sutcliffe Play Limited
Surface Type: Matta
Item Quantity: 1
Equipment Compliance: Yes
Surface Area Compliance: Yes

We have completed a visual inspection of the suspension links, cable and fixing points from ground level, however it is not possible to fully inspect these areas without either hiring equipment to gain access or removing the cable and suspension and inspecting at ground level. We recommend that the main cable and fixing security is thoroughly inspected at least in accordance with the manufacturers recommendations to check for wear, damage, security or internal rusting; this will help to ensure the continued safe use of the equipment - Inspect in accordance with the manufacturers recommendations

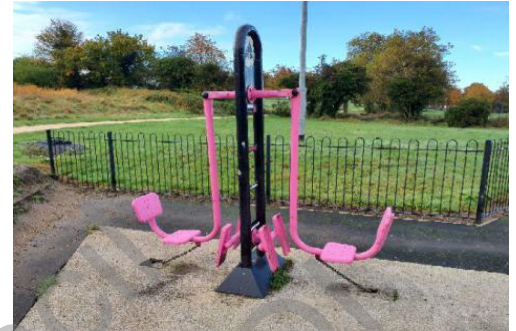
Item: Leg Press
Manufacturer: The Great Outdoor Gym Company
Surface Type: Wet Pour
Item Quantity: 1
Equipment Compliance: Yes
Surface Area Compliance: Yes
Life Expectancy: 3 - 5 Years
Total Findings: 6

The connecting lugs are showing signs of wear - Monitor for any further deterioration and repair as required

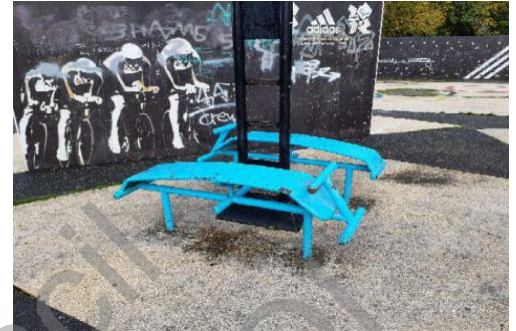
Item: Ab Station
Manufacturer: The Great Outdoor Gym Company
Surface Type: Wet Pour
Item Quantity: 1
Equipment Compliance: Yes
Surface Area Compliance: Yes
Life Expectancy: 5 -10 Years
Total Findings: 4

The paintwork on this item has been damaged or worn exposing the metal underneath which is rusting / corroding - Treat affected areas and repaint

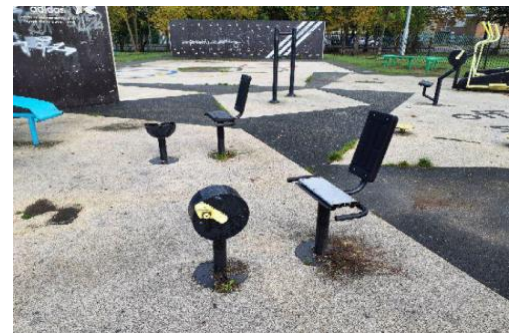
Item: Cycle
Manufacturer: The Great Outdoor Gym Company
Surface Type: Wet Pour
Item Quantity: 2
Equipment Compliance: Yes
Surface Area Compliance: Yes
Life Expectancy: 1 - 3 Years
Total Findings: 3

The mechanism has been removed from one item - Replace the missing components or remove the item completely

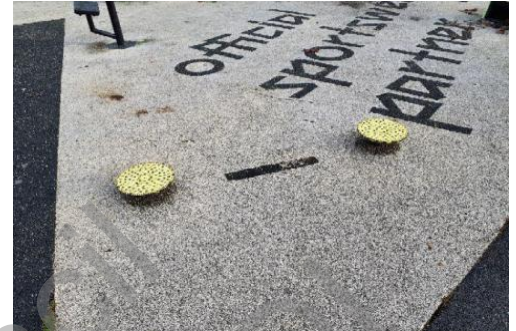
Item: Hip Twister
Manufacturer: The Great Outdoor Gym Company
Surface Type: Wet Pour
Item Quantity: 1
Equipment Compliance: No
Surface Area Compliance: Yes
Life Expectancy: <12 Months
Total Findings: 3

The rotating user station is not appropriately marked with a guideline of user direction and/or the original position as required by BS EN 16630 - Monitor - No remedial work recommended

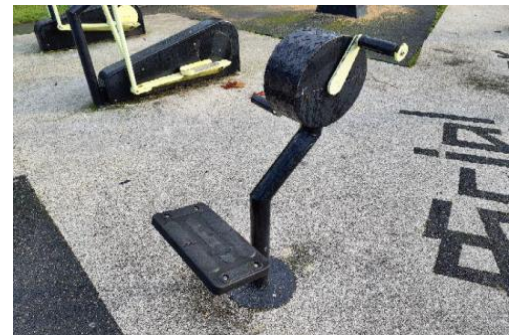
Item: Hand Bike
Manufacturer: The Great Outdoor Gym Company
Surface Type: Wet Pour
Item Quantity: 1
Equipment Compliance: Yes
Surface Area Compliance: Yes
Life Expectancy: 3 - 5 Years
Total Findings: 3

There is some evidence of fire damage to the item - Monitor for any further deterioration and repair as required

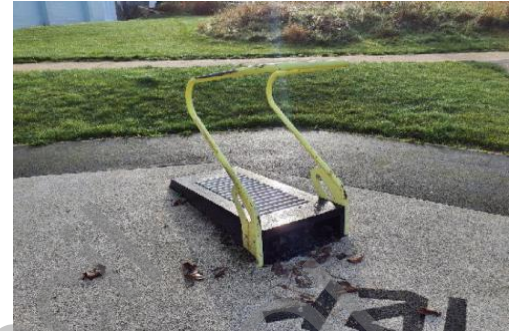
The paintwork on this item has been damaged or worn exposing the metal underneath which is rusting / corroding - Treat affected areas and repaint

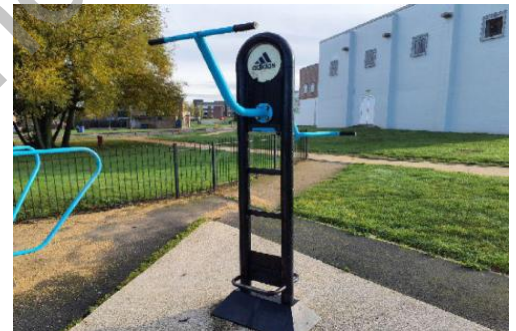
There is/are bolt cap covers missing or damaged on the item - Replace missing or damaged bolt cap covers

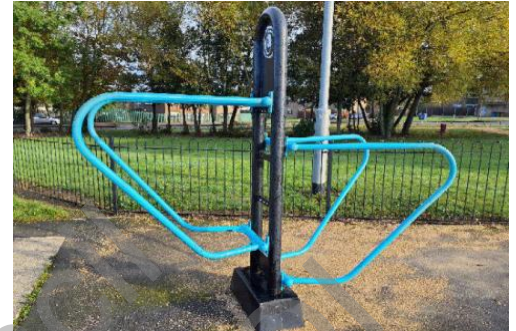
Item: Dip Station
Manufacturer: The Great Outdoor Gym Company
Surface Type: Wet Pour
Item Quantity: 1
Equipment Compliance: Yes
Surface Area Compliance: Yes
Life Expectancy: 5 -10 Years
Total Findings: 1

The paintwork on this item has been damaged or worn exposing the metal underneath which is rusting / corroding - Treat affected areas and repaint

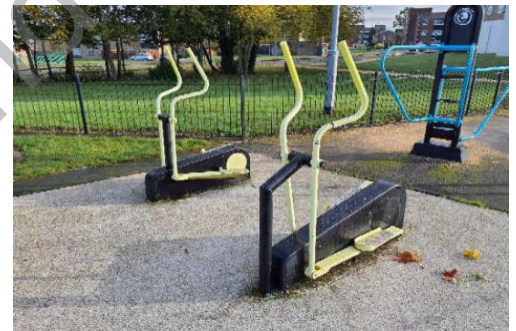
Item: Cross Trainer
Manufacturer: The Great Outdoor Gym Company
Surface Type: Wet Pour
Item Quantity: 2
Equipment Compliance: Yes
Surface Area Compliance: Yes
Life Expectancy: 3 - 5 Years
Total Findings: 2

The bushes are worn or missing - Replace worn or missing bushes

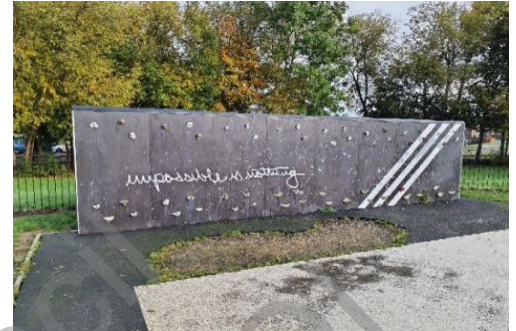
Item: Traverse Wall
Manufacturer: Park Leisure Ltd
Surface Type: Wet Pour
Item Quantity: 1
Equipment Compliance: Yes
Surface Area Compliance: Yes
Life Expectancy: 5 -10 Years
Total Findings: 3

There is some damage to the item - Monitor for any further deterioration and repair as required

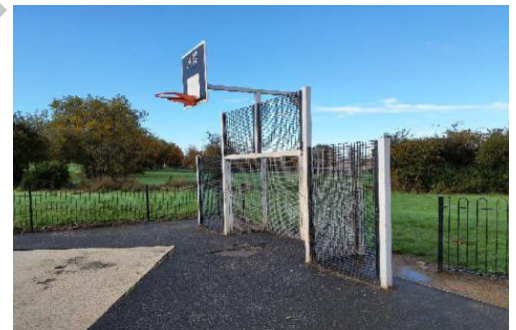
Item: Goalmouth and Basketball Post
Manufacturer: Park Leisure Ltd
Surface Type: Wet Pour
Item Quantity: 1
Equipment Compliance: No
Surface Area Compliance: N/A
Life Expectancy: 5 -10 Years
Total Findings: 2

A clearly visible facility sign should be provided in a prominent position with the wording as detailed BS EN 15312- the equipment is not intended for children less than 3 years old- the warning - Do not climb on the framework or nets- the warning - Do not hang on the ring (if provided)- the warning - Do not wear rings or other jewellery- name and telephone number of the administrator- number to call in case of accident - Provide signage to BS EN 15312

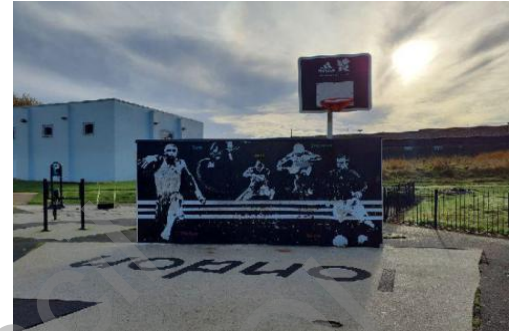
Item: Kickabout Wall
Manufacturer: Park Leisure Ltd
Surface Type: Wet Pour
Item Quantity: 1
Equipment Compliance: Yes
Surface Area Compliance: Yes
Life Expectancy: 5 -10 Years
Total Findings: 4

A clearly visible facility sign should be provided in a prominent position with the wording as detailed BS EN 15312- the equipment is not intended for children less than 3 years old- the warning - Do not climb on the framework or nets- the warning - Do not hang on the ring (if provided)- the warning - Do not wear rings or other jewellery- name and telephone number of the administrator- number to call in case of accident - Provide signage to BS EN 15312

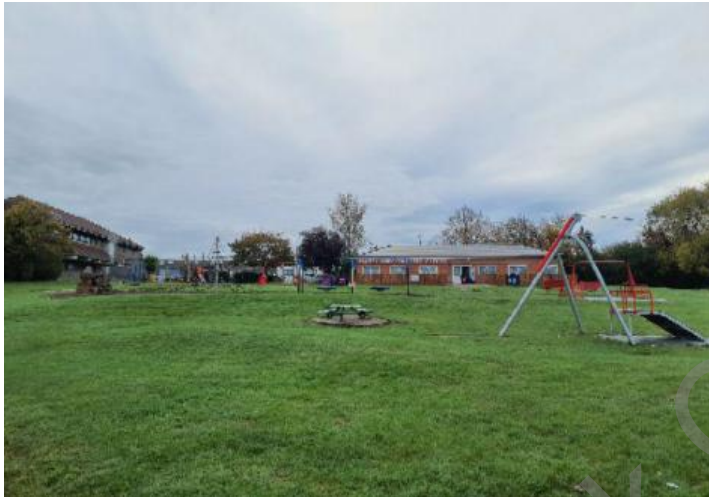
Item: Ancillary Items - Site General
Manufacturer: Owner/Operator

Finding: There are trip hazards at the edges of the surface

Action: Reinstate surrounding surface levels to remove the trip points

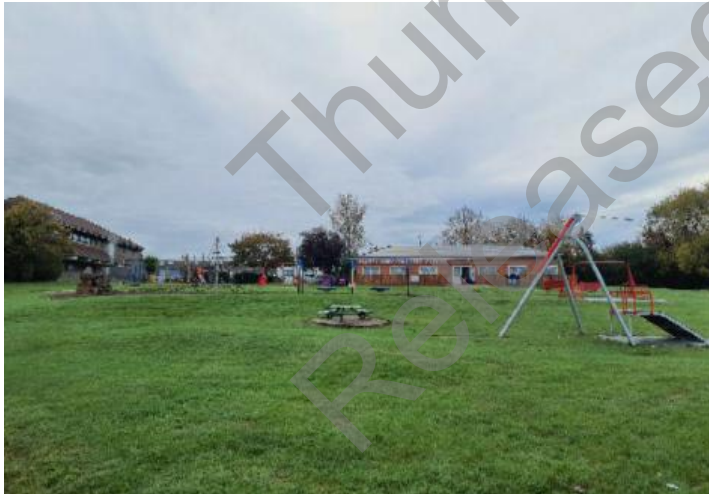
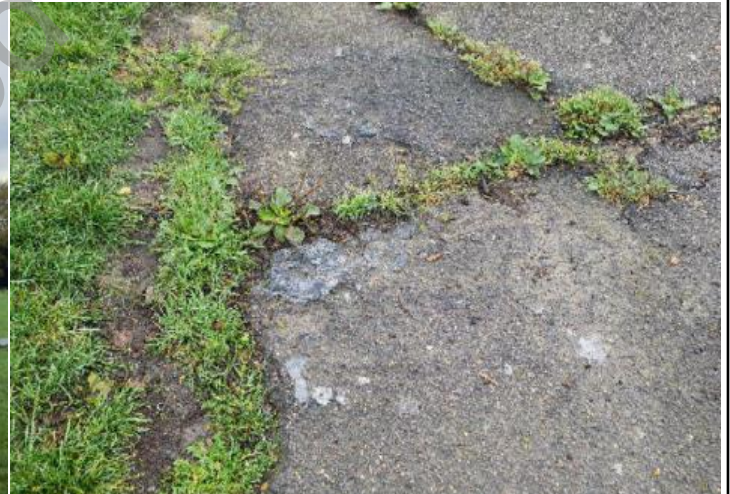
Item: Ancillary Items - Site General
Manufacturer: Owner/Operator

Risk Level: L - Low Risk
Surface: N/A

Finding: There is some evidence of fire damage to the surfacing

Action: Monitor for any further deterioration and repair as required

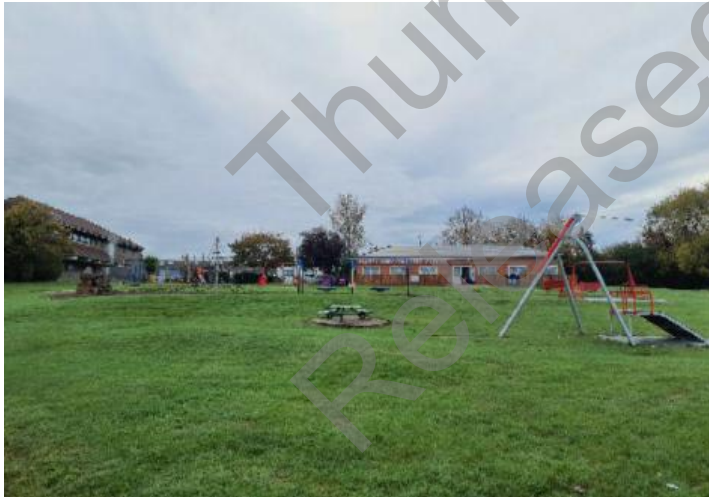
Item: Ancillary Items - Site General
Manufacturer: Owner/Operator

Risk Level: L - Low Risk
Surface: N/A

Finding: There are redundant bases in the area due to the removal of equipment and there are foundations that are exposed causing trips

Action: Consider removing bases and reinstating the surface to cover the exposed foundations

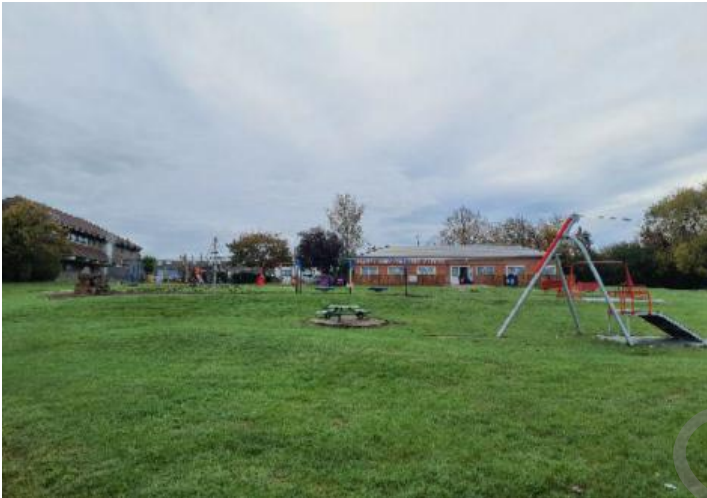
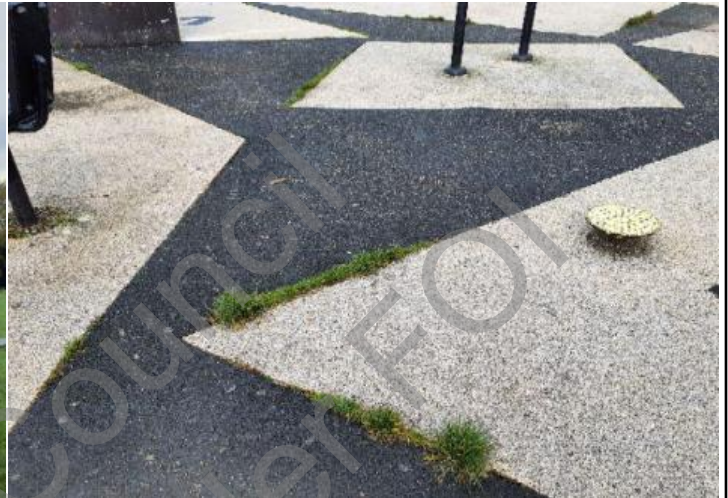
Item: Ancillary Items - Site General
Manufacturer: Owner/Operator

Risk Level: L - Low Risk
Surface: N/A

Finding: There is weed / vegetation growth on, between, or around the edges of the surfacing **Action:** Remove weed / vegetation growth

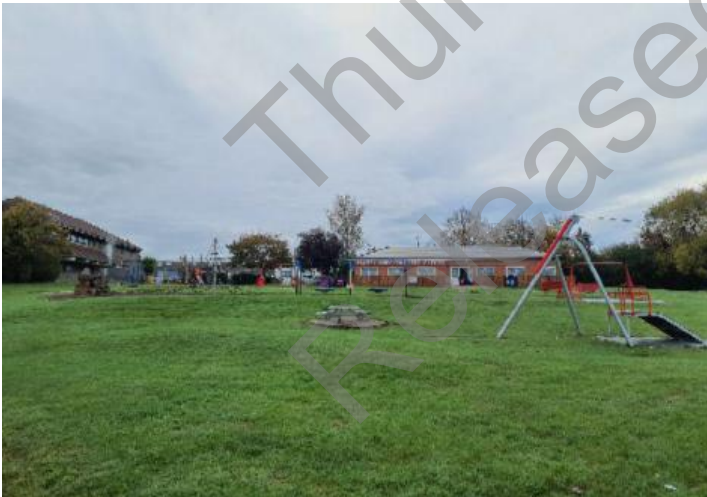
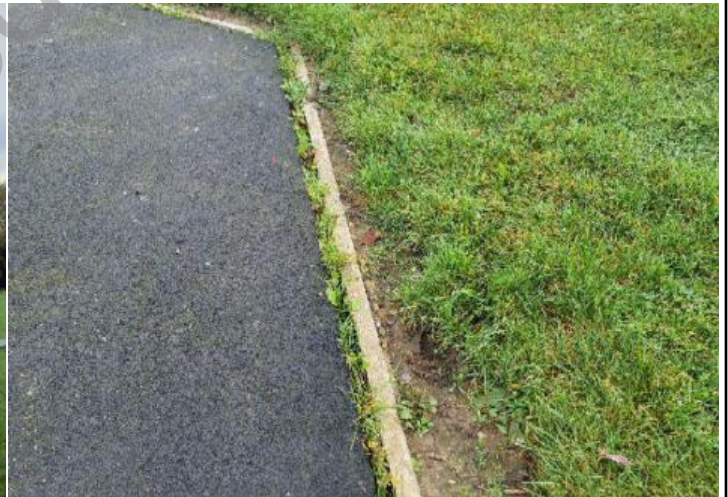
Item: Ancillary Items - Site General
Manufacturer: Owner/Operator

Risk Level: L - Low Risk
Surface: N/A

Finding: There are significant gaps (over 30mm) between the surface and the edging or between the joints in the surface; these are large enough for a small foot to enter **Action:** Repair surfacing

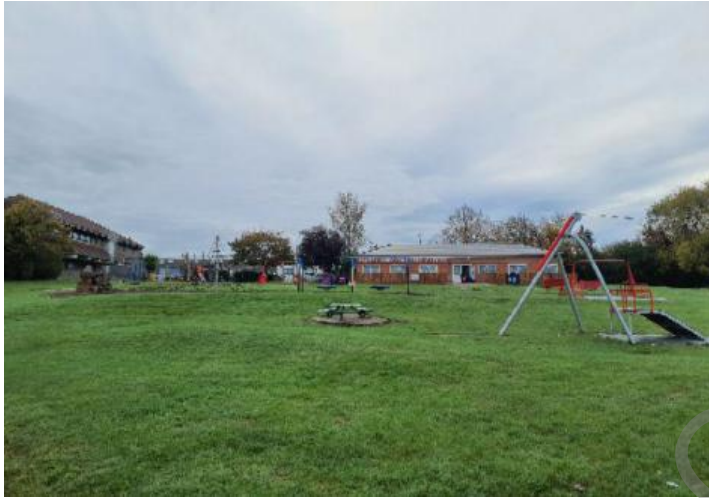
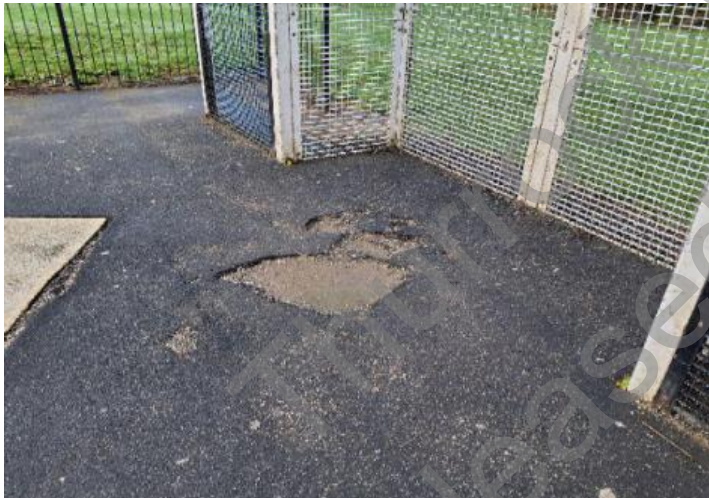
Item: Ancillary Items - Site General
Manufacturer: Owner/Operator

Risk Level: M - Moderate Risk
Surface: N/A

Finding: There is moderate damage to the surface

Action: Repair the damaged areas of surfacing

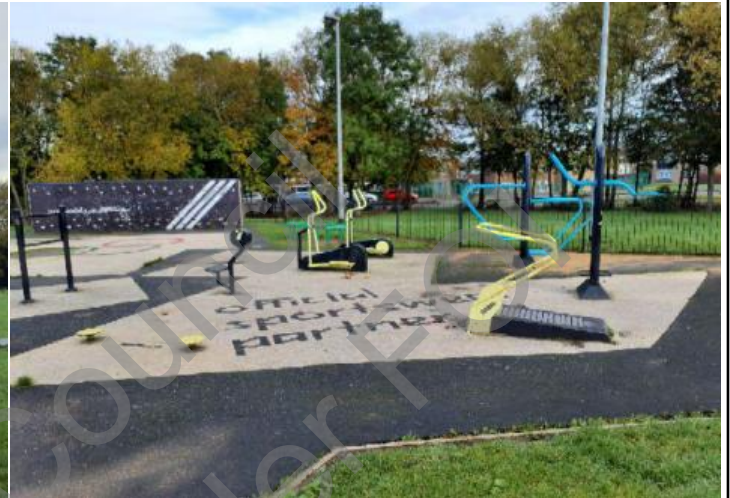
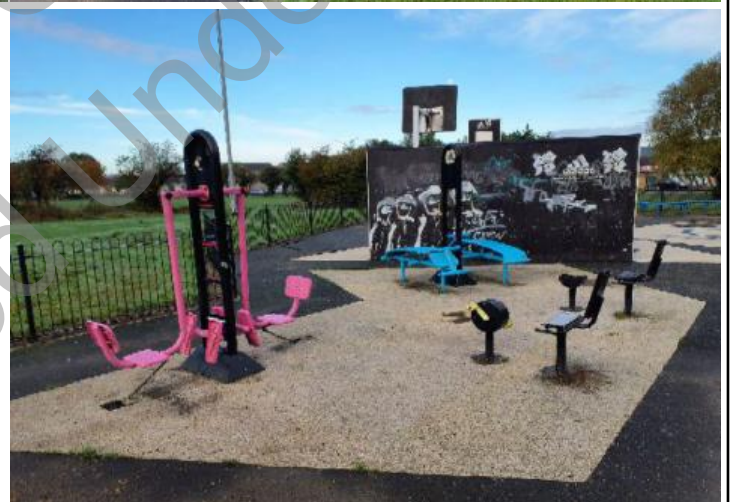
Item: Ancillary Items - Site General
Manufacturer: Owner/Operator

Risk Level: V - Very Low Risk
Surface: N/A

Finding: There is no instruction label provided; an instruction label should be provided with each item of equipment in accordance with the requirements of BS EN 16630

Action: Provide appropriate instruction label/s

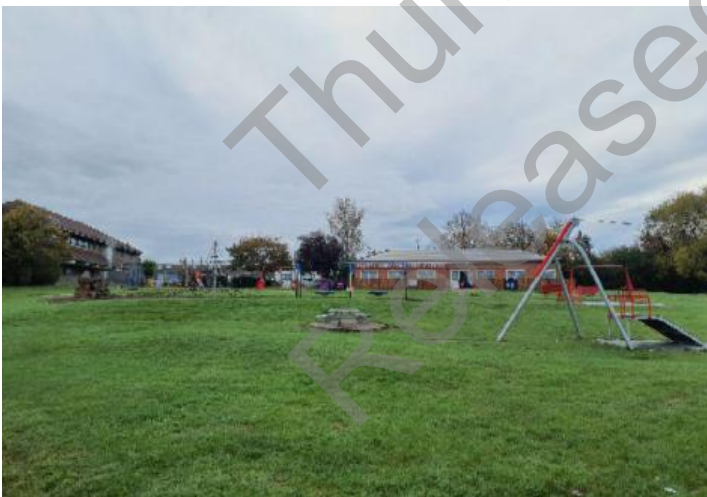
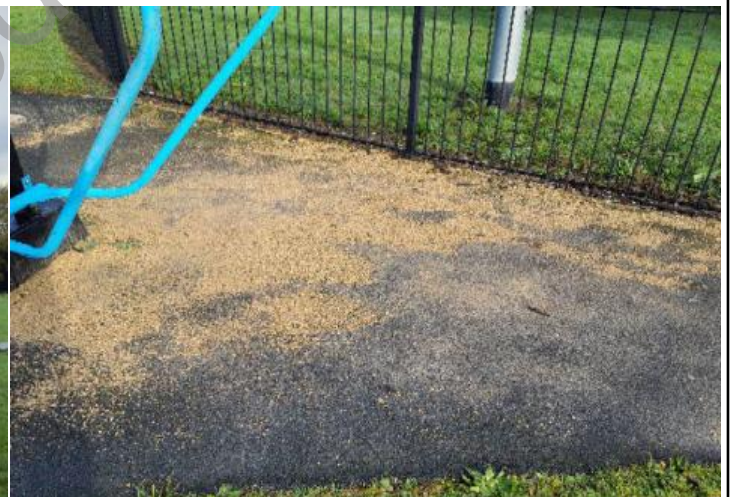
Item: Ancillary Items - Site General
Manufacturer: Owner/Operator

Risk Level: L - Low Risk
Surface: N/A

Finding: There is a large amount of gravel on the surface
Action: Remove from area

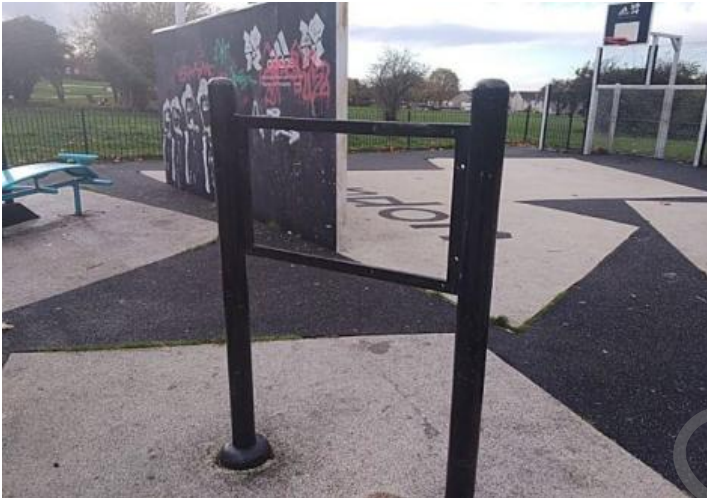
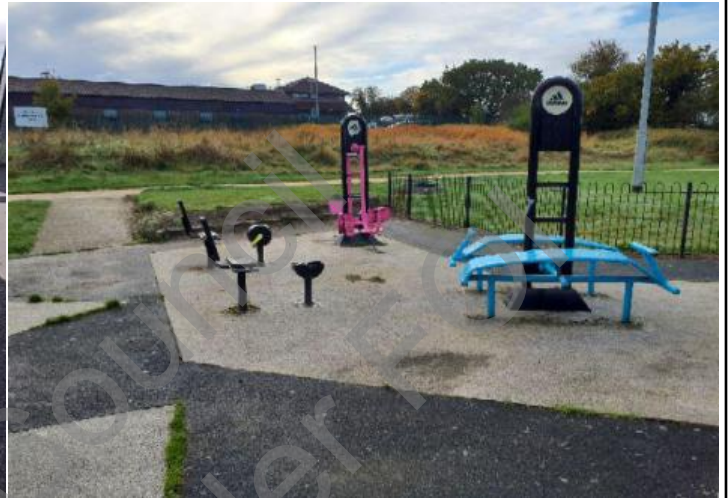
Item: Ancillary Items - Sign
Manufacturer: Owner/Operator

Risk Level: V - Very Low Risk
Surface: N/A

Finding: Signage should be provided for the outdoor fitness equipment in accordance with the requirements of BS EN 16630, key requirements of the sign include, but are not limited to, intended users, medical safety and emergency contact details

Action: Provide appropriate signage

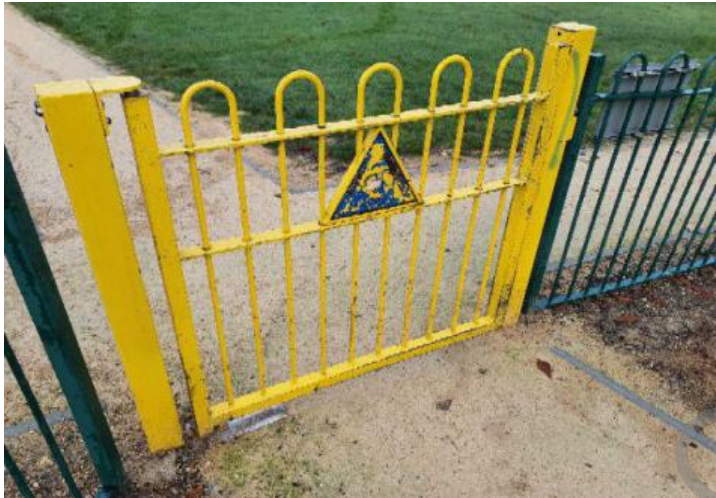
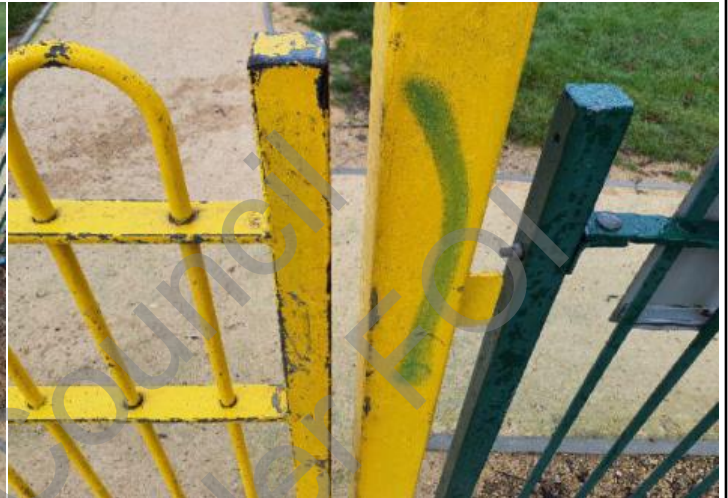
Item: Gates - Gate - Self Closing
Manufacturer: Not Identified

Risk Level: L - Low Risk
Surface: Grass

Finding: No slamming plate has been fitted to the gates and the gate leaves pass the slamming posts
Action: Provide slamming plates

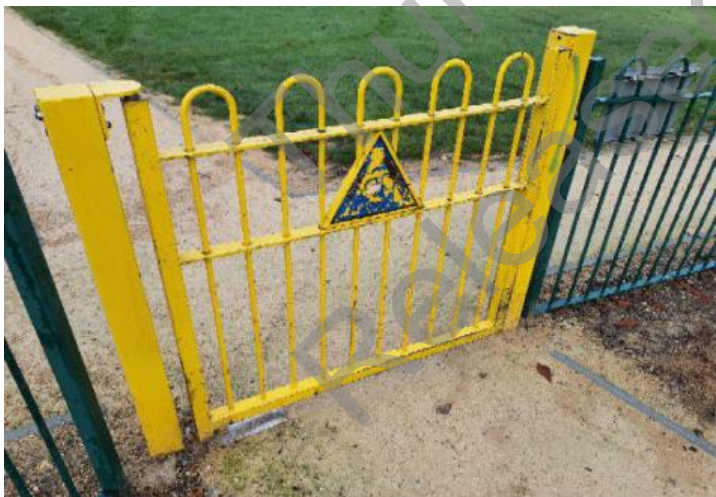
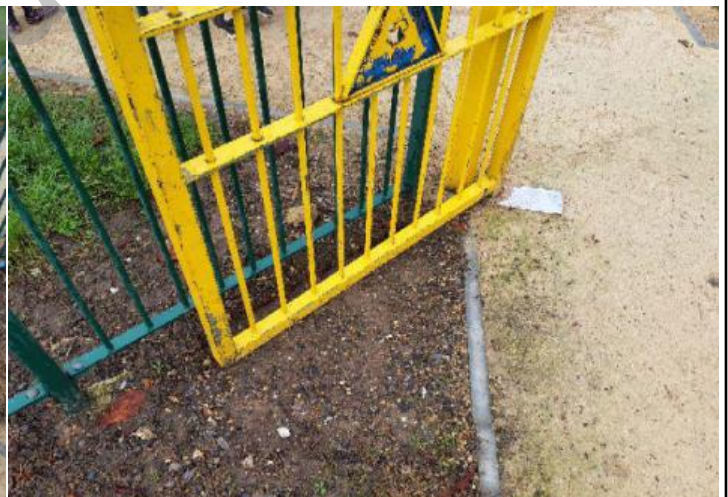
Item: Gates - Gate - Self Closing
Manufacturer: Not Identified

Risk Level: V - Very Low Risk
Surface: Grass

Finding: The gate is snagging on the surrounding surface preventing it from closing correctly
Action: Carry out remedial works to ensure the gate closes correctly

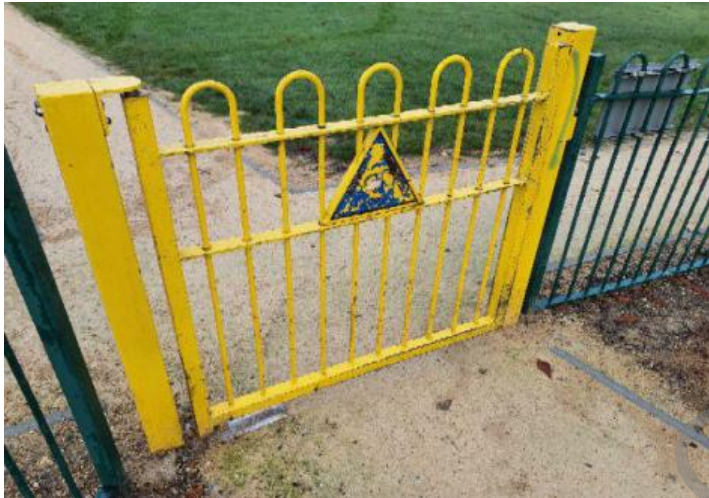
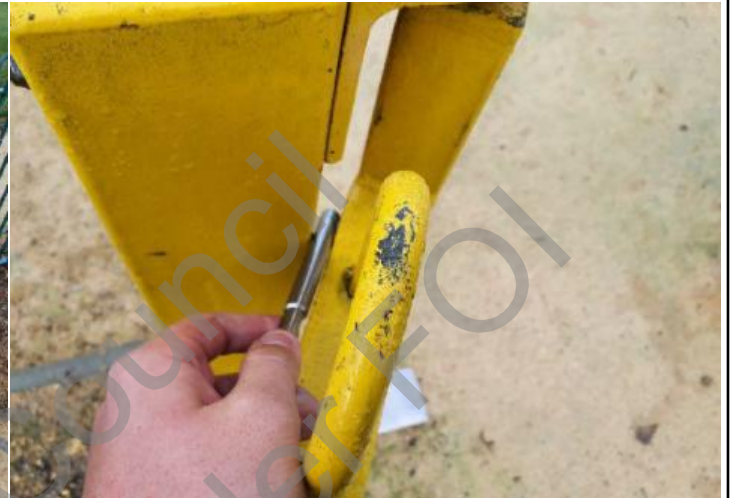
Item: Gates - Gate - Self Closing
Manufacturer: Not Identified

Risk Level: L - Low Risk
Surface: Grass

Finding: There are openings that are less than 12mm that could trap or crush fingers

Action: Provide a 12mm gap throughout full range of motion at both sides of gate

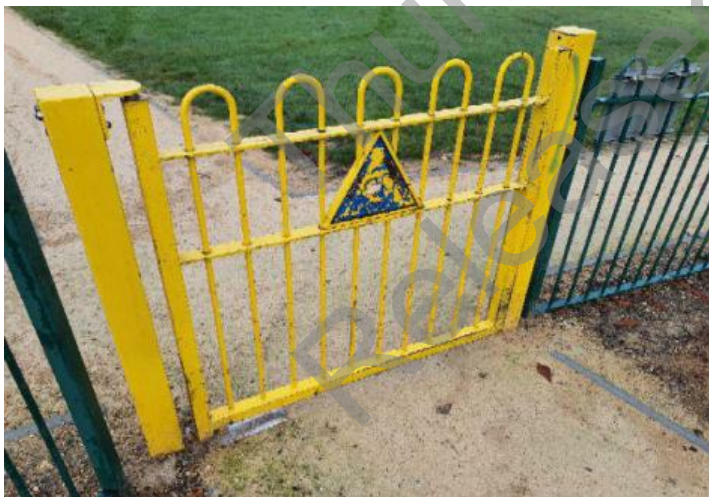
Item: Gates - Gate - Self Closing
Manufacturer: Not Identified

Risk Level: L - Low Risk
Surface: Grass

Finding: The surface has eroded in some areas and may be slippery in wet conditions

Action: Reinstate the surface

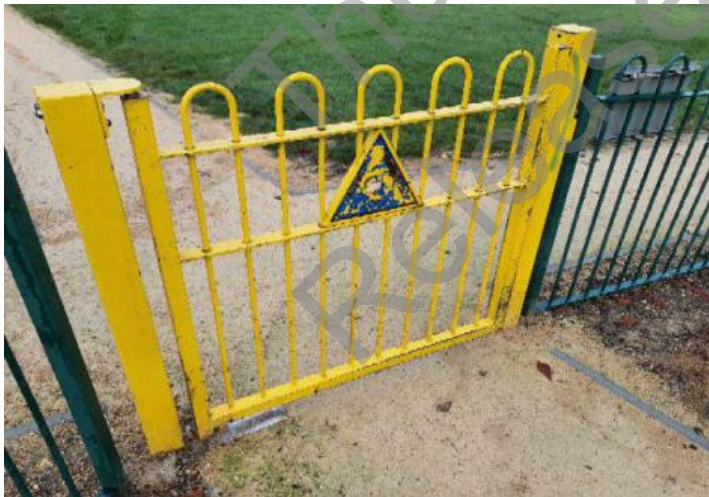
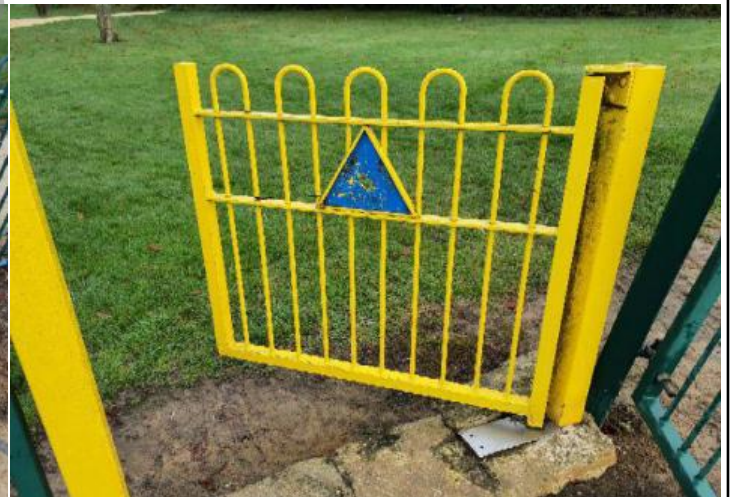
Item: Gates - Gate - Self Closing
Manufacturer: Not Identified

Risk Level: V - Very Low Risk
Surface: Grass

Finding: The gate is not operating correctly

Action: Take effective action to ensure the gate closes between 4 and 8 seconds

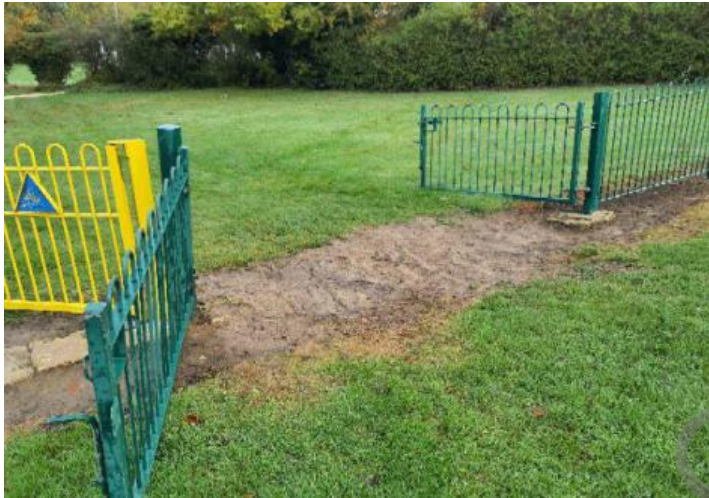
Item: Gates - Gate - Maintenance
Manufacturer: Not Identified

Risk Level: L - Low Risk
Surface: Grass

Finding: The surface has eroded and the foundations are exposed

Action: Reinstate surrounding surfaces to cover the foundations

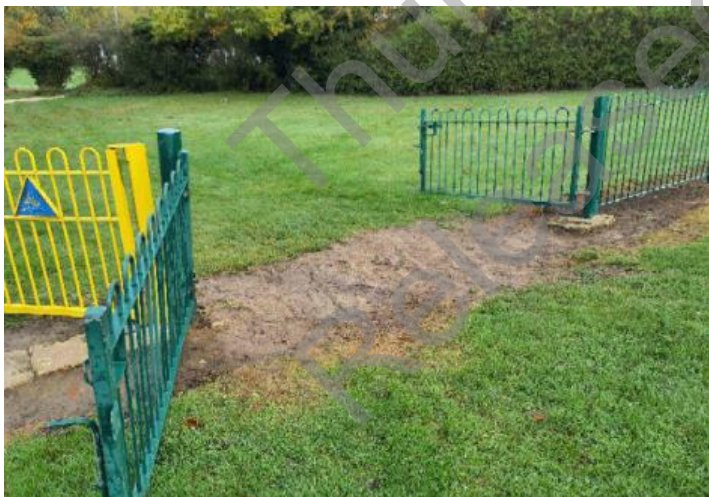
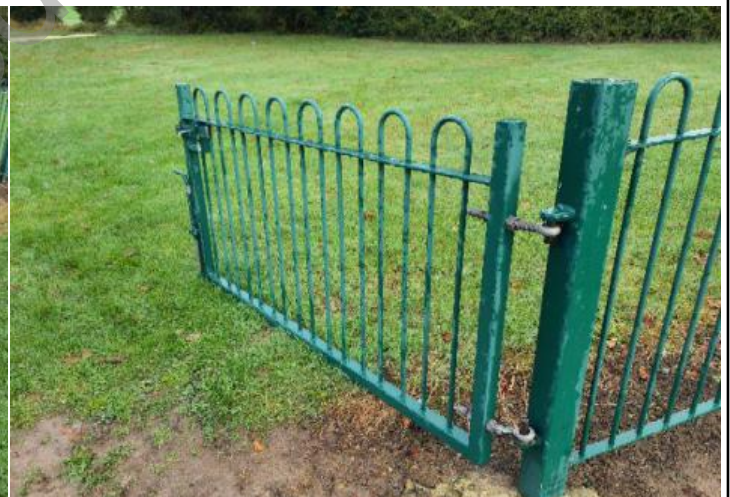
Item: Gates - Gate - Maintenance
Manufacturer: Not Identified

Risk Level: L - Low Risk
Surface: Grass

Finding: There is no padlock on the maintenance gate

Action: Provide a padlock to secure the gate

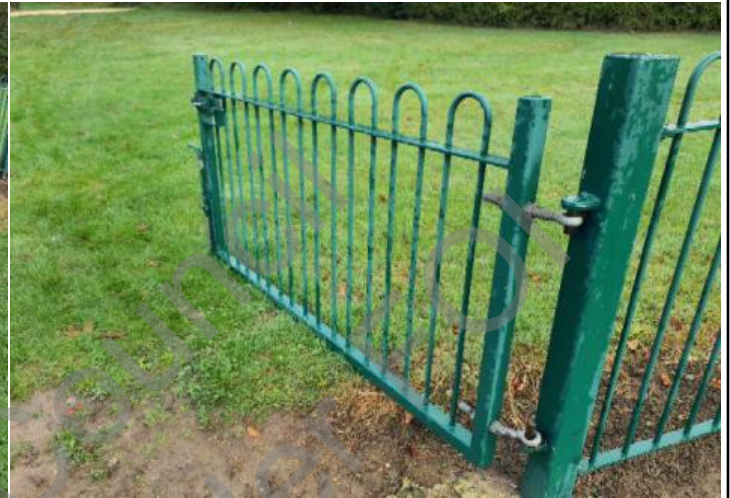
Item: Gates - Gate - Maintenance
Manufacturer: Not Identified

Risk Level: L - Low Risk
Surface: Grass

Finding: The gate has no drop bolt sleeves and/or drop bolts fitted

Action: Provide drop bolt sleeves and/or drop bolts

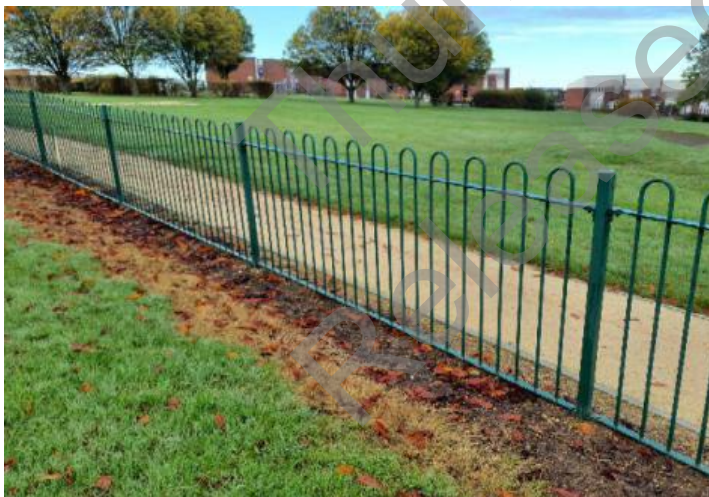
Item: Fences - Fence - Bow Top
Manufacturer: Not Identified

Risk Level: L - Low Risk
Surface: Grass

Finding: There is some damage to the fence sections

Action: Monitor for any further deterioration and repair as required

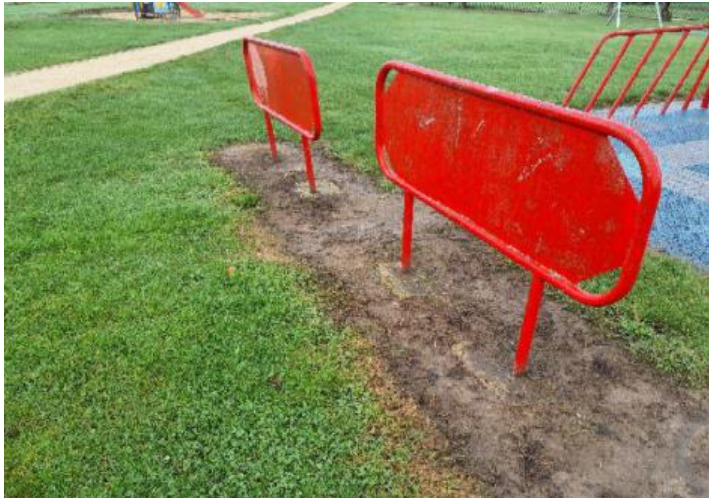
Item: Swings - Swing Barrier
Manufacturer: Not Identified

Risk Level: L - Low Risk
Surface: Grass

Finding: The surface has eroded and the foundations are exposed

Action: Reinststate surrounding surfaces to cover the foundations
