Annual Inspection

Thurrock Council

Corringham Town Park

Springhouse Road, Corringham, Essex, SS17 7NB

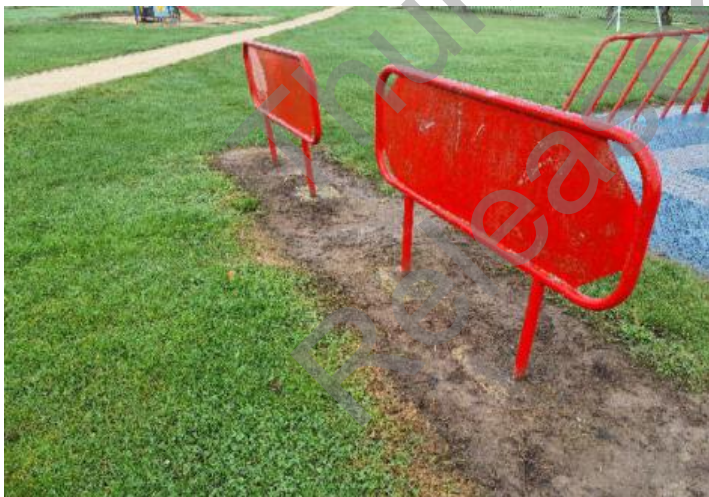
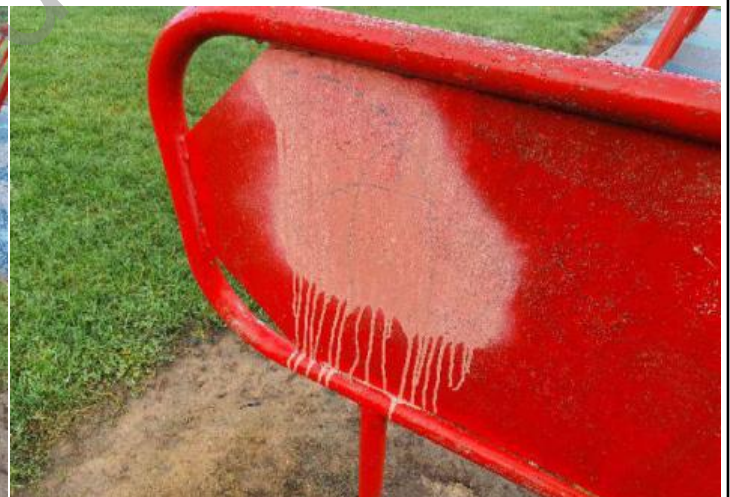
Item: Swings - Swing Barrier
Manufacturer: Not Identified

Risk Level: N - Risk Assessment not Undertaken
Surface: Grass

Finding: There is offensive graffiti present

Action: Remove as soon as practicable

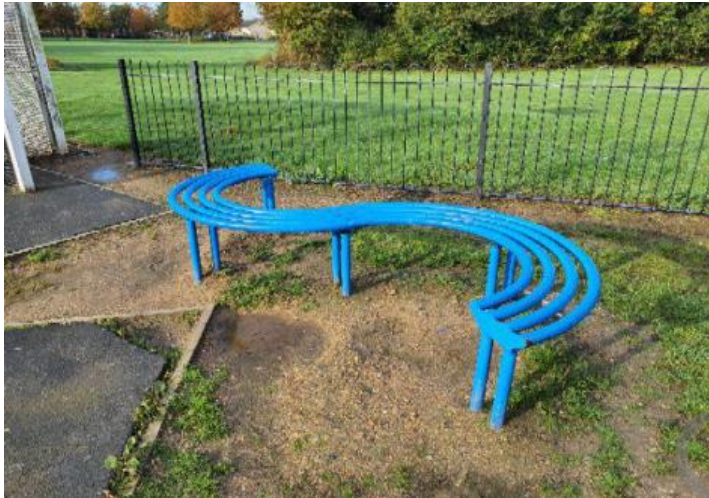
Item: Ancillary Items - Bench
Manufacturer: Not Identified

Risk Level: L - Low Risk
Surface: Grass

Finding: The surface has eroded in some areas and may be slippery in wet conditions
Action: Reinstate the surface

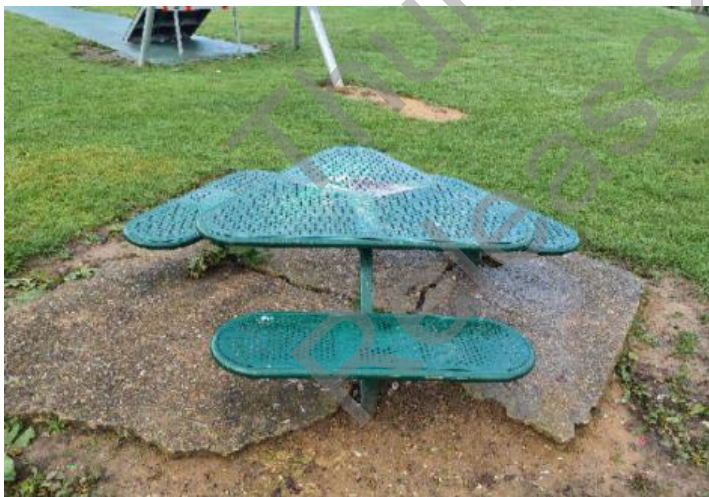
Item: Ancillary Items - Picnic Table
Manufacturer: Not Identified

Risk Level: L - Low Risk
Surface: Concrete

Finding: The surfacing is severely damaged
Action: Repair damaged areas of surfacing

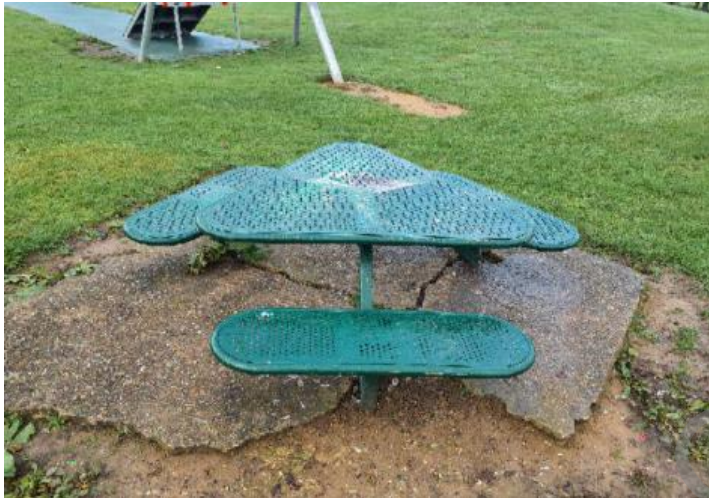
Item: Ancillary Items - Picnic Table
Manufacturer: Not Identified

Risk Level: L - Low Risk
Surface: Concrete

Finding: There are trip hazards at the edges of the surface

Action: Reinstate surrounding surface levels to remove the trip points

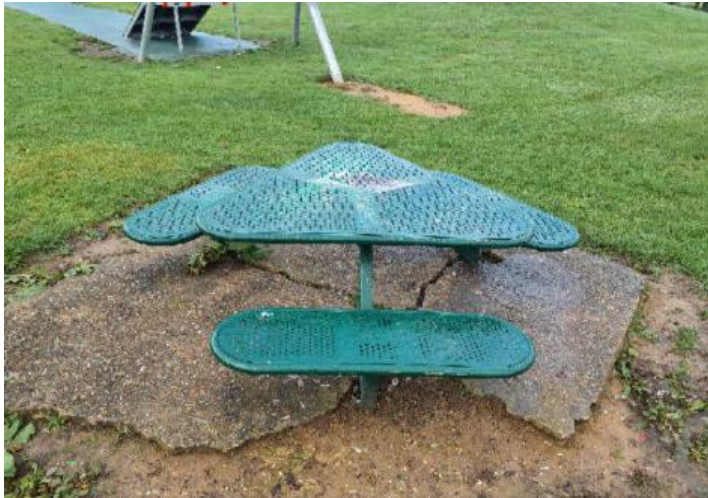
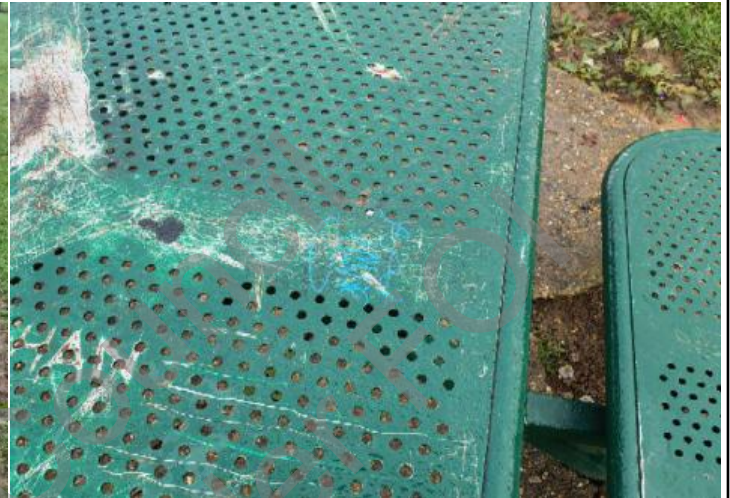
Item: Ancillary Items - Picnic Table
Manufacturer: Not Identified

Finding: There is some graffiti present

Action: Remove the graffiti

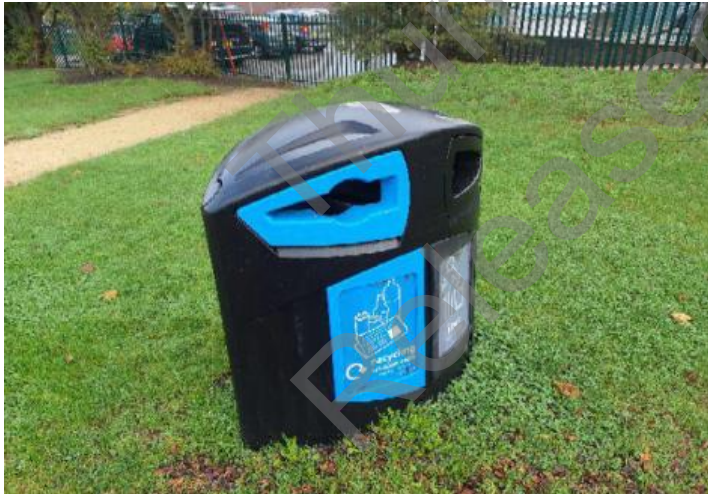
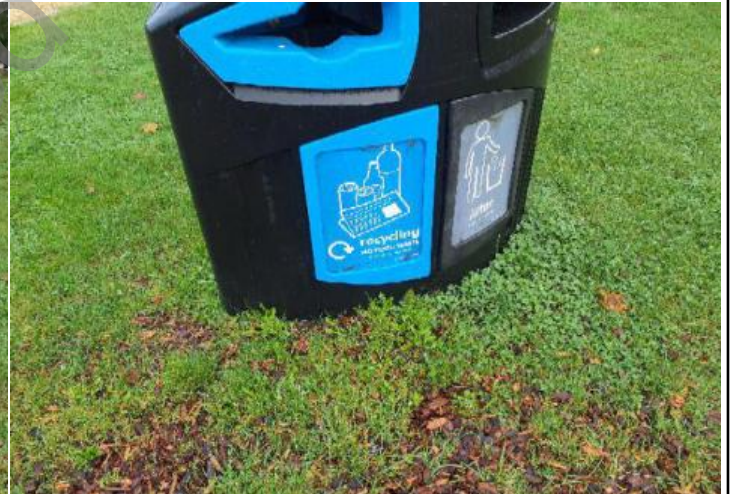
Item: Ancillary Items - Litter Bin
Manufacturer: Not Identified

Finding: The bin is not securely fixed to the surface and there is some possibility of the item tipping or rolling over

Action: Secure the bin to the ground

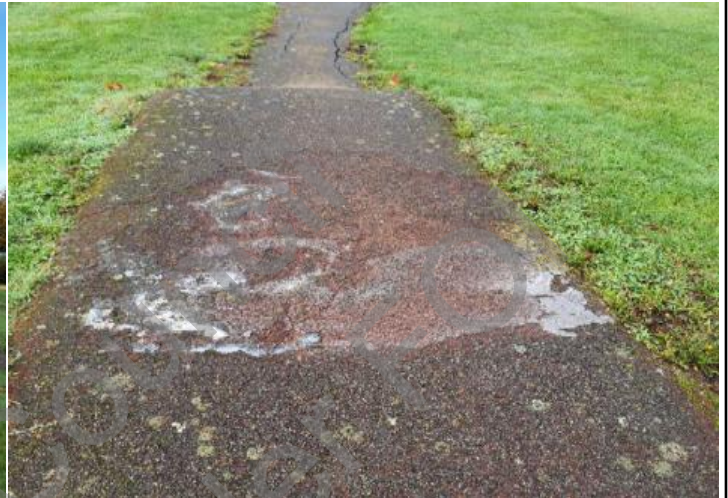
Finding: There is some evidence of fire damage to the surfacing

Action: Monitor for any further deterioration and repair as required

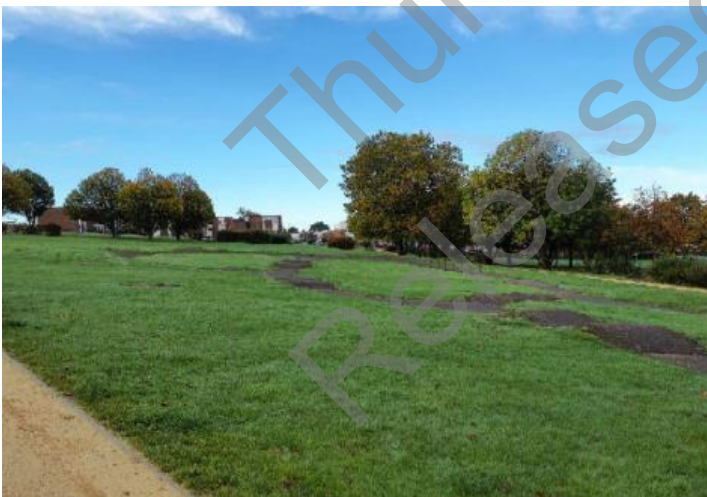
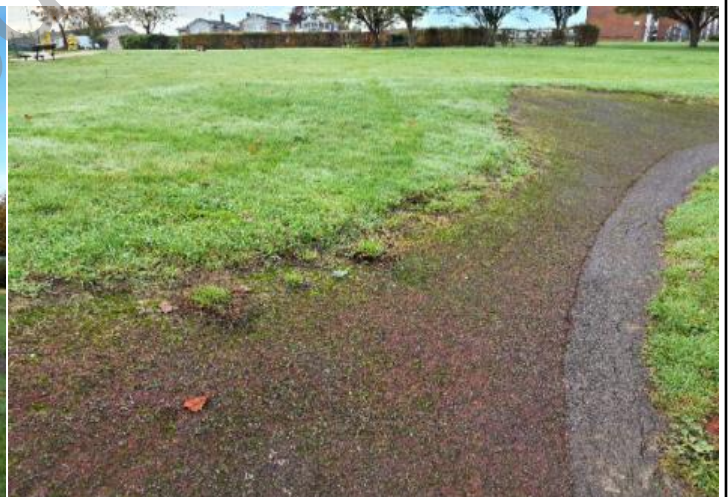
Finding: There is algae, silt or moss growth on the surface resulting in slippery conditions

Action: Clean and treat appropriately

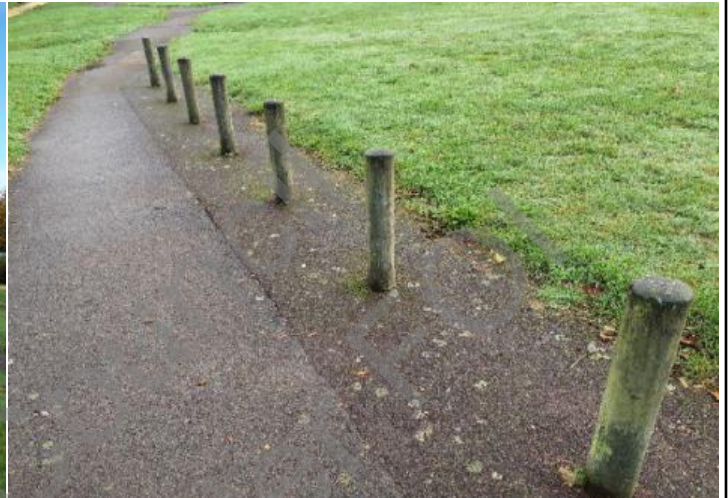
Finding: There is some evidence of rot in the timber

Action: Monitor for any further deterioration and replace as required

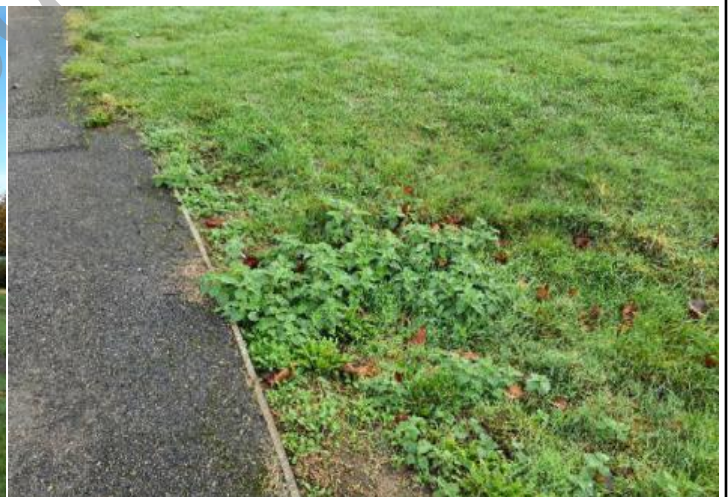
Finding: There is nettle growth in the area

Action: Remove and maintain

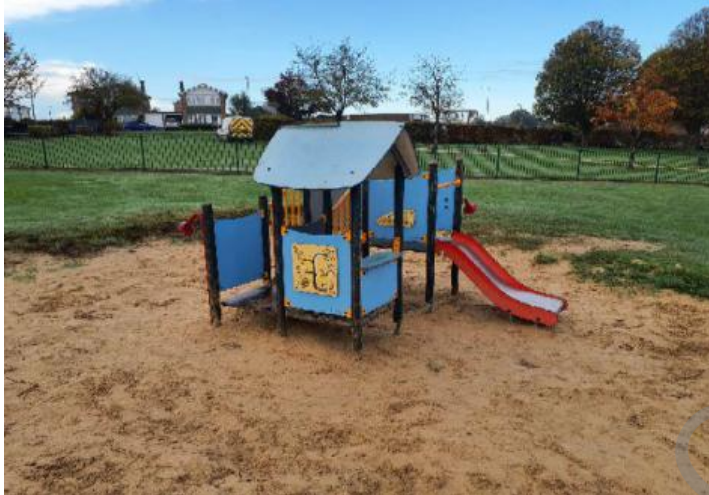
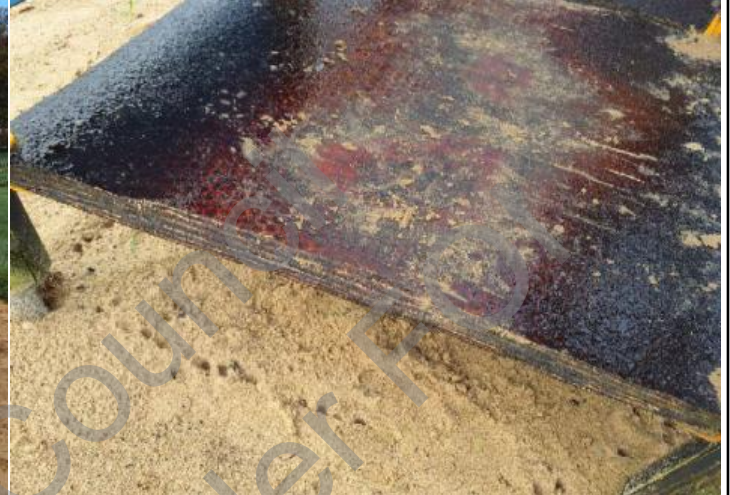
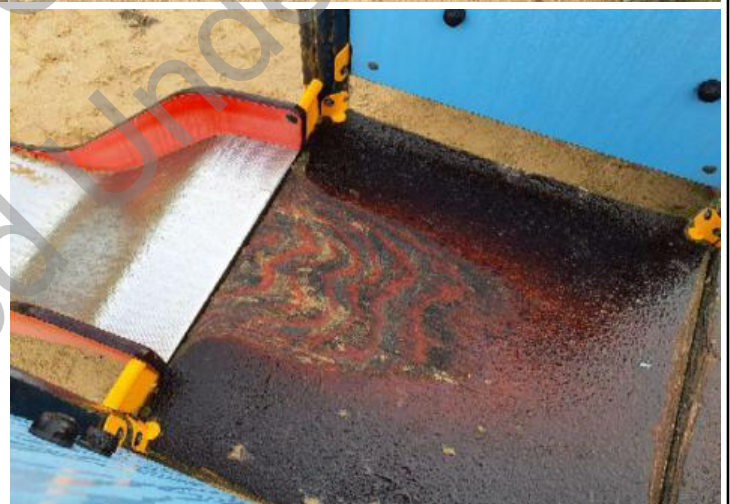
Finding: Parts of the timber are rough or splintered

Action: Remove all rough or sharp edges

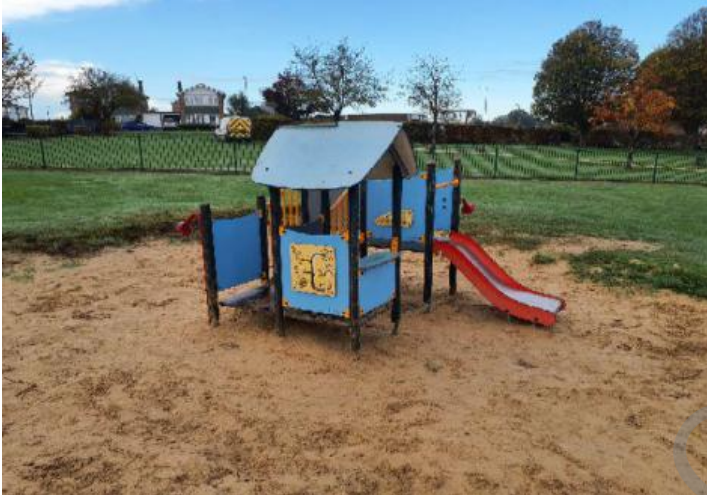
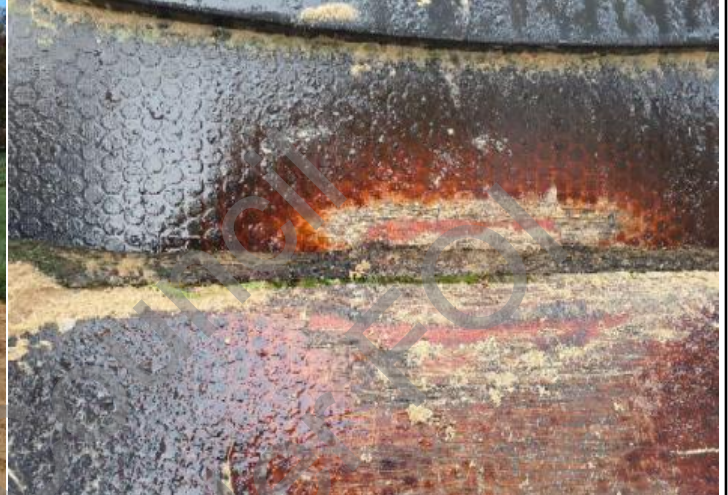
Finding: There is some evidence of rot in the timber

Action: Monitor for any further deterioration and replace as required

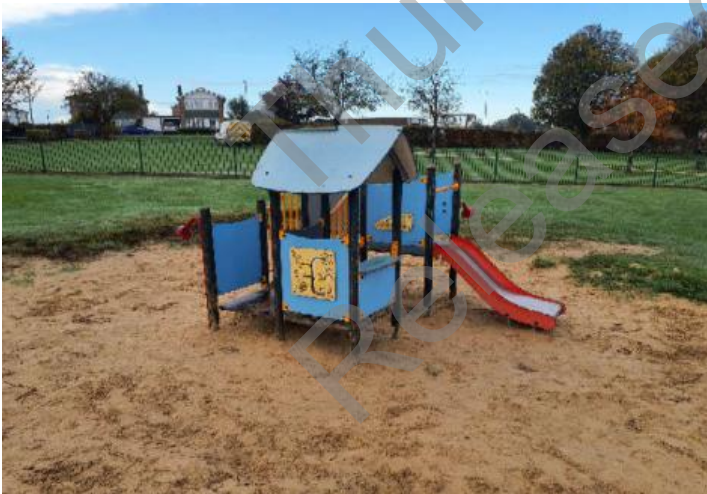
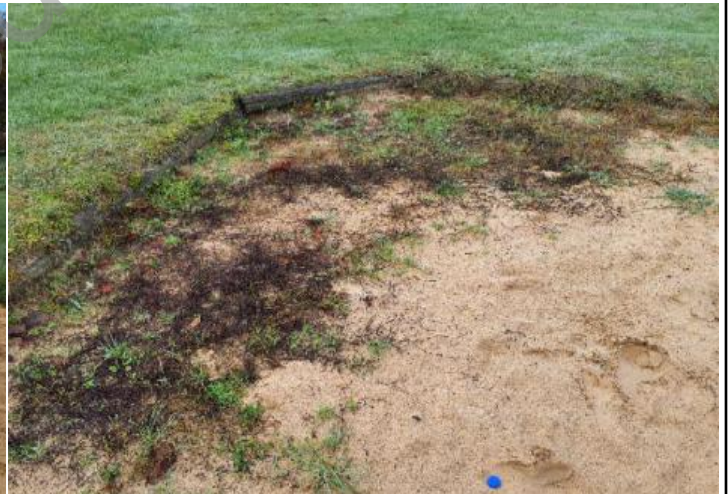
Finding: There is weed / vegetation growth on, between, or around the edges of the surfacing

Action: Remove weed / vegetation growth

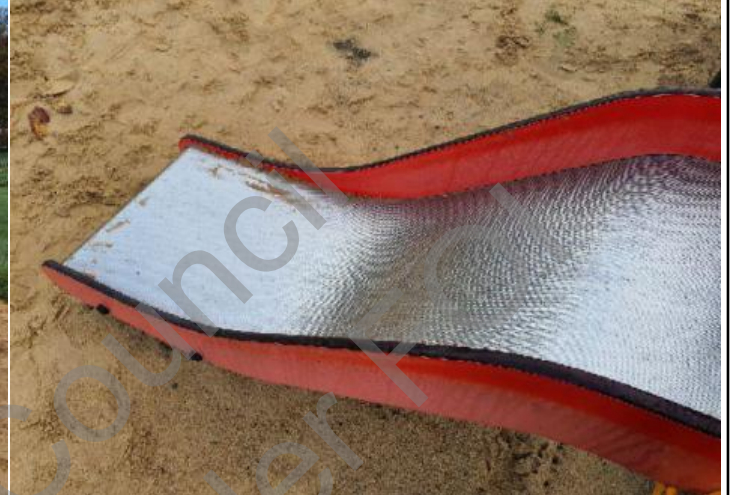
Finding: There are a number of dents in the slide surface

Action: Monitor for any further deterioration and repair as required

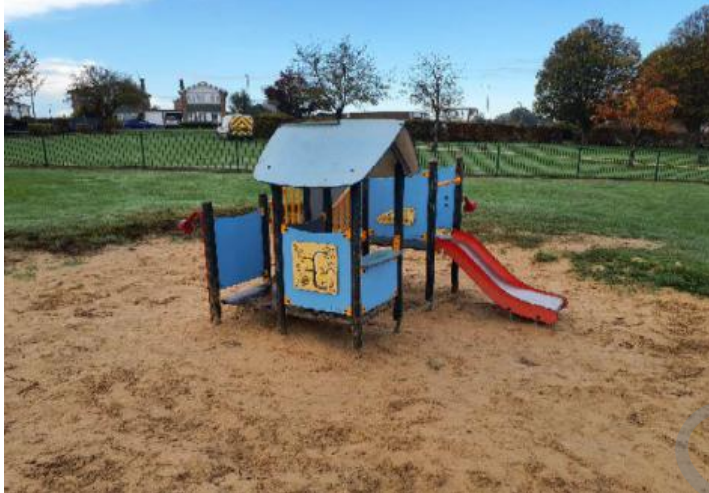
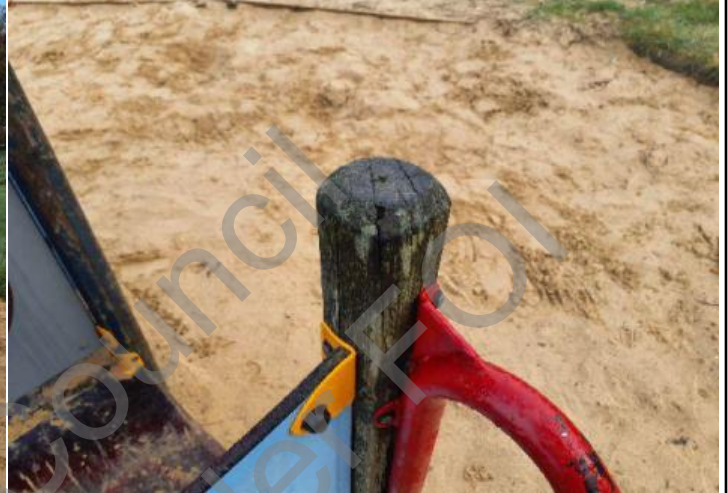
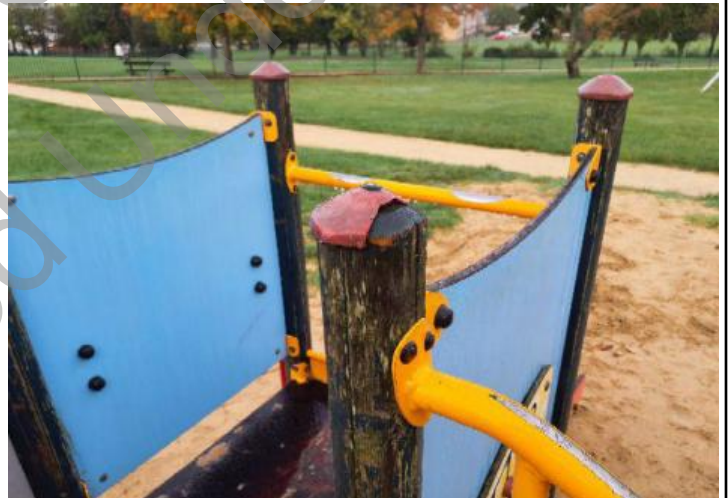
Finding: There are post / end caps missing or damage on the item

Action: Replace missing/damaged post caps

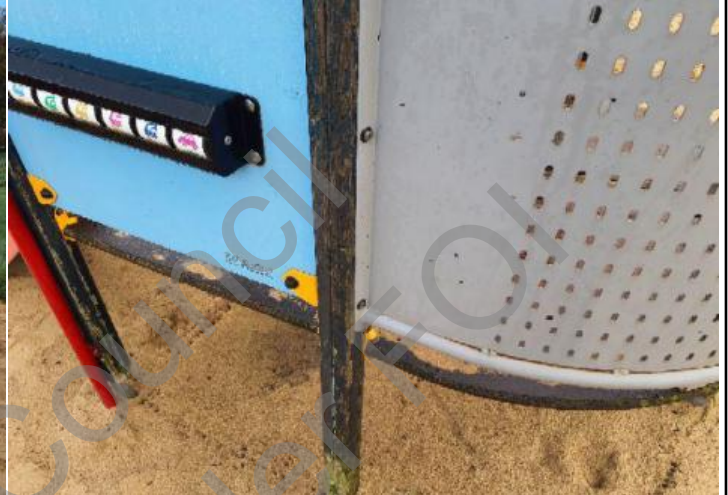
Finding: The timber stain is in poor condition

Action: Prepare all affected parts and re-stain with an appropriate preservative

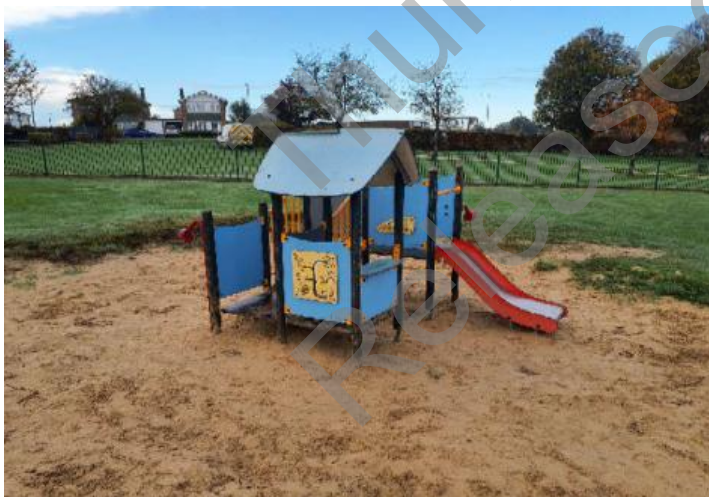
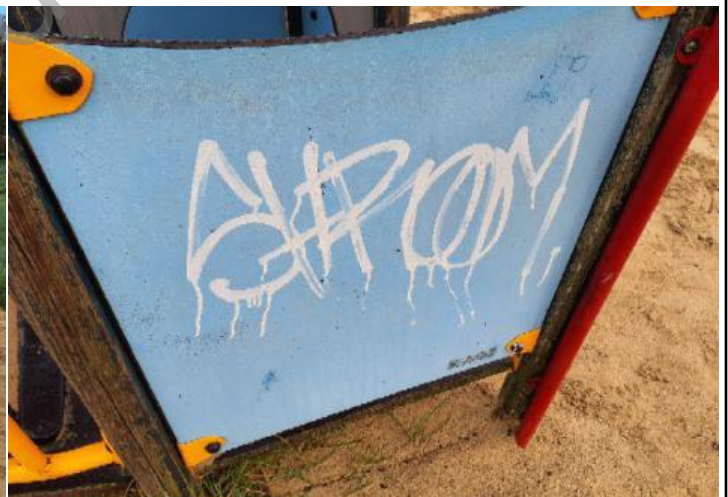
Finding: There is some graffiti present

Action: Remove the graffiti

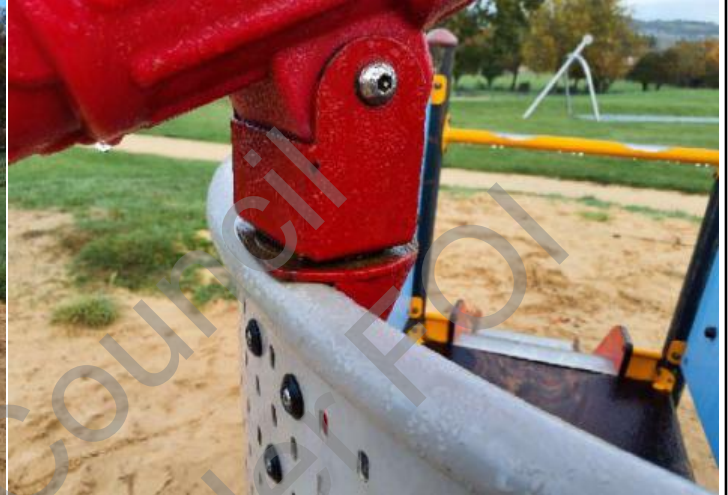
Finding: The paintwork on this item has been damaged or worn exposing the metal underneath which is rusting / corroding

Action: Treat affected areas and repaint

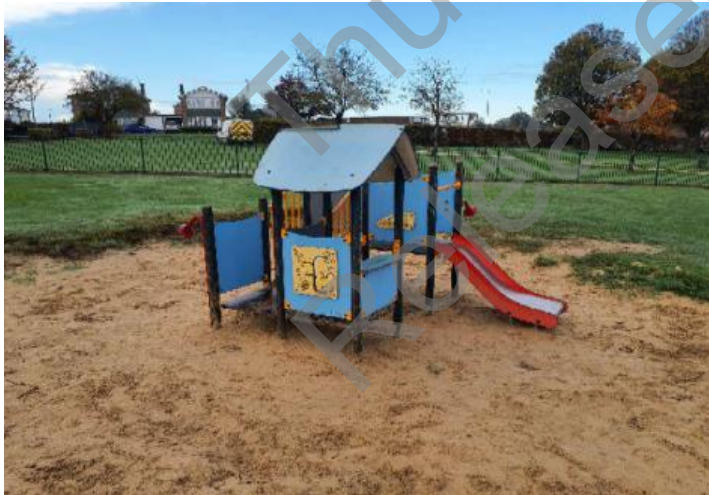
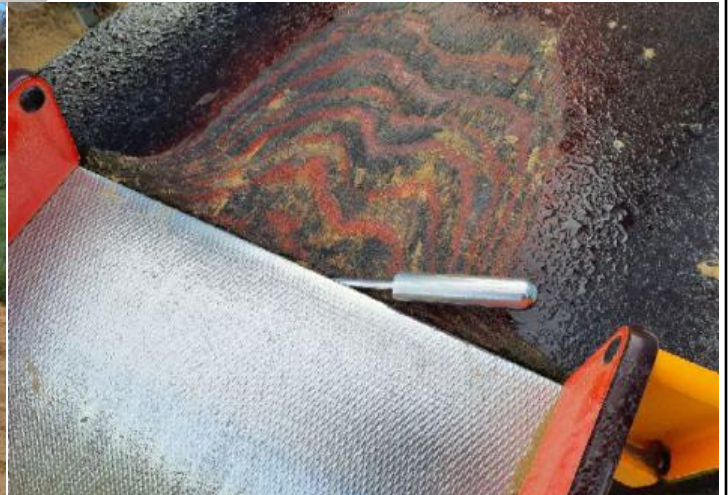
Finding: There is/are finger entrapment/s in the slide starting section and the item fails to meet the requirements of BS EN 1176 Part 1 4.2.7.6 Entrapment of fingers

Action: Remove entrapment

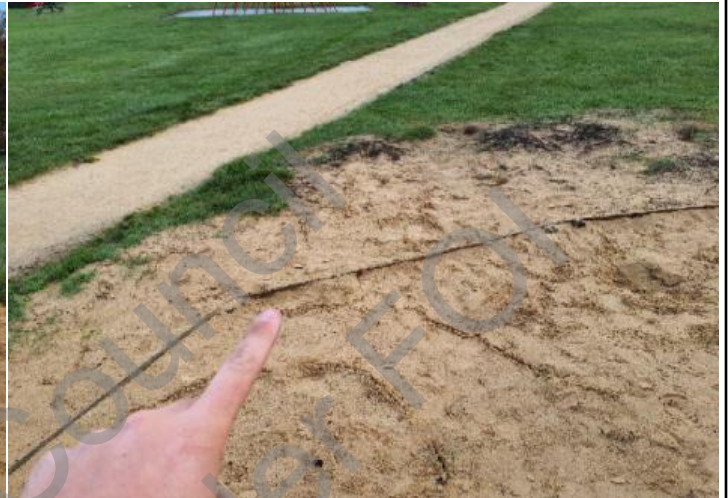
Finding: There are trip hazards at the edges of the surface
Action: Reinstate surrounding surface levels to remove the trip points

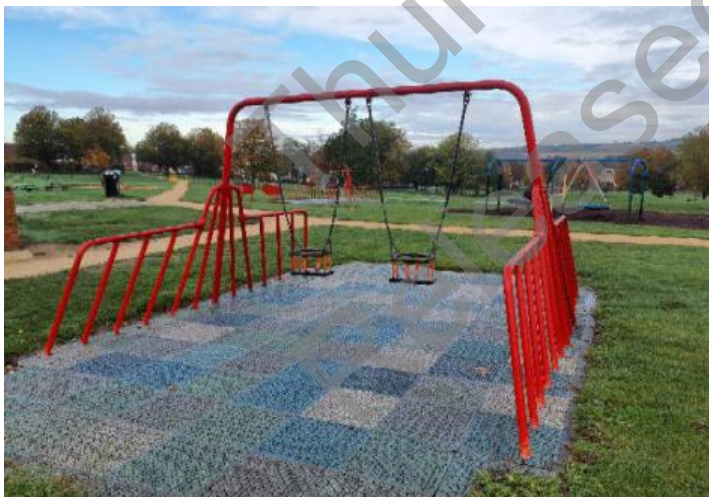
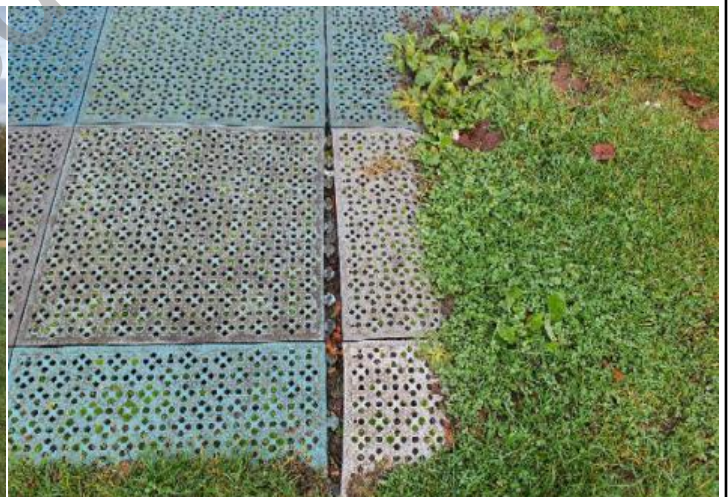
Finding: There are gaps opening in between the tiles
Action: Reinstate the surface

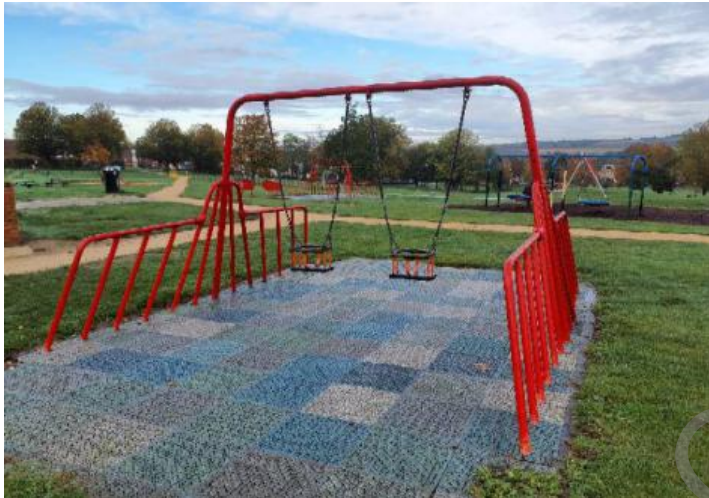
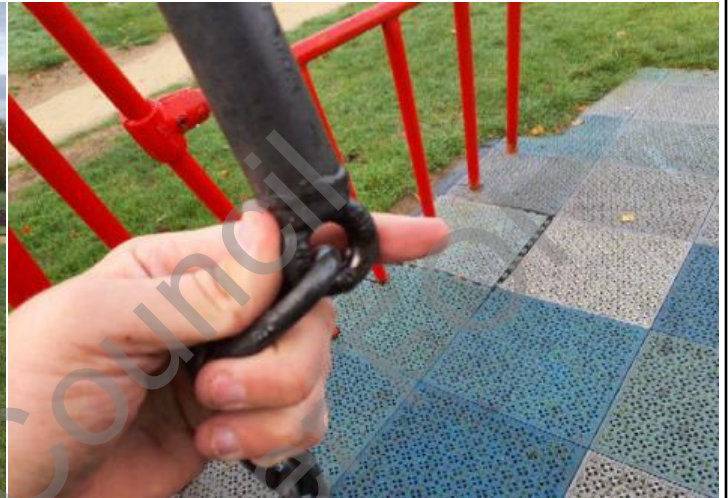
Finding: The connecting lugs are showing signs of wear

Action: Monitor for any further deterioration and repair as required

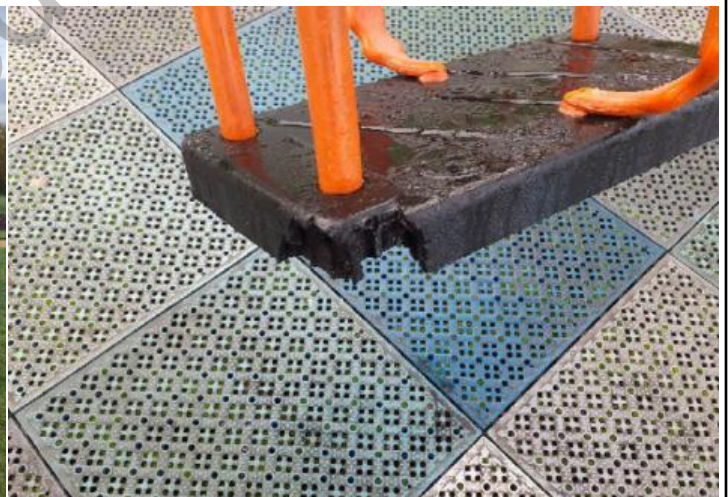
Finding: The seat has minor damage or wear

Action: Monitor for any further deterioration and replace as required

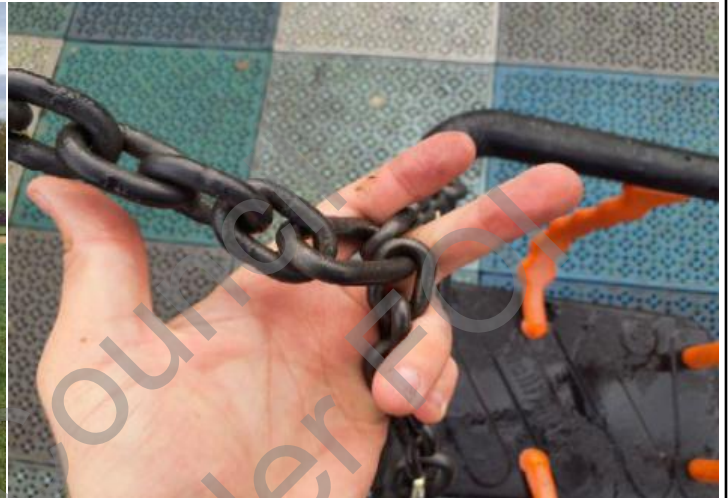
Finding: There is some notable evidence of chain wear

Action: Monitor for any further deterioration and replace when 40% worn

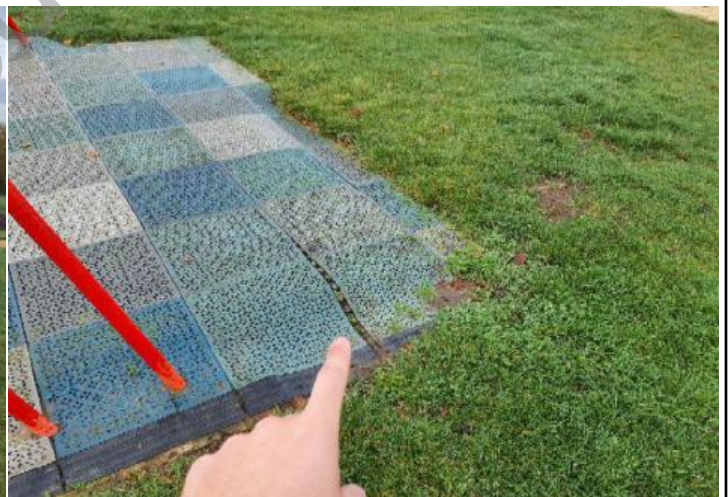
Finding: The surface has subsided in some areas

Action: Monitor for any further deterioration and repair as required

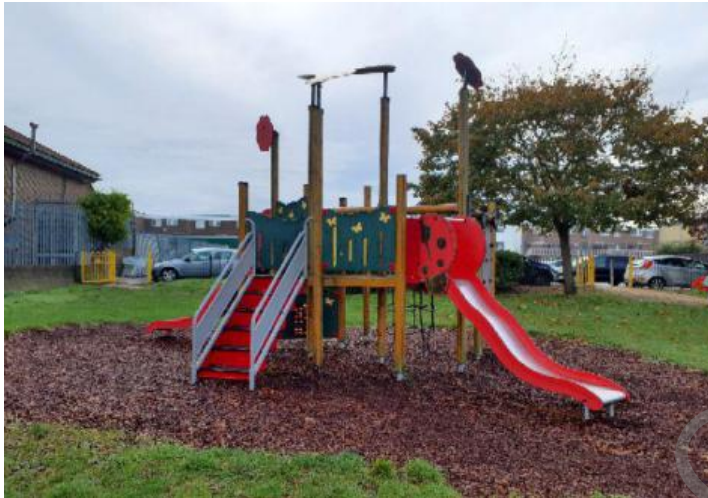
Finding: There are a number of dents in the slide surface

Action: Monitor for any further deterioration and repair as required

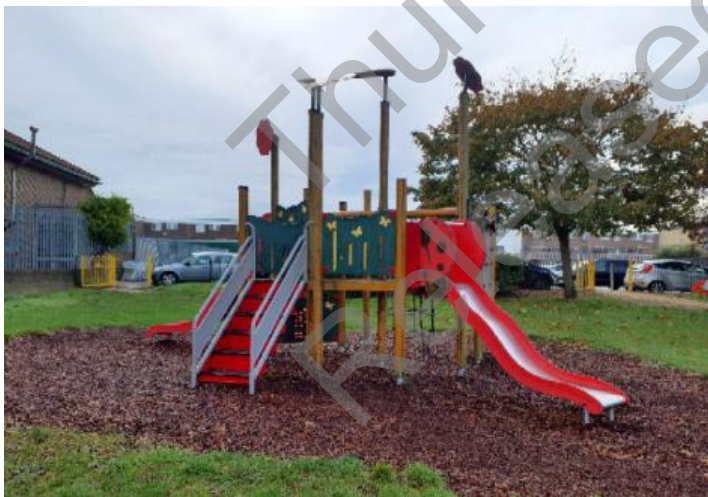
Finding: There are post / end caps missing from the item

Action: Replace missing post caps

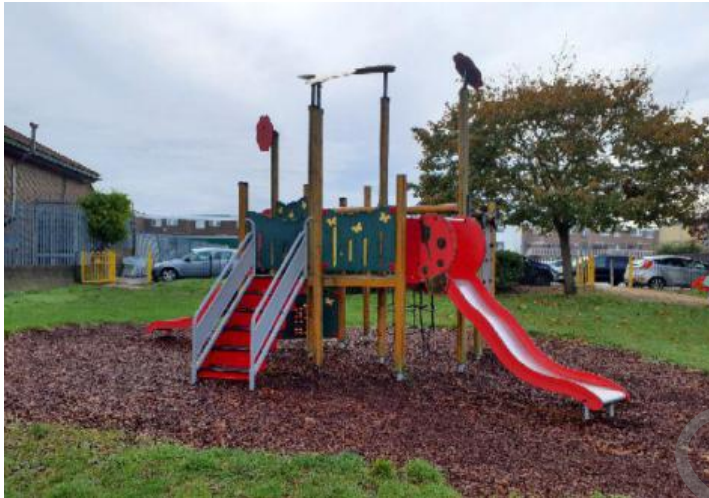
Finding: There is some evidence of fire damage to the item **Action:** Monitor for any further deterioration and repair as required

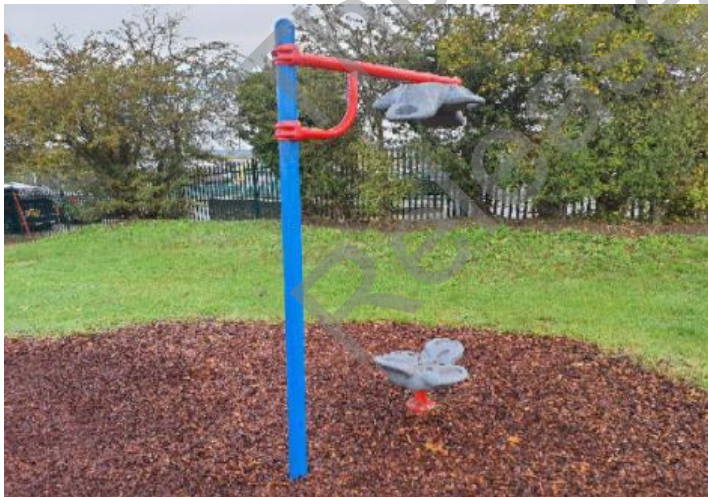
Finding: The item has missing component(s)

Action: Consider replacing missing components

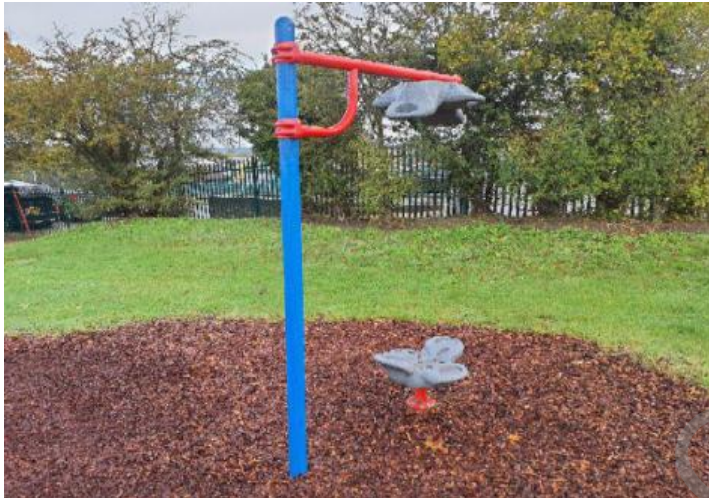
Item: Rotor Play - Misc Item
Manufacturer: Playworld Systems (Europe) Ltd

Finding: The bearing is showing signs of wear

Action: Monitor for any further deterioration and replace as required

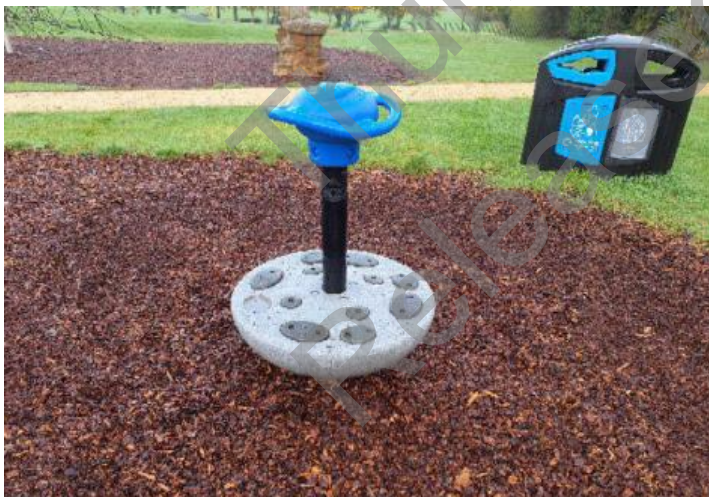
Item: Rotor Play - Spinning Pole
Manufacturer: Playworld Systems (Europe) Ltd

Finding: The bearing is showing signs of wear

Action: Monitor for any further deterioration and replace as required

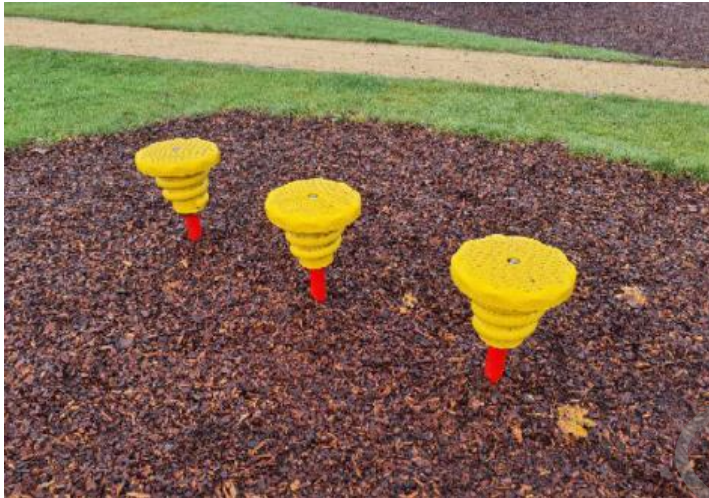
Item: Activity Equipment - Stepping Stones
Manufacturer: Playworld Systems (Europe) Ltd

Finding: The item has been damaged

Action: Monitor for any further deterioration and replace as required

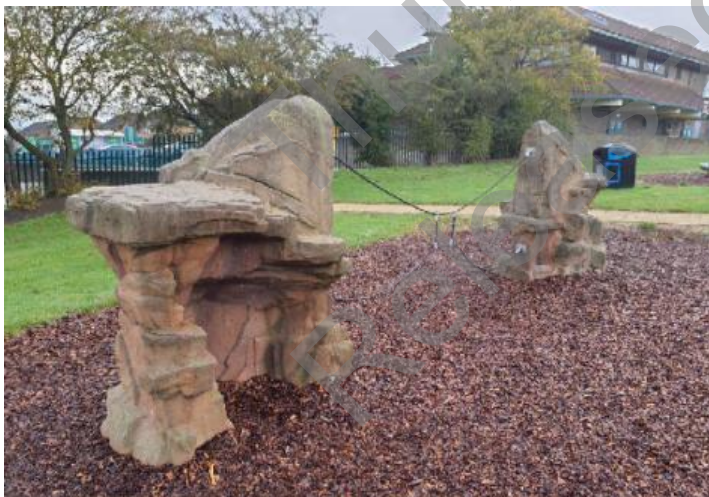
Item: Activity Equipment - Climbing Wall
Manufacturer: Not Identified

Finding: The rope has worn and wire strands are exposed

Action: Replace rope or net

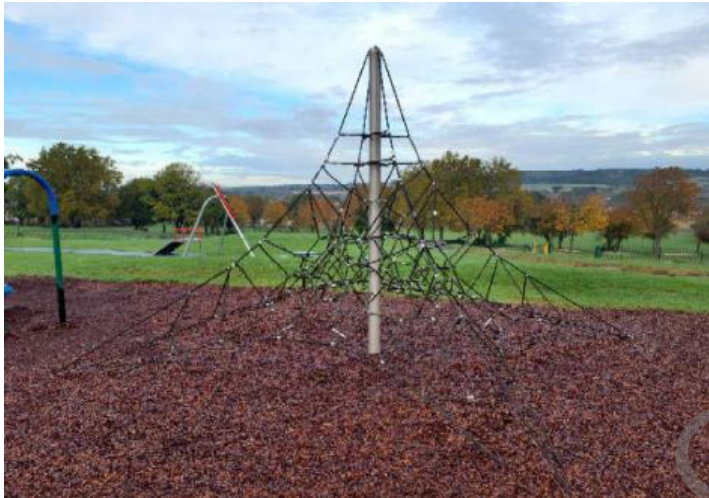
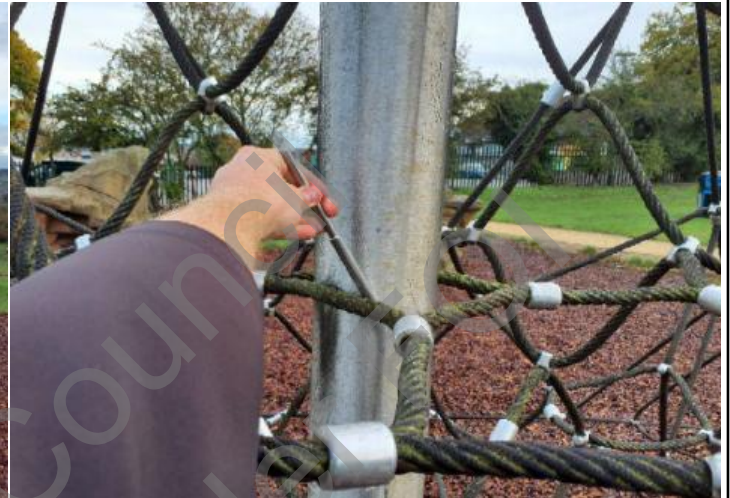
Item: Activity Equipment - Space Net
Manufacturer: Kompan Ltd

Finding: There is a potential crushing point between the rope and the central post in contravention of BS EN 1176 Part 1

Action: Re-tension ropes to ensure the rope is spaced evenly around the post

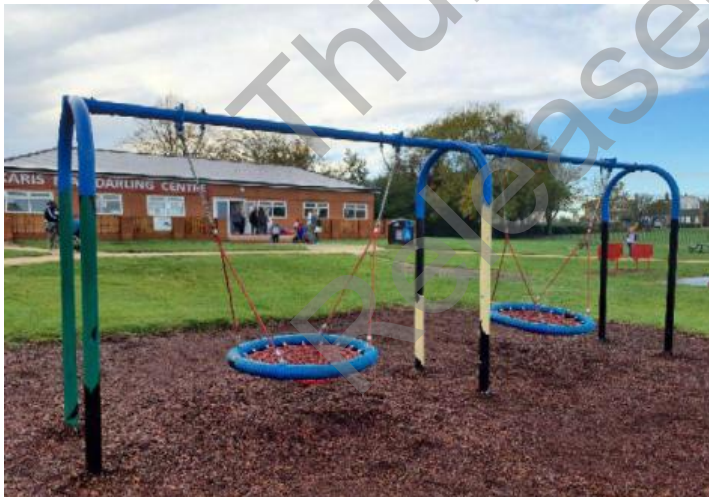
Item: Swings - 2 Bay Swing
Manufacturer: Playworld Systems (Europe) Ltd

Finding: The bushes are showing signs of wear

Action: Monitor for any further deterioration and replace as required

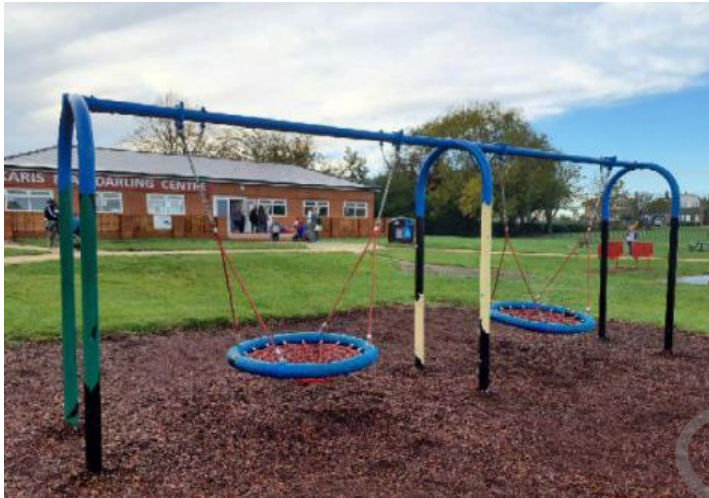
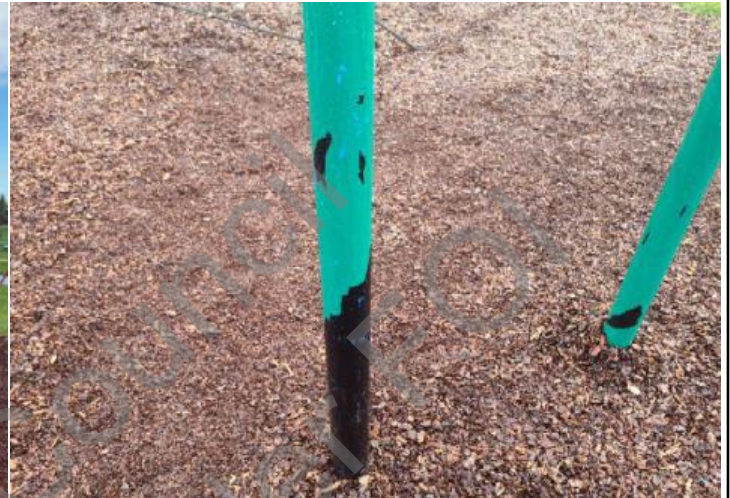
Item: Swings - 2 Bay Swing
Manufacturer: Playworld Systems (Europe) Ltd

Finding: The paint is flaking off the metalwork

Action: Rub down and re-paint

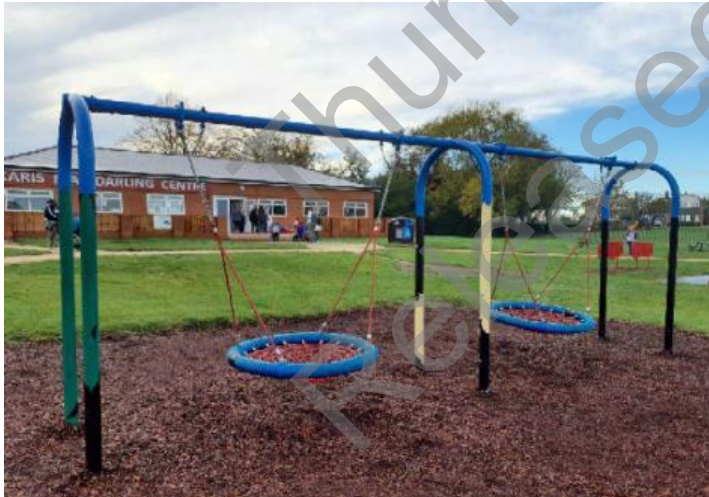
Item: Swings - 2 Bay Swing
Manufacturer: Playworld Systems (Europe) Ltd

Finding: There is some evidence of fire damage to the item

Action: Monitor for any further deterioration and repair as required

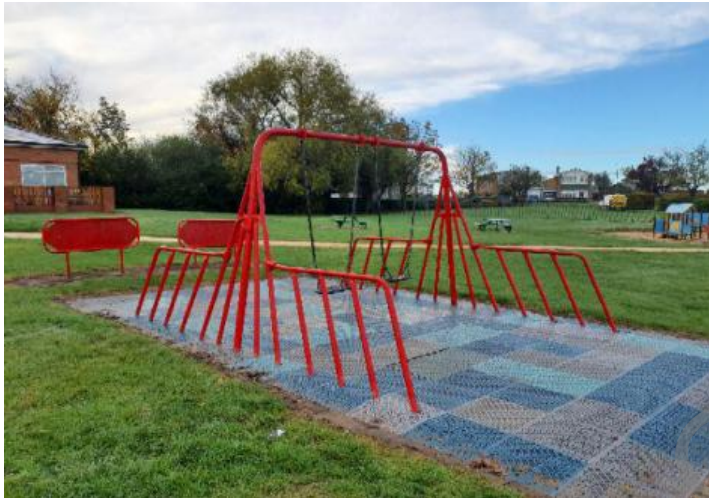
Item: Swings - 1 Bay 2 Seat (Flat)
Manufacturer: Wicksteed Playgrounds

Finding: There are gaps opening in between the tiles

Action: Monitor for any further deterioration and repair as required

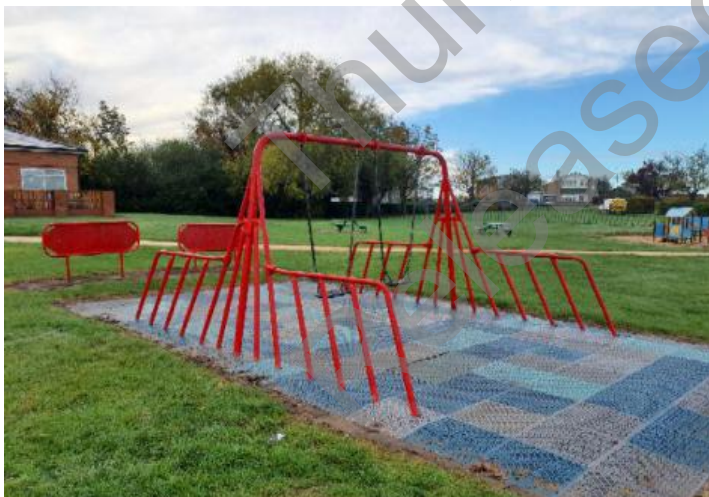
Item: Swings - 1 Bay 2 Seat (Flat)
Manufacturer: Wicksteed Playgrounds

Finding: The chain openings are in excess of 8.6mm and do not meet the recommendations of BS EN 1176 Part 1

Action: Monitor - No remedial work recommended

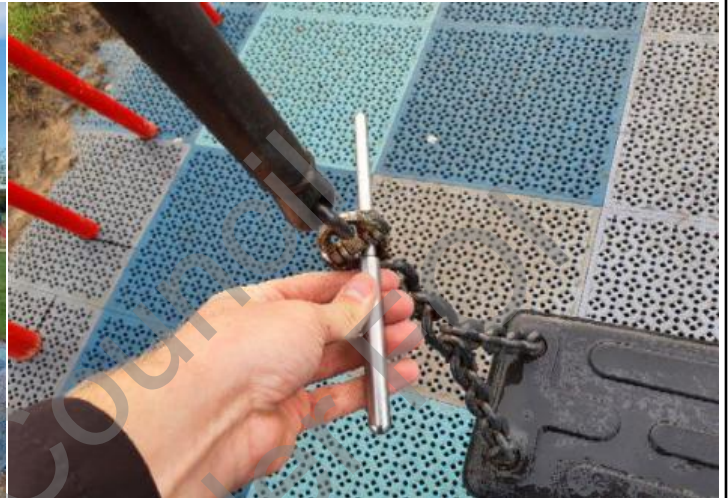
Item: Swings - 1 Bay 2 Seat (Flat)
Manufacturer: Wicksteed Playgrounds

Finding: The connecting links are in excess of 8.6mm and less than 12mm and fail the requirements of BS EN 1176 Part 1; clause 4.2.13, Chains

Action: Monitor use and replace with compliant links at the next maintenance cycle

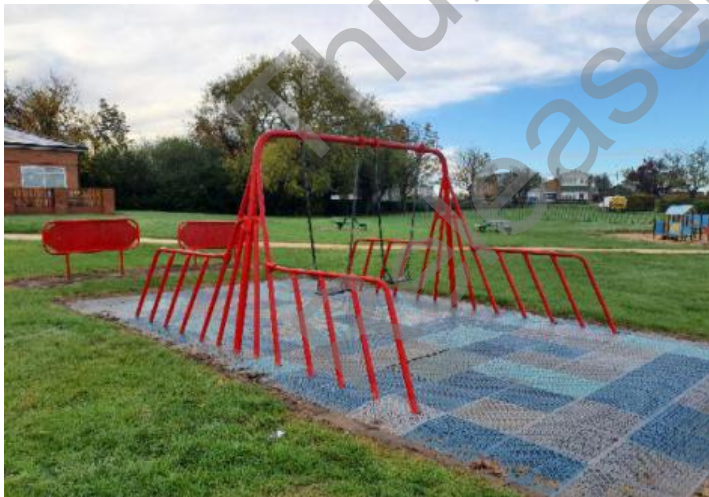
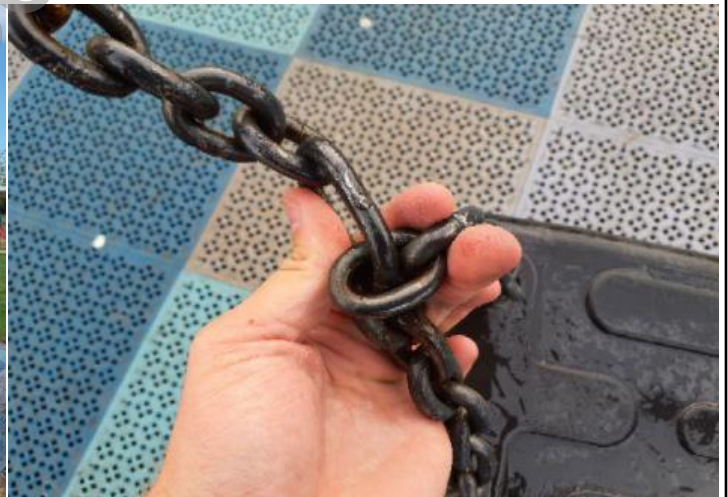
Item: Swings - 1 Bay 2 Seat (Flat)
Manufacturer: Wicksteed Playgrounds

Finding: There is some notable evidence of chain wear

Action: Monitor for any further deterioration and replace when 40% worn

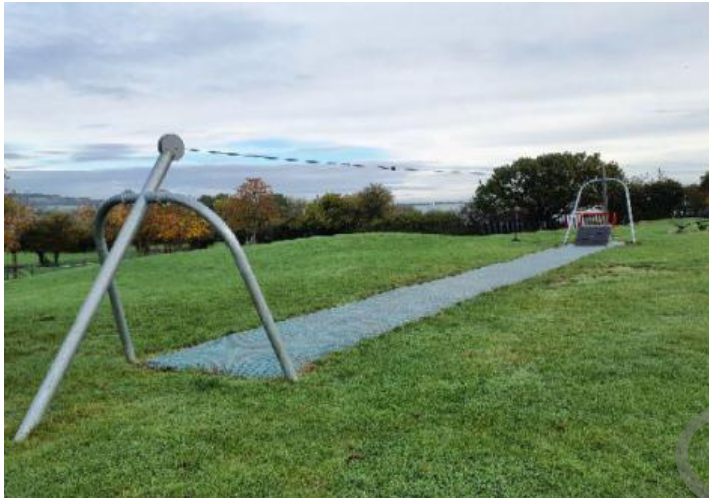
Item: Other - Cable Runway
Manufacturer: Sutcliffe Play Limited

Finding: We have completed a visual inspection of the suspension links, cable and fixing points from ground level, however it is not possible to fully inspect these areas without either hiring equipment to gain access or removing the cable and suspension and inspecting at ground level. We recommend that the main cable and fixing security is thoroughly inspected at least in accordance with the manufacturers recommendations to check for wear, damage, security or internal rusting; this will help to ensure the continued safe use of the equipment

Action: Inspect in accordance with the manufacturers recommendations
