Annual Inspection

Thurrock Council

Corringham Town Park

Springhouse Road, Corringham, Essex, SS17 7NB

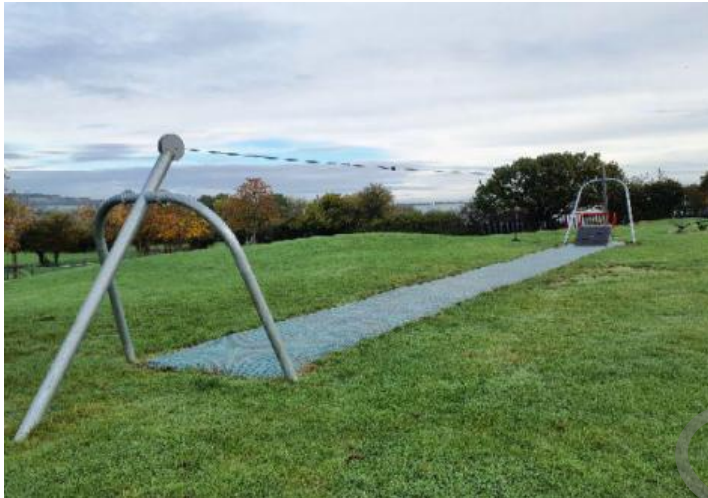
Item: Other - Cable Runway
Manufacturer: Sutcliffe Play Limited

Finding: The cableway seat has been damaged

Action: Monitor for any further deterioration and replace as required

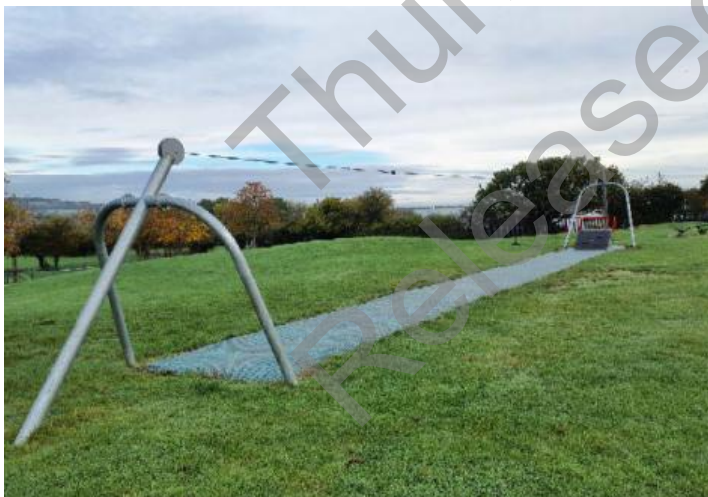
Item: Other - Cable Runway
Manufacturer: Sutcliffe Play Limited

Finding: There is some notable evidence of chain wear

Action: Monitor for any further deterioration and replace when 40% worn

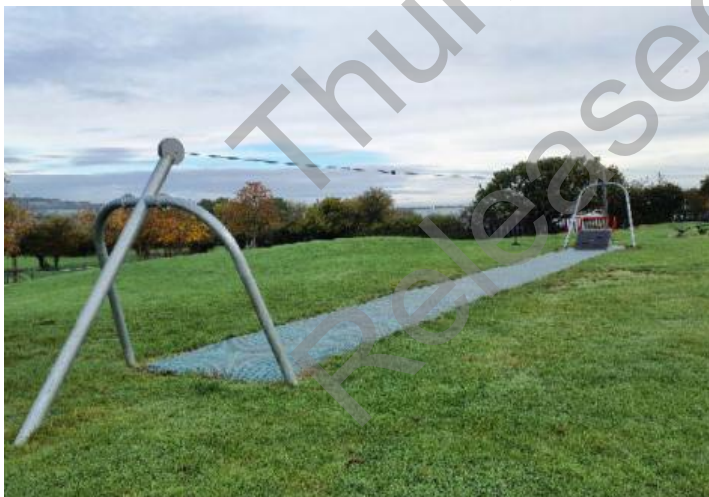
Item: Other - Cable Runway
Manufacturer: Sutcliffe Play Limited

Finding: The dampening spring or tyre is damaged or broken on the item

Action: Replace spring or tyre

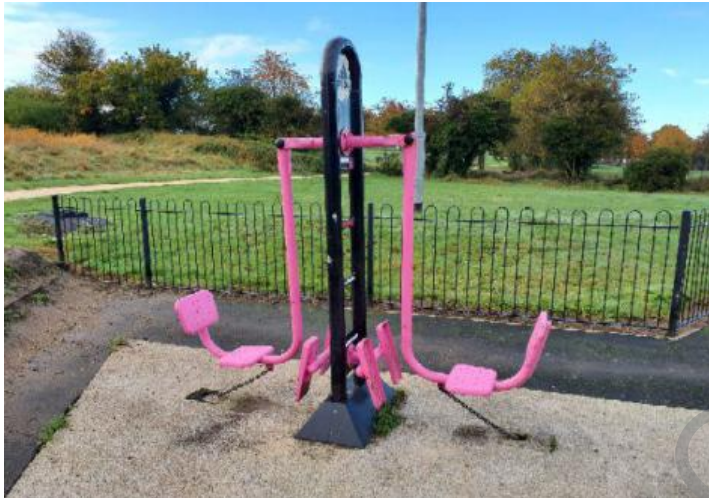
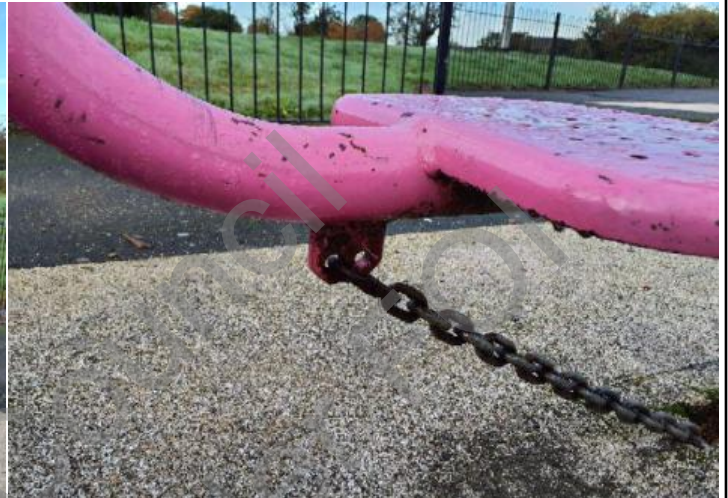
Item: Outdoor Fitness Equipment - Leg Press
Manufacturer: The Great Outdoor Gym Company

Finding: The connecting lugs are showing signs of wear

Action: Monitor for any further deterioration and repair as required

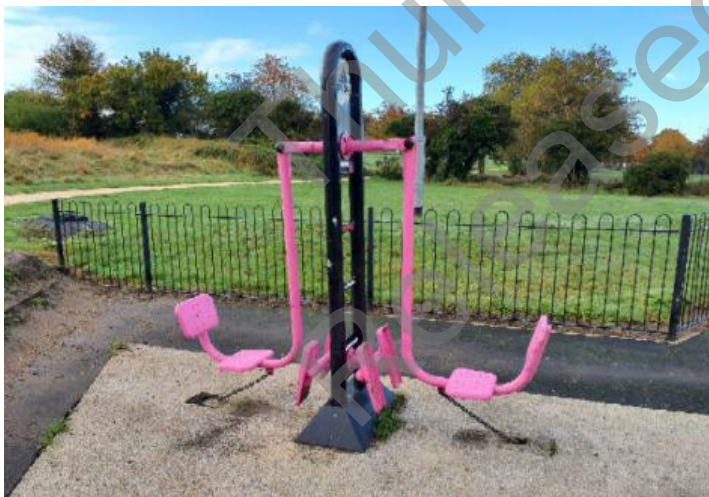
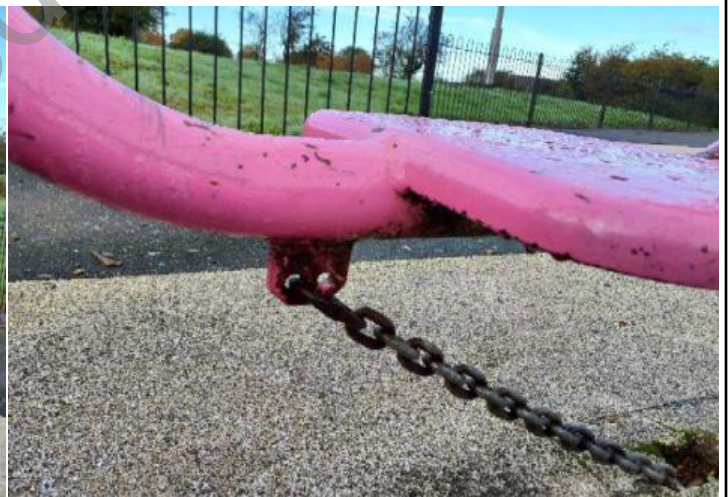
Item: Outdoor Fitness Equipment - Leg Press
Manufacturer: The Great Outdoor Gym Company

Finding: There is some wear to the shackles

Action: Monitor for any further deterioration and replace when 40% worn

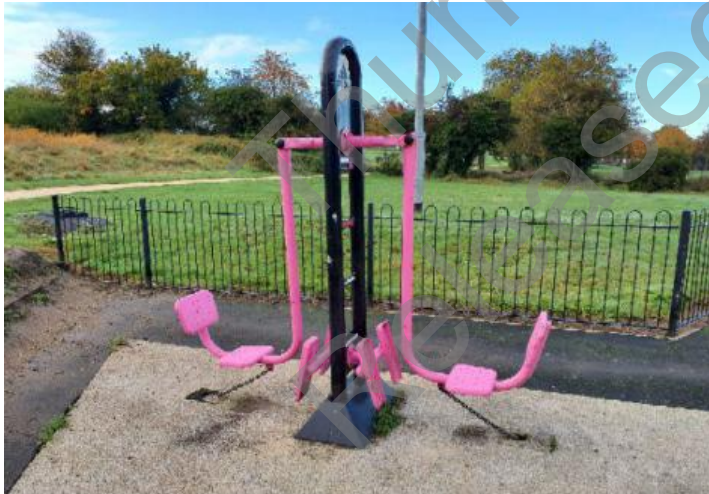
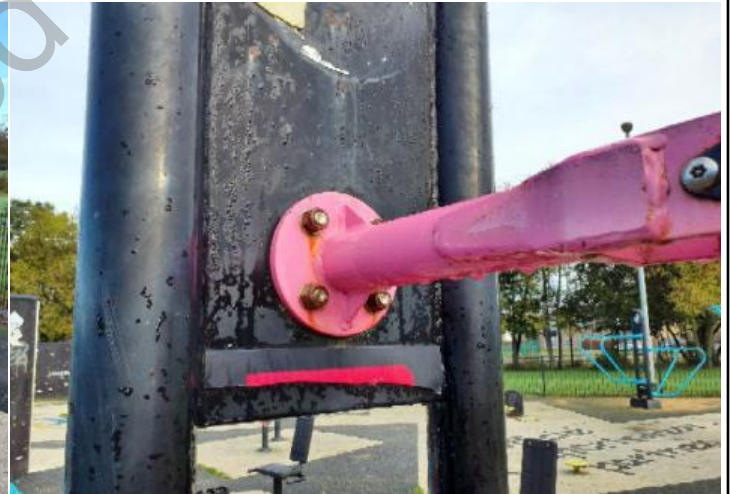
Item: Outdoor Fitness Equipment - Leg Press
Manufacturer: The Great Outdoor Gym Company

Finding: There is/are bolt cap covers missing or damaged on the item

Action: Replace missing or damaged bolt cap covers

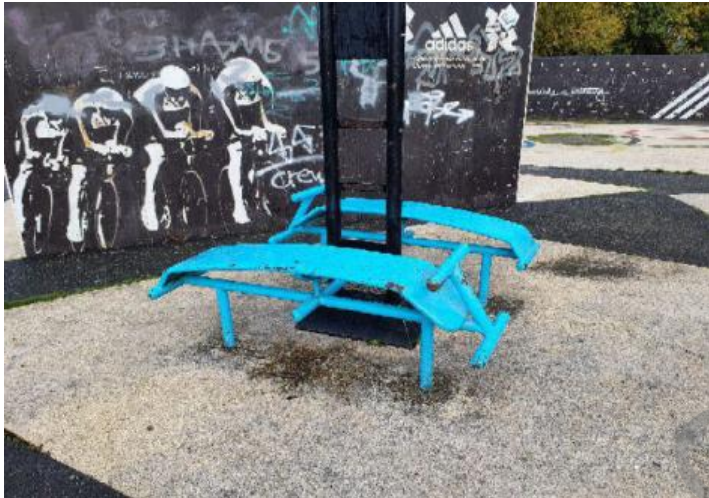
Item: Outdoor Fitness Equipment - Ab Station
Manufacturer: The Great Outdoor Gym Company

Finding: The paintwork on this item has been damaged or worn exposing the metal underneath which is rusting / corroding

Action: Treat affected areas and repaint

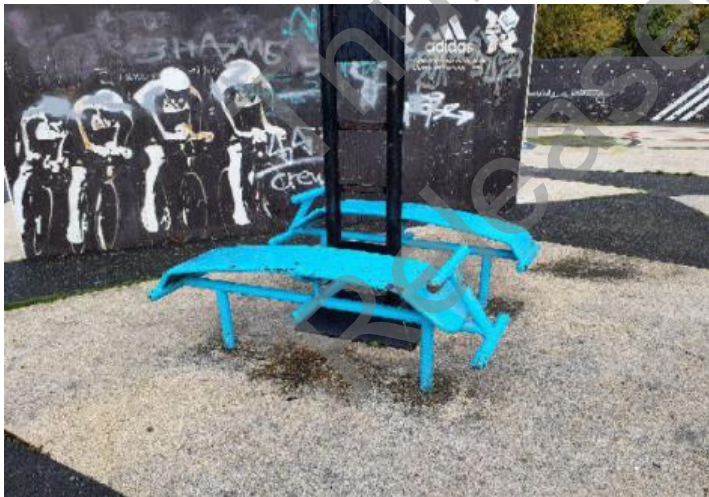
Item: Outdoor Fitness Equipment - Ab Station
Manufacturer: The Great Outdoor Gym Company

Finding: There is/are bolt cap covers missing or damaged on the item

Action: Replace missing or damaged bolt cap covers

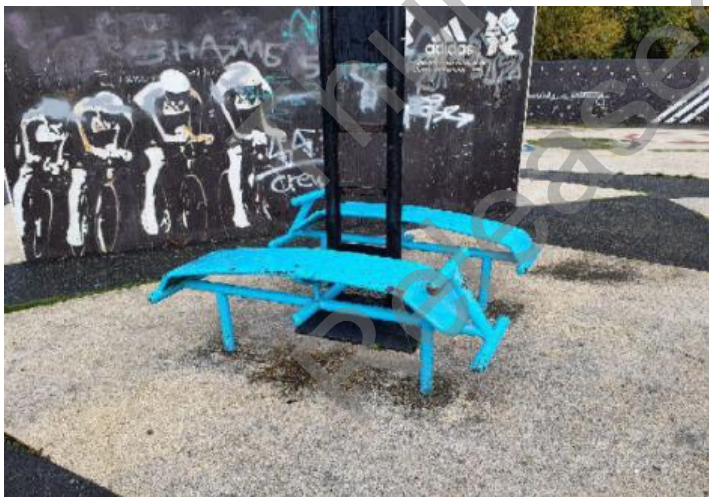
Item: Outdoor Fitness Equipment - Ab Station
Manufacturer: The Great Outdoor Gym Company

Finding: There is some damage to the item

Action: Monitor for any further deterioration and repair as required

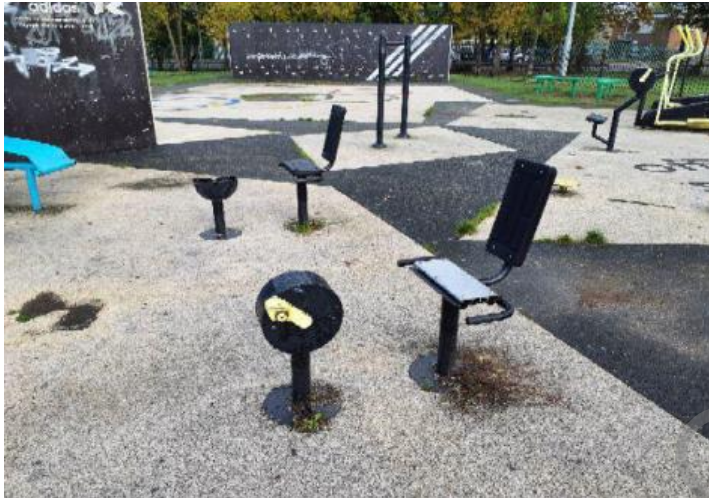
Item: Outdoor Fitness Equipment - Cycle
Manufacturer: The Great Outdoor Gym Company

Finding: The mechanism has been removed from one item **Action:** Replace the missing components or remove the item completely

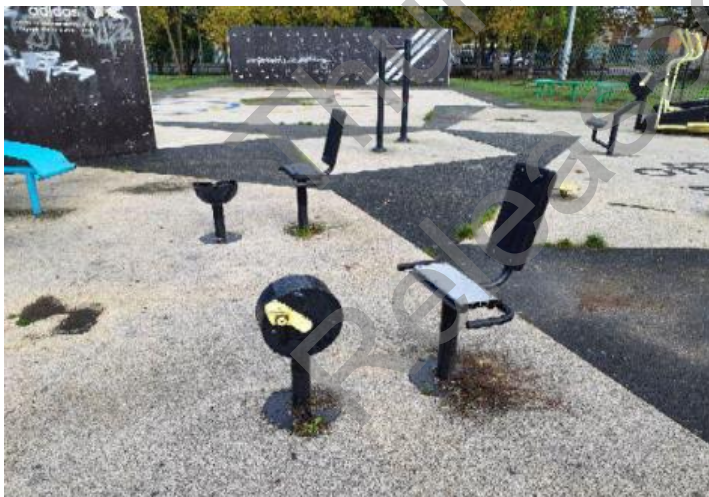
Item: Outdoor Fitness Equipment - Cycle
Manufacturer: The Great Outdoor Gym Company

Finding: There is some damage to the seat **Action:** Monitor for any further deterioration and repair as required

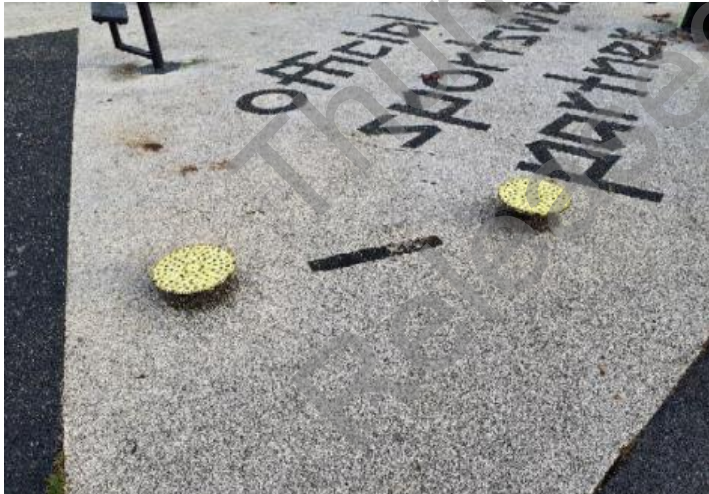
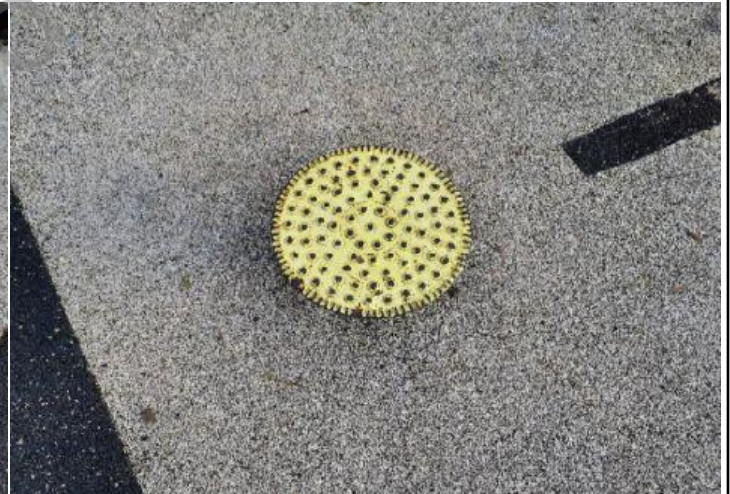
Item: Outdoor Fitness Equipment - Hip Twister
Manufacturer: The Great Outdoor Gym Company

Finding: The rotating user station is not appropriately marked with a guideline of user direction and/or the original position as required by BS EN 16630

Action: Monitor - No remedial work recommended

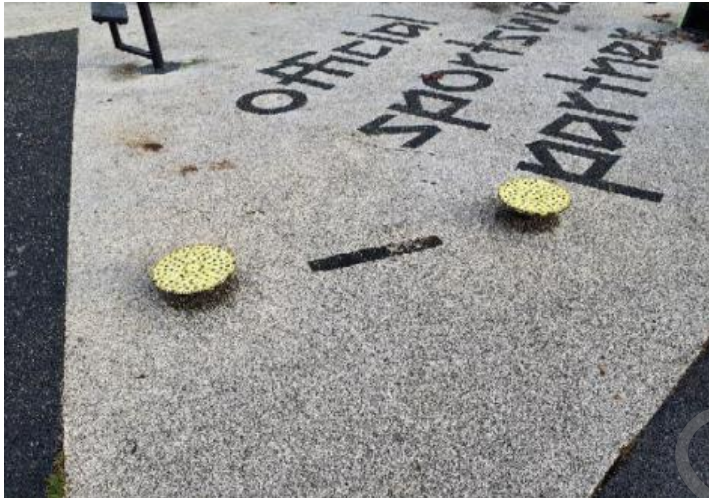
Item: Outdoor Fitness Equipment - Hip Twister
Manufacturer: The Great Outdoor Gym Company

Finding: The deflection of the rotating user station exceeds the maximum 105 degrees required by BS EN 16630
Action: Monitor - No remedial work recommended

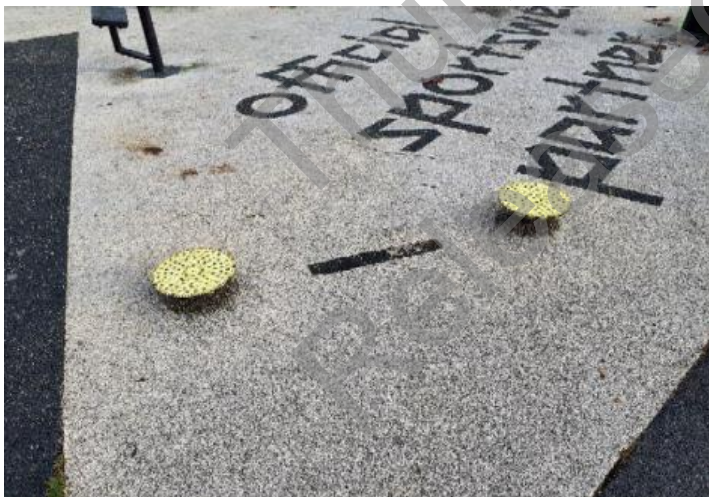
Item: Outdoor Fitness Equipment - Hip Twister
Manufacturer: The Great Outdoor Gym Company

Finding: The frame has been removed
Action: Consider replacing missing components

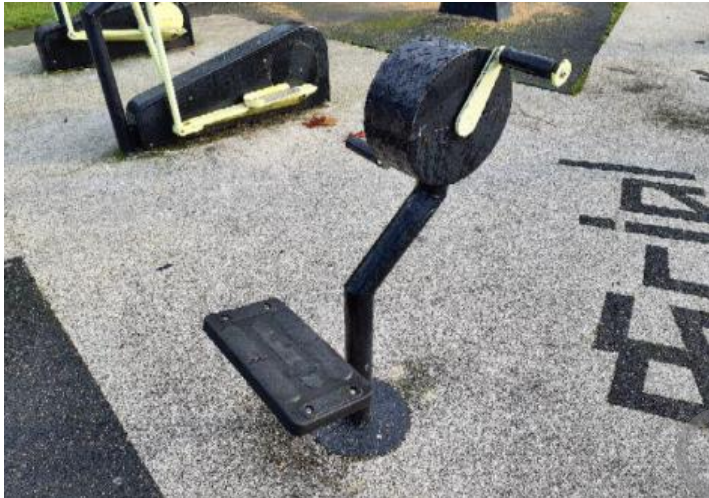
Item: Outdoor Fitness Equipment - Hand Bike
Manufacturer: The Great Outdoor Gym Company

Finding: There is some evidence of fire damage to the item **Action:** Monitor for any further deterioration and repair as required

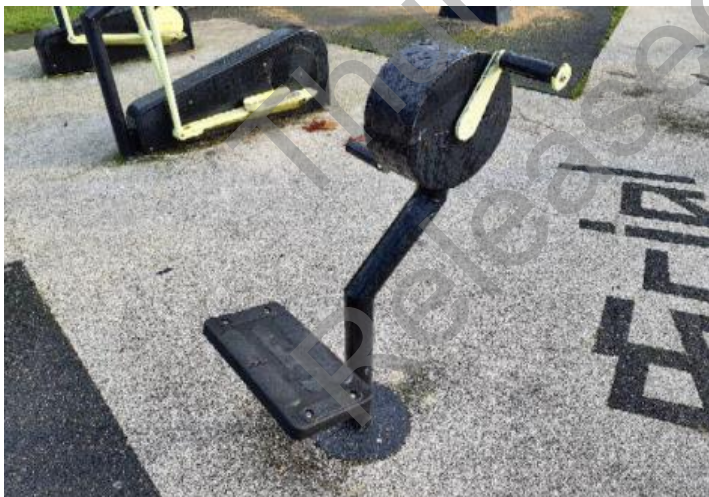
Item: Outdoor Fitness Equipment - Hand Bike
Manufacturer: The Great Outdoor Gym Company

Finding: The paintwork on this item has been damaged or worn exposing the metal underneath which is rusting / corroding **Action:** Treat affected areas and repaint

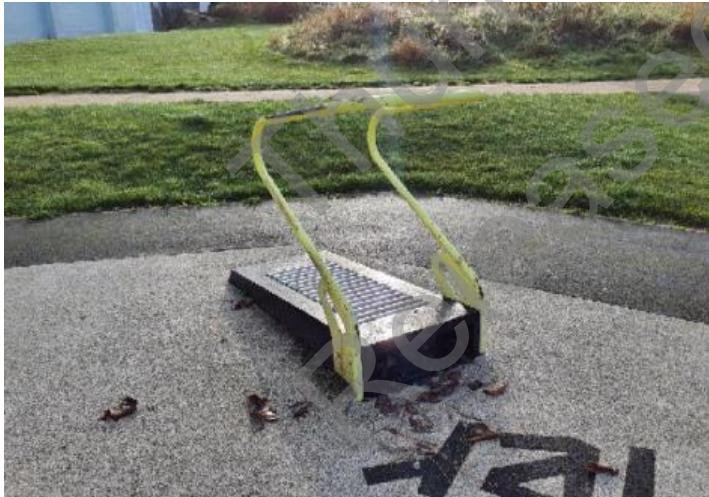
Item: Outdoor Fitness Equipment - Treadmill
Manufacturer: The Great Outdoor Gym Company

Finding: The paintwork on this item has been damaged or worn exposing the metal underneath which is rusting / corroding

Action: Treat affected areas and repaint

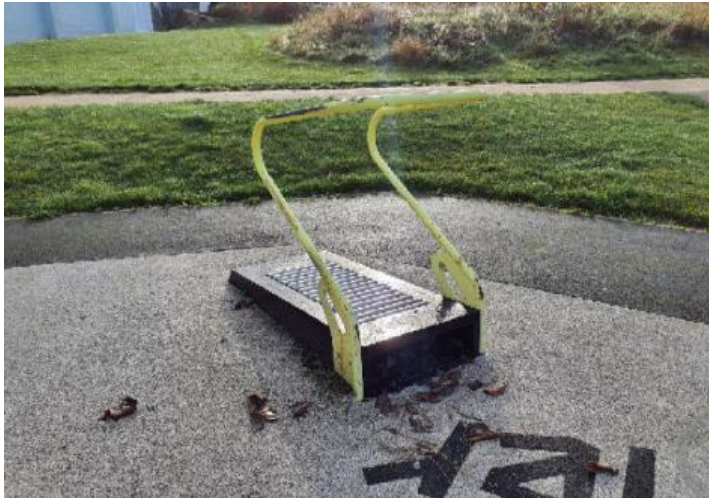
Item: Outdoor Fitness Equipment - Treadmill
Manufacturer: The Great Outdoor Gym Company

Finding: The inspection plate has been removed

Action: Replace the missing inspection plate

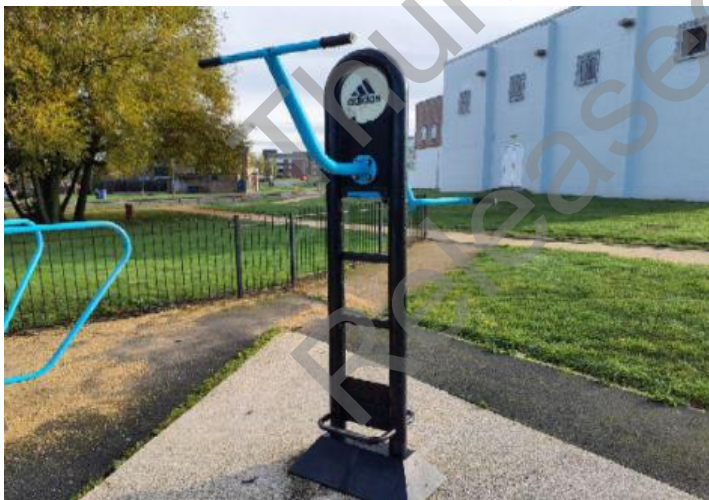
Item: Outdoor Fitness Equipment - Pull Up Station
Manufacturer: The Great Outdoor Gym Company

Finding: There is/are bolt cap covers missing or damaged on the item

Action: Replace missing or damaged bolt cap covers

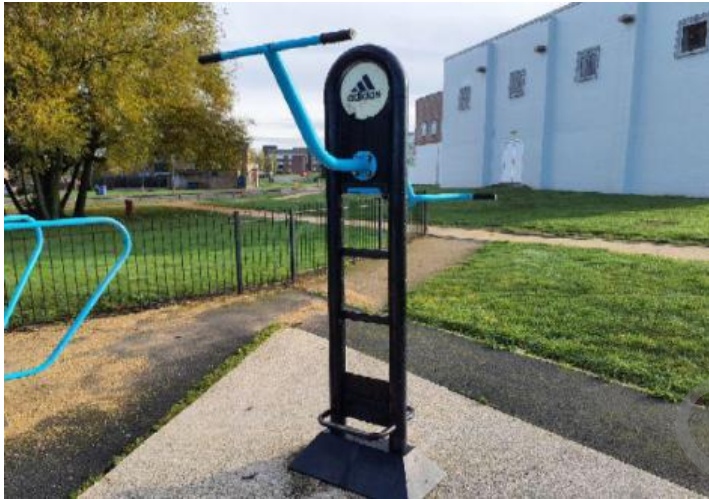
Item: Outdoor Fitness Equipment - Pull Up Station
Manufacturer: The Great Outdoor Gym Company

Finding: The signage is damaged and sharp edges are present

Action: Replace signage

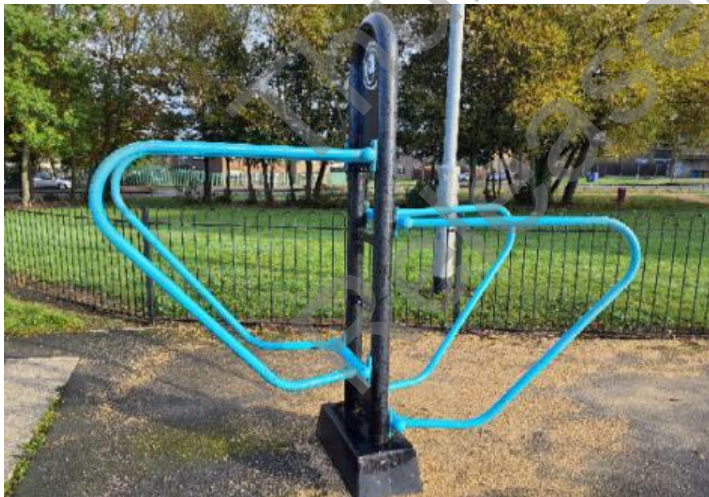
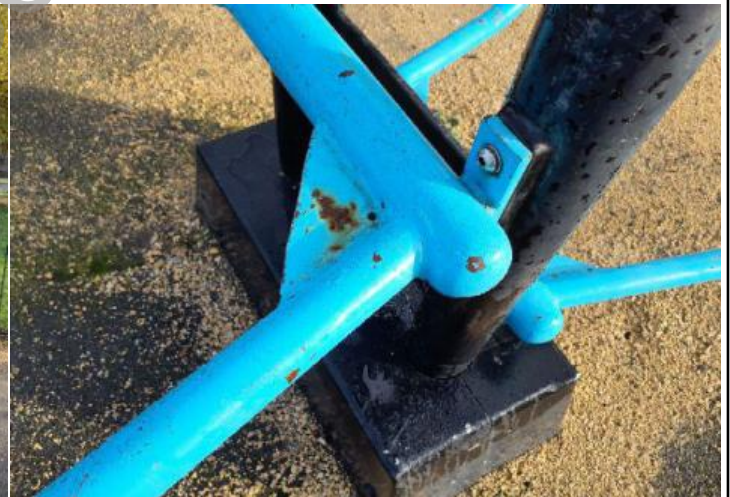
Item: Outdoor Fitness Equipment - Dip Station
Manufacturer: The Great Outdoor Gym Company

Finding: The paintwork on this item has been damaged or worn exposing the metal underneath which is rusting / corroding

Action: Treat affected areas and repaint

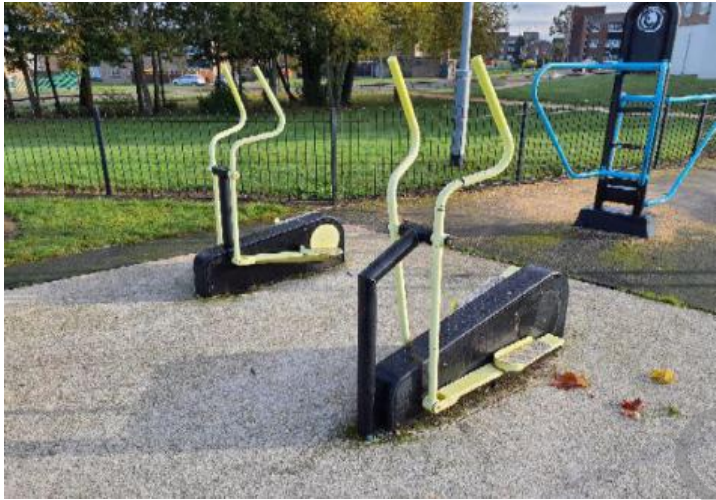
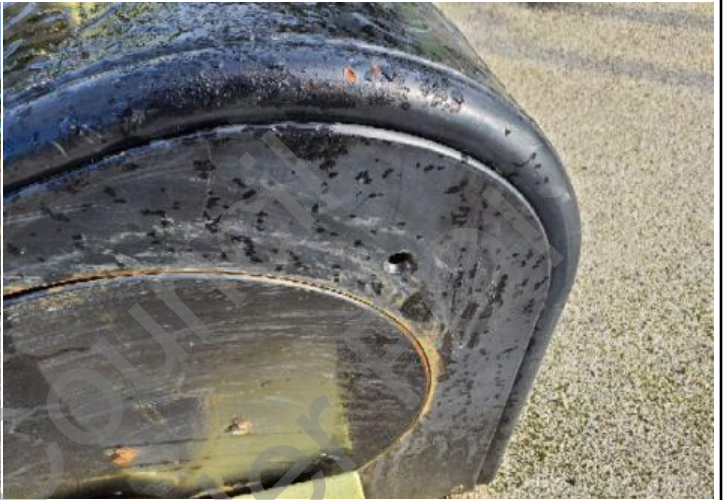
Item: Outdoor Fitness Equipment - Cross Trainer **Risk Level:** L - Low Risk
Manufacturer: The Great Outdoor Gym Company **Surface:** Wet Pour

Finding: There is or are fixings missing on the item

Action: Replace all missing fixings

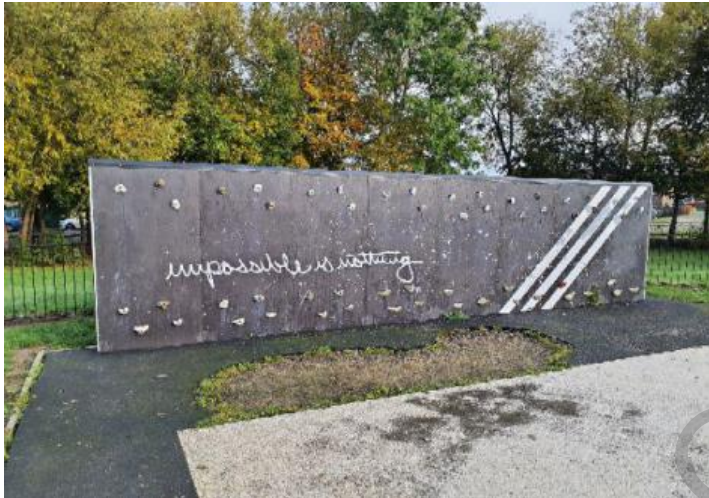
Item: Activity Equipment - Traverse Wall
Manufacturer: Park Leisure Ltd

Finding: There is some damage to the item

Action: Monitor for any further deterioration and repair as required

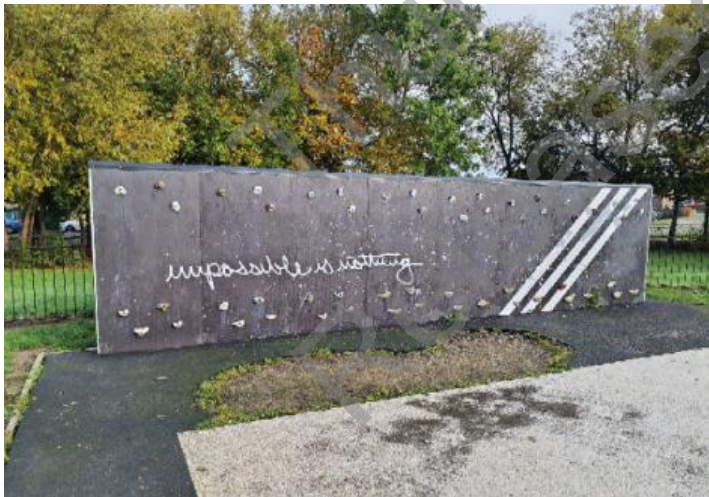
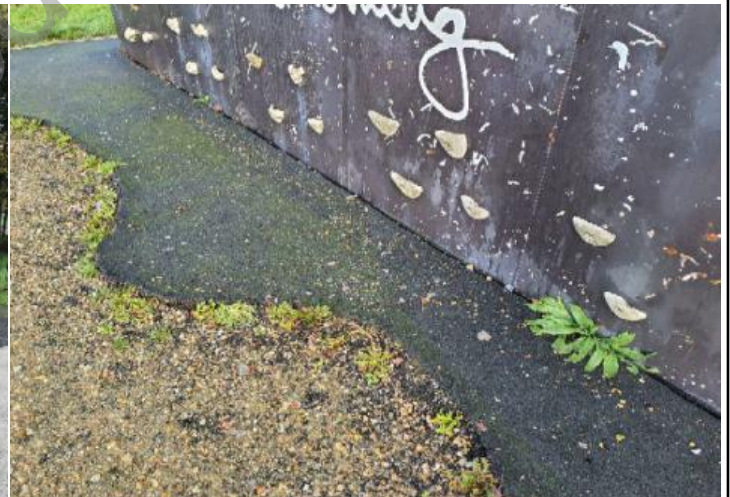
Item: Activity Equipment - Traverse Wall
Manufacturer: Park Leisure Ltd

Finding: There is a significant amount of broken glass on site

Action: Remove the glass and maintain the area

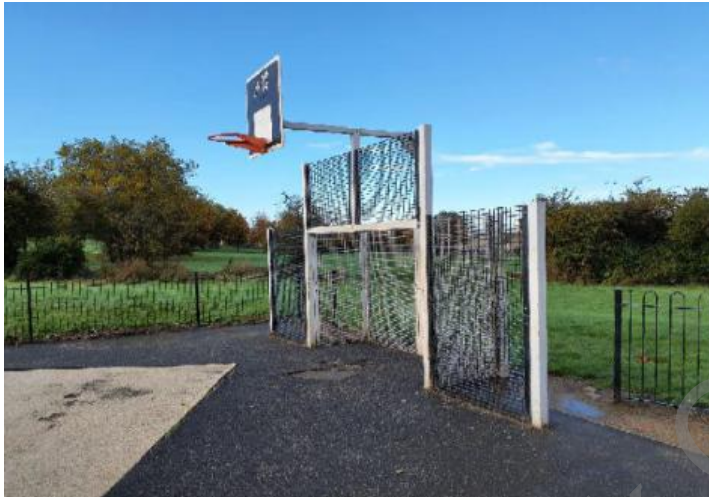
Item: Multi Use Games Area - Goalmouth and Basketball Post
Manufacturer: Park Leisure Ltd

Finding: A clearly visible facility sign should be provided in a prominent position with the wording as detailed BS EN 15312- the equipment is not intended for children less than 3 years old- the warning - Do not climb on the framework or nets- the warning - Do not hang on the ring (if provided)- the warning - Do not wear rings or other jewellery- name and telephone number of the administrator- number to call in case of accident

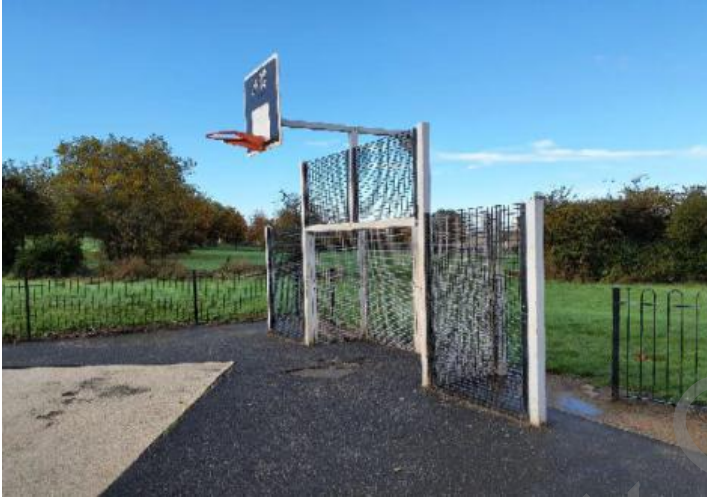
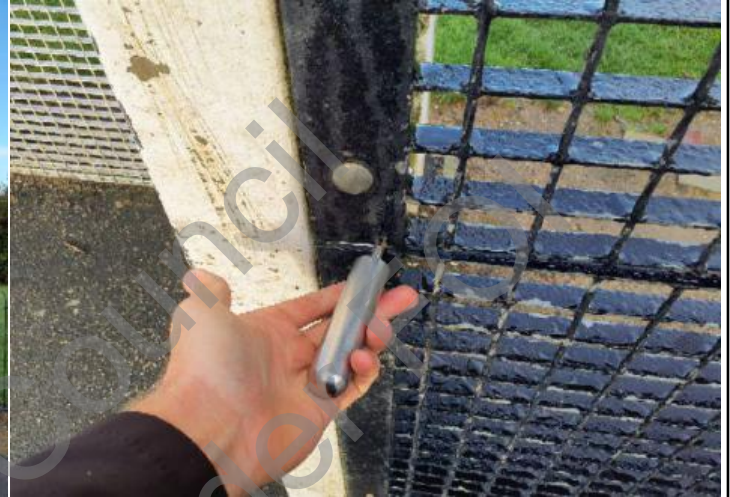
Item: Multi Use Games Area - Goalmouth and Basketball Post
Manufacturer: Park Leisure Ltd

Finding: There is/are finger entrapments in the frame and the item fails to meet the requirements of BS EN 15312 Clause 4.4.2.2 Entrapment of fingers

Action: Monitor - No remedial work recommended

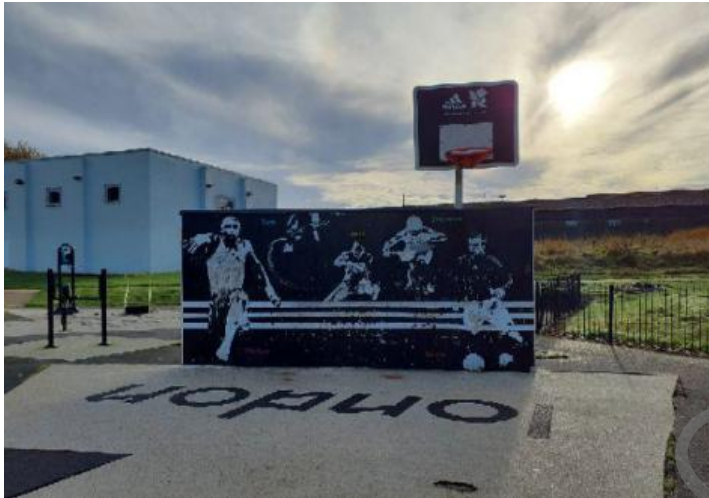
Item: Multi Use Games Area - Kickabout Wall
Manufacturer: Park Leisure Ltd

Finding: A clearly visible facility sign should be provided in a prominent position with the wording as detailed BS EN 15312- the equipment is not intended for children less than 3 years old- the warning - Do not climb on the framework or nets- the warning - Do not hang on the ring (if provided)- the warning - Do not wear rings or other jewellery- name and telephone number of the administrator- number to call in case of accident

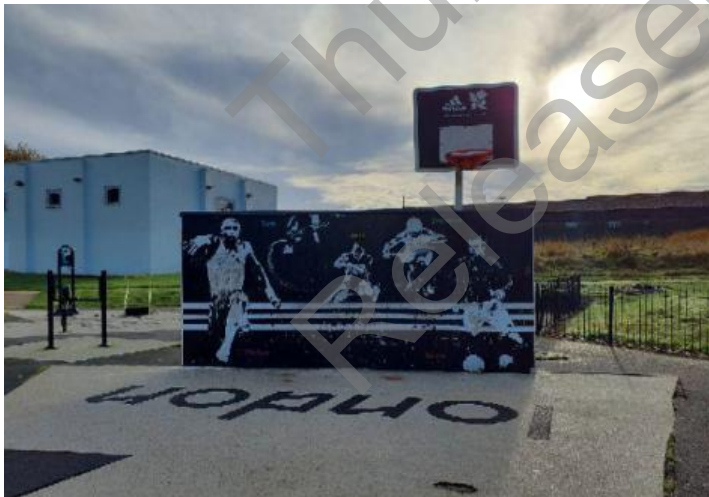
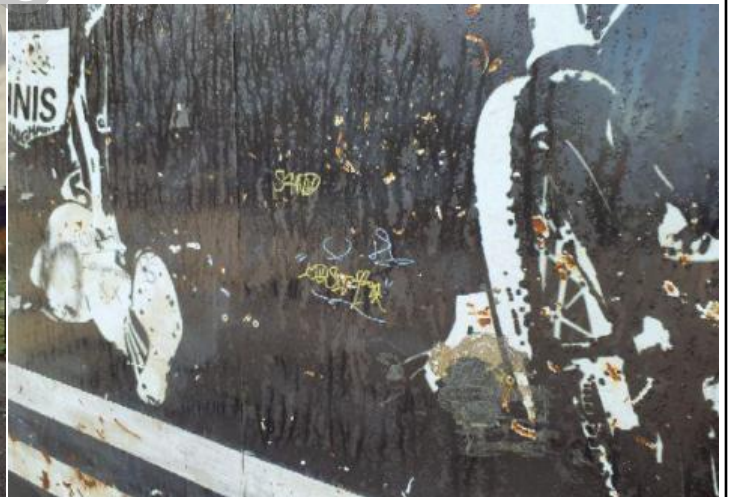
Item: Multi Use Games Area - Kickabout Wall
Manufacturer: Park Leisure Ltd

Finding: There is some graffiti present

Action: Remove the graffiti
