Assessment of Settings

Thurrock Scheduled Ancient Monuments

April 2023

Authored by Historic Environment Team,
Place Services, Essex County Council

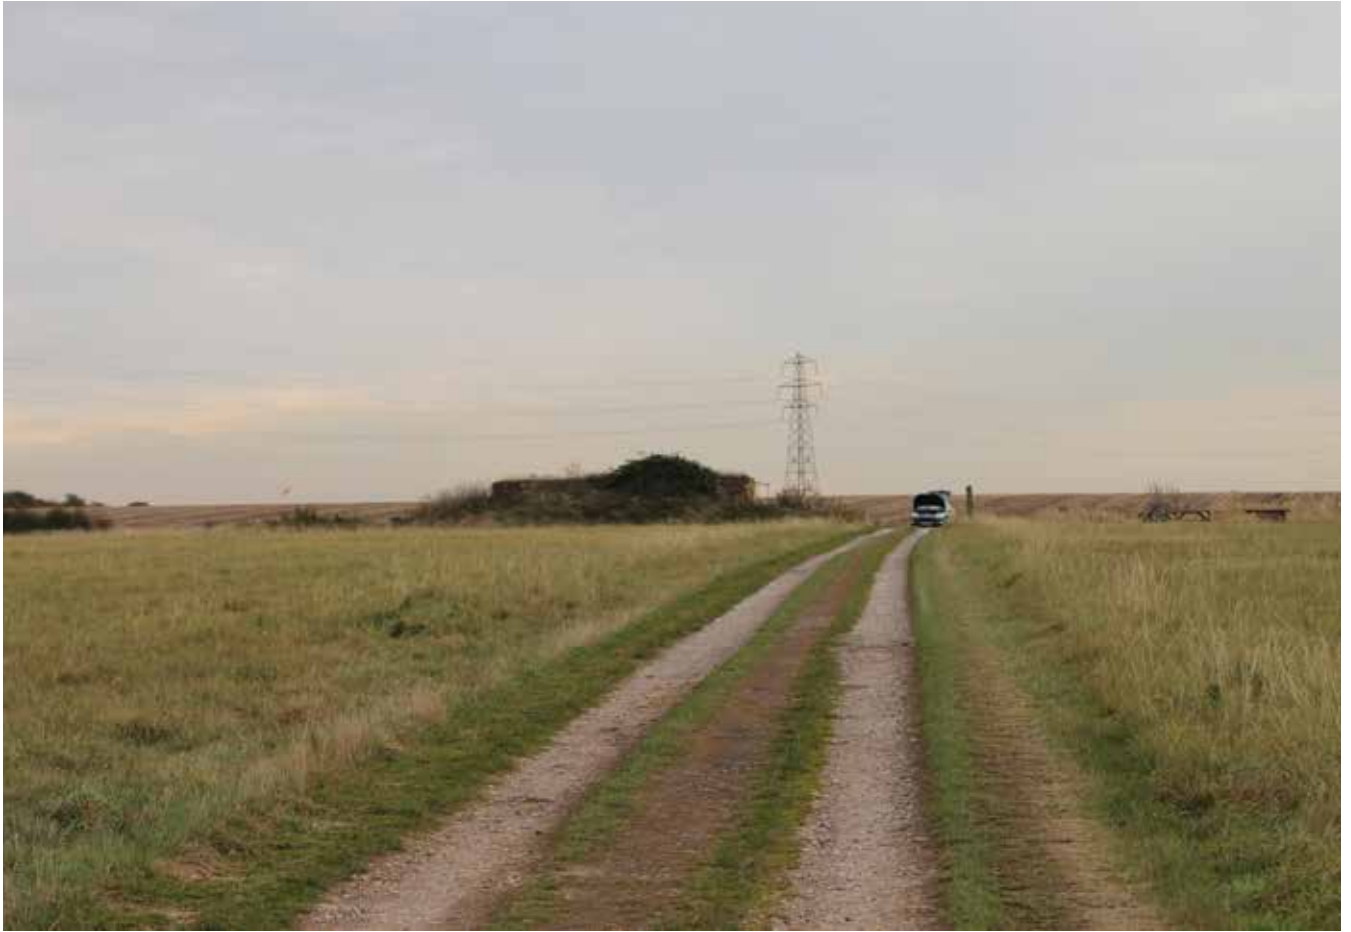
View 1: View looking south across the night-shelters (above-ground in the centre and the top of the below-ground on the right), also showing the modern pylon and the wind sock to the left.

underground rooms. The only part of this shelter visible above-ground is the escape hatch and a steel chimney pipe. This structure was found to be prone to flooding and was replaced by an above-ground night shelter, located to the east, during the course of the war.

The monument is largely in good repair, with the above ground shelter currently being used as the club house for a model aeroplane club. The below ground shelter is difficult to access and there was some standing-water on the floor. It is known that there has been some dumping of waste materials into this part of the structure.

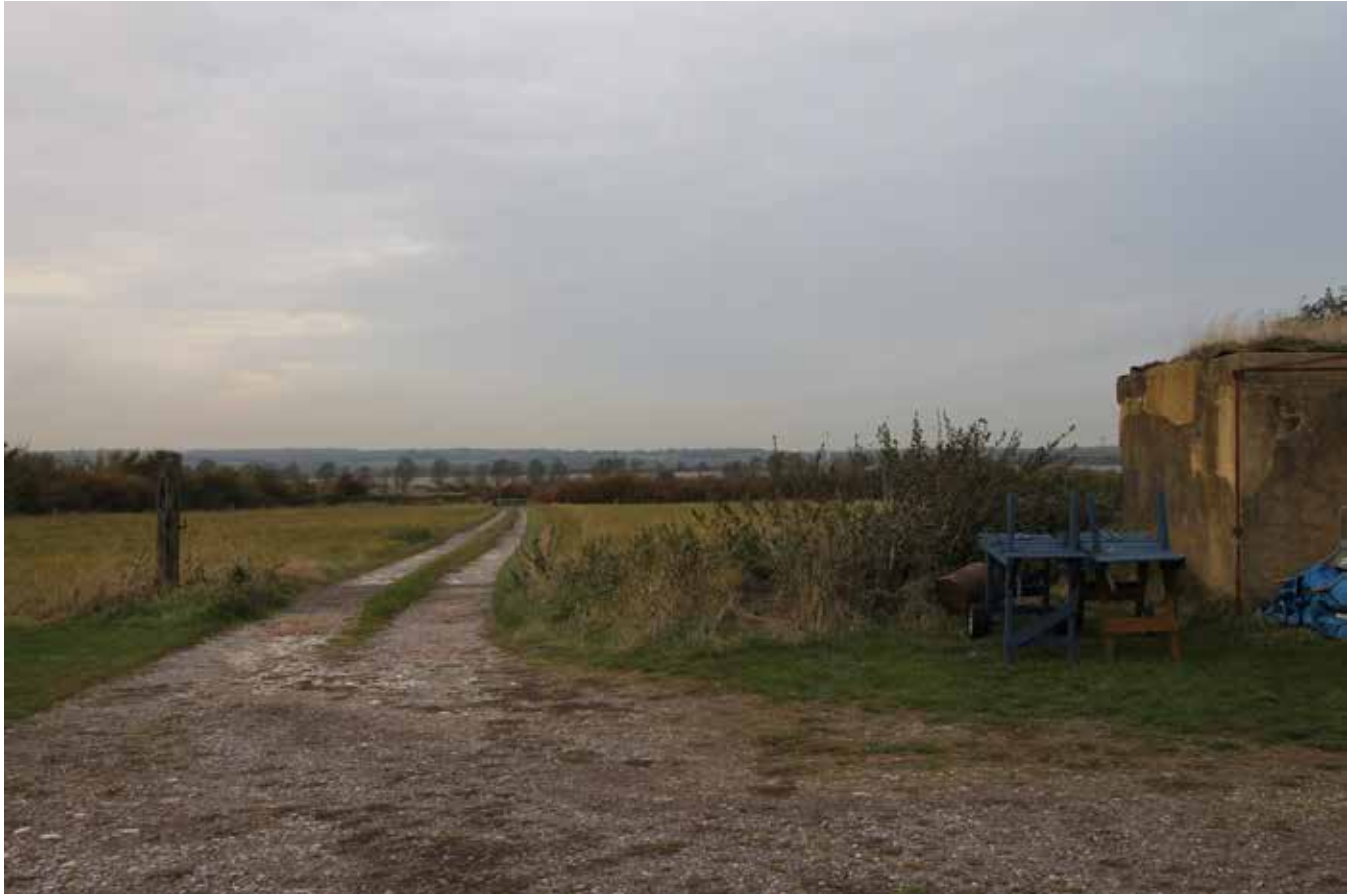
View 2: View looking northwards past the night-shelter to right, showing the long view over the former decoy airfield and beyond to open countryside.

Apart from the scheduled concrete structures nothing further survives from the bomb decoy itself, largely due to these being ephemeral surface-laid structures, such as grass runways, lines of electrical wires, and movable lighting.

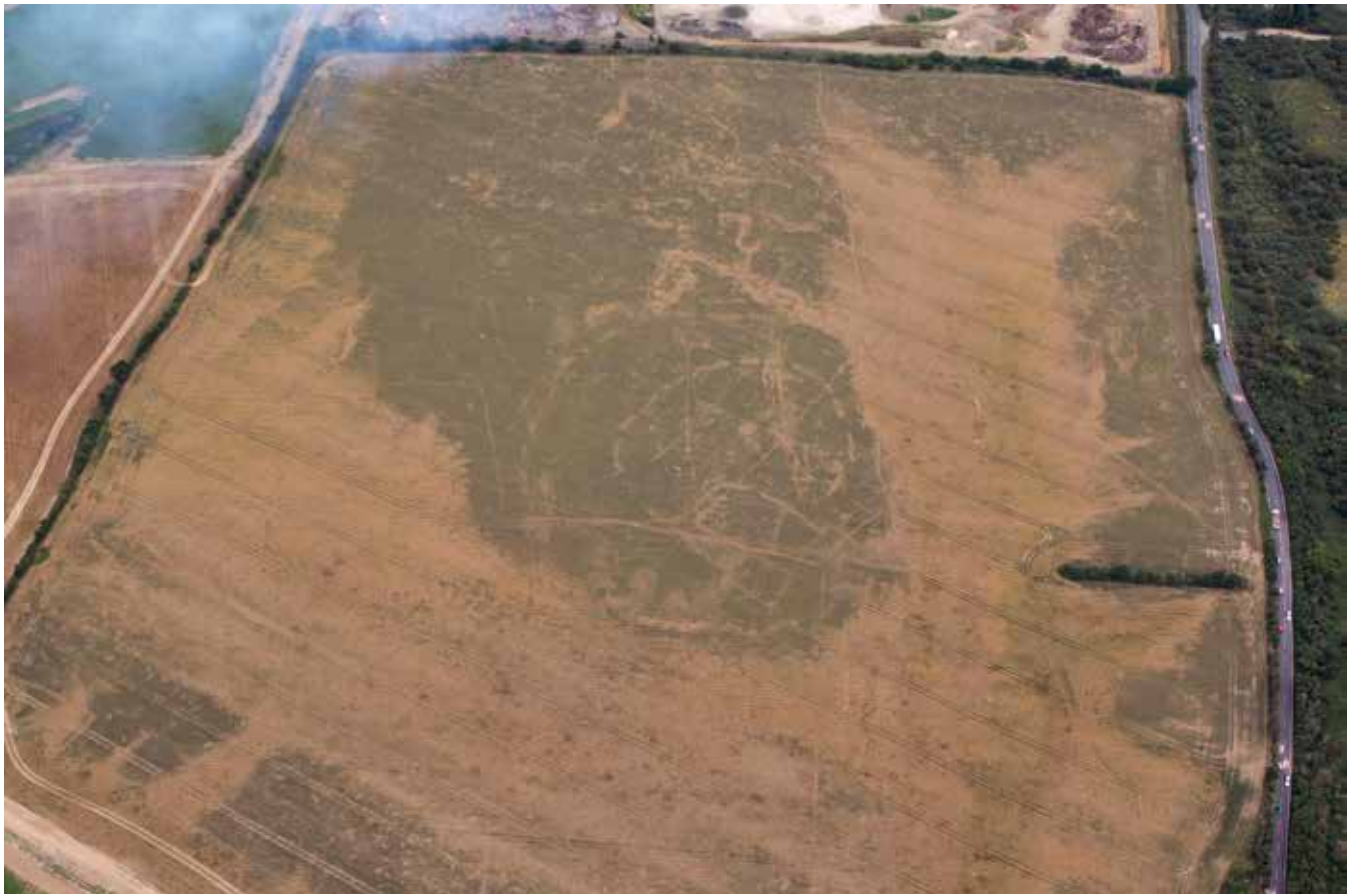
Figure 6 Aerial view of the cropmarks, looking north, the causewayed enclosure is visible in the centre of the photographs as the lighter dashed lines forming two concentric circles. (EX11_04_048 ©ECC)

Trial trenching has shown that the causewayed enclosure survives well beneath the plough soil. This investigation has left 90% of the monument undisturbed. These excavations produced significant information concerning the original form and construction of the monument as well as discovering quantities of Neolithic flint tools and pottery sherds. There are only five causewayed enclosures known in Essex and so the information contained within this monument can give rare insights into the economy of the locality as well as the social and religious life of the people who occupied it. The establishment of an Iron Age settlement site here is also of great interest and indicates that the site had been adapted for a variety of uses throughout its long life.

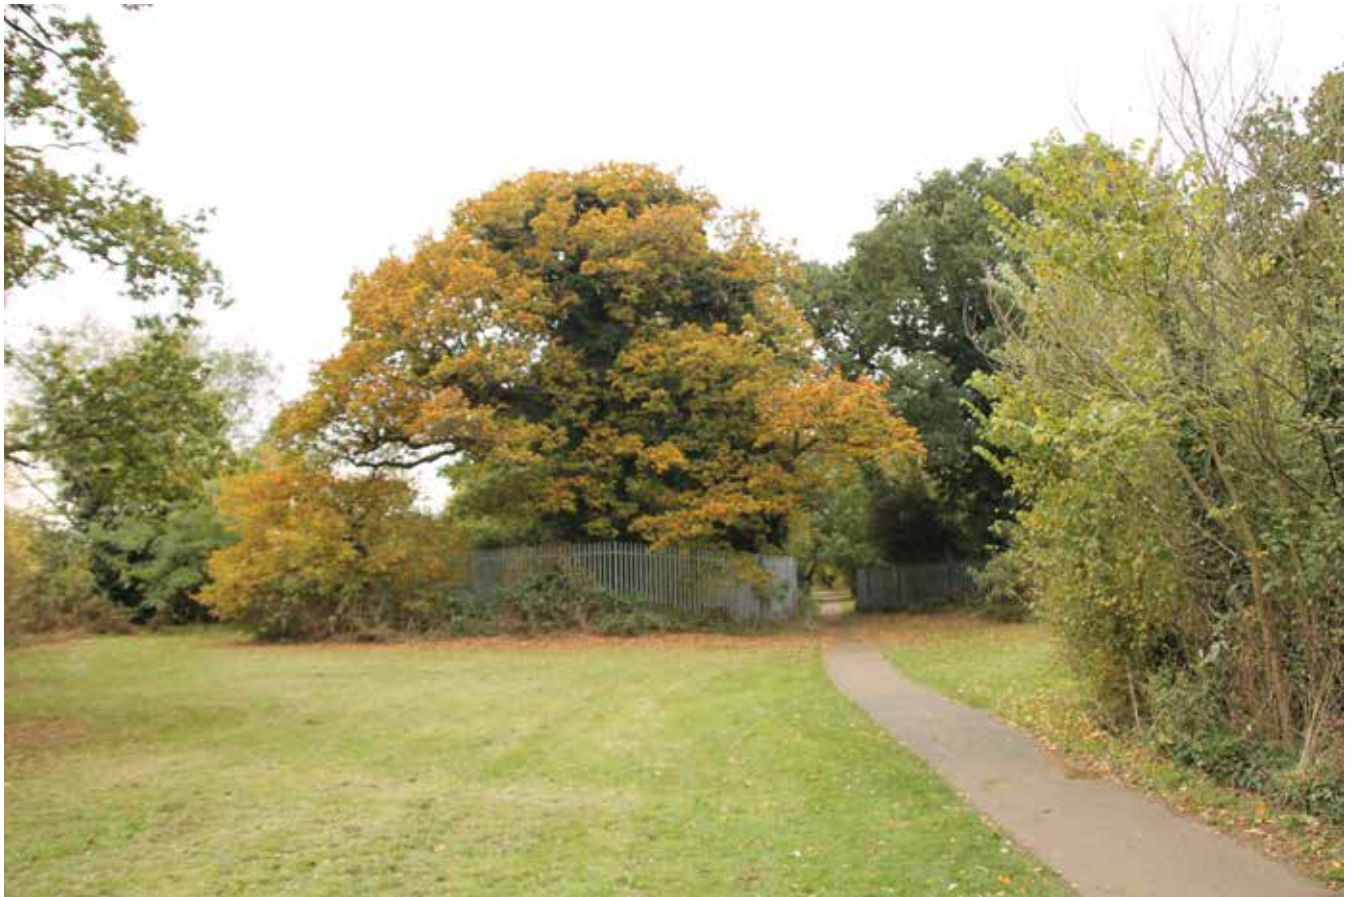
View 1: View looking west to two of the open dene holes (behind grey security fencing), located on either side of the main footpath. The rear boundary of the properties fronting Parkside is on the left and shrubby growth and trees are to the right.

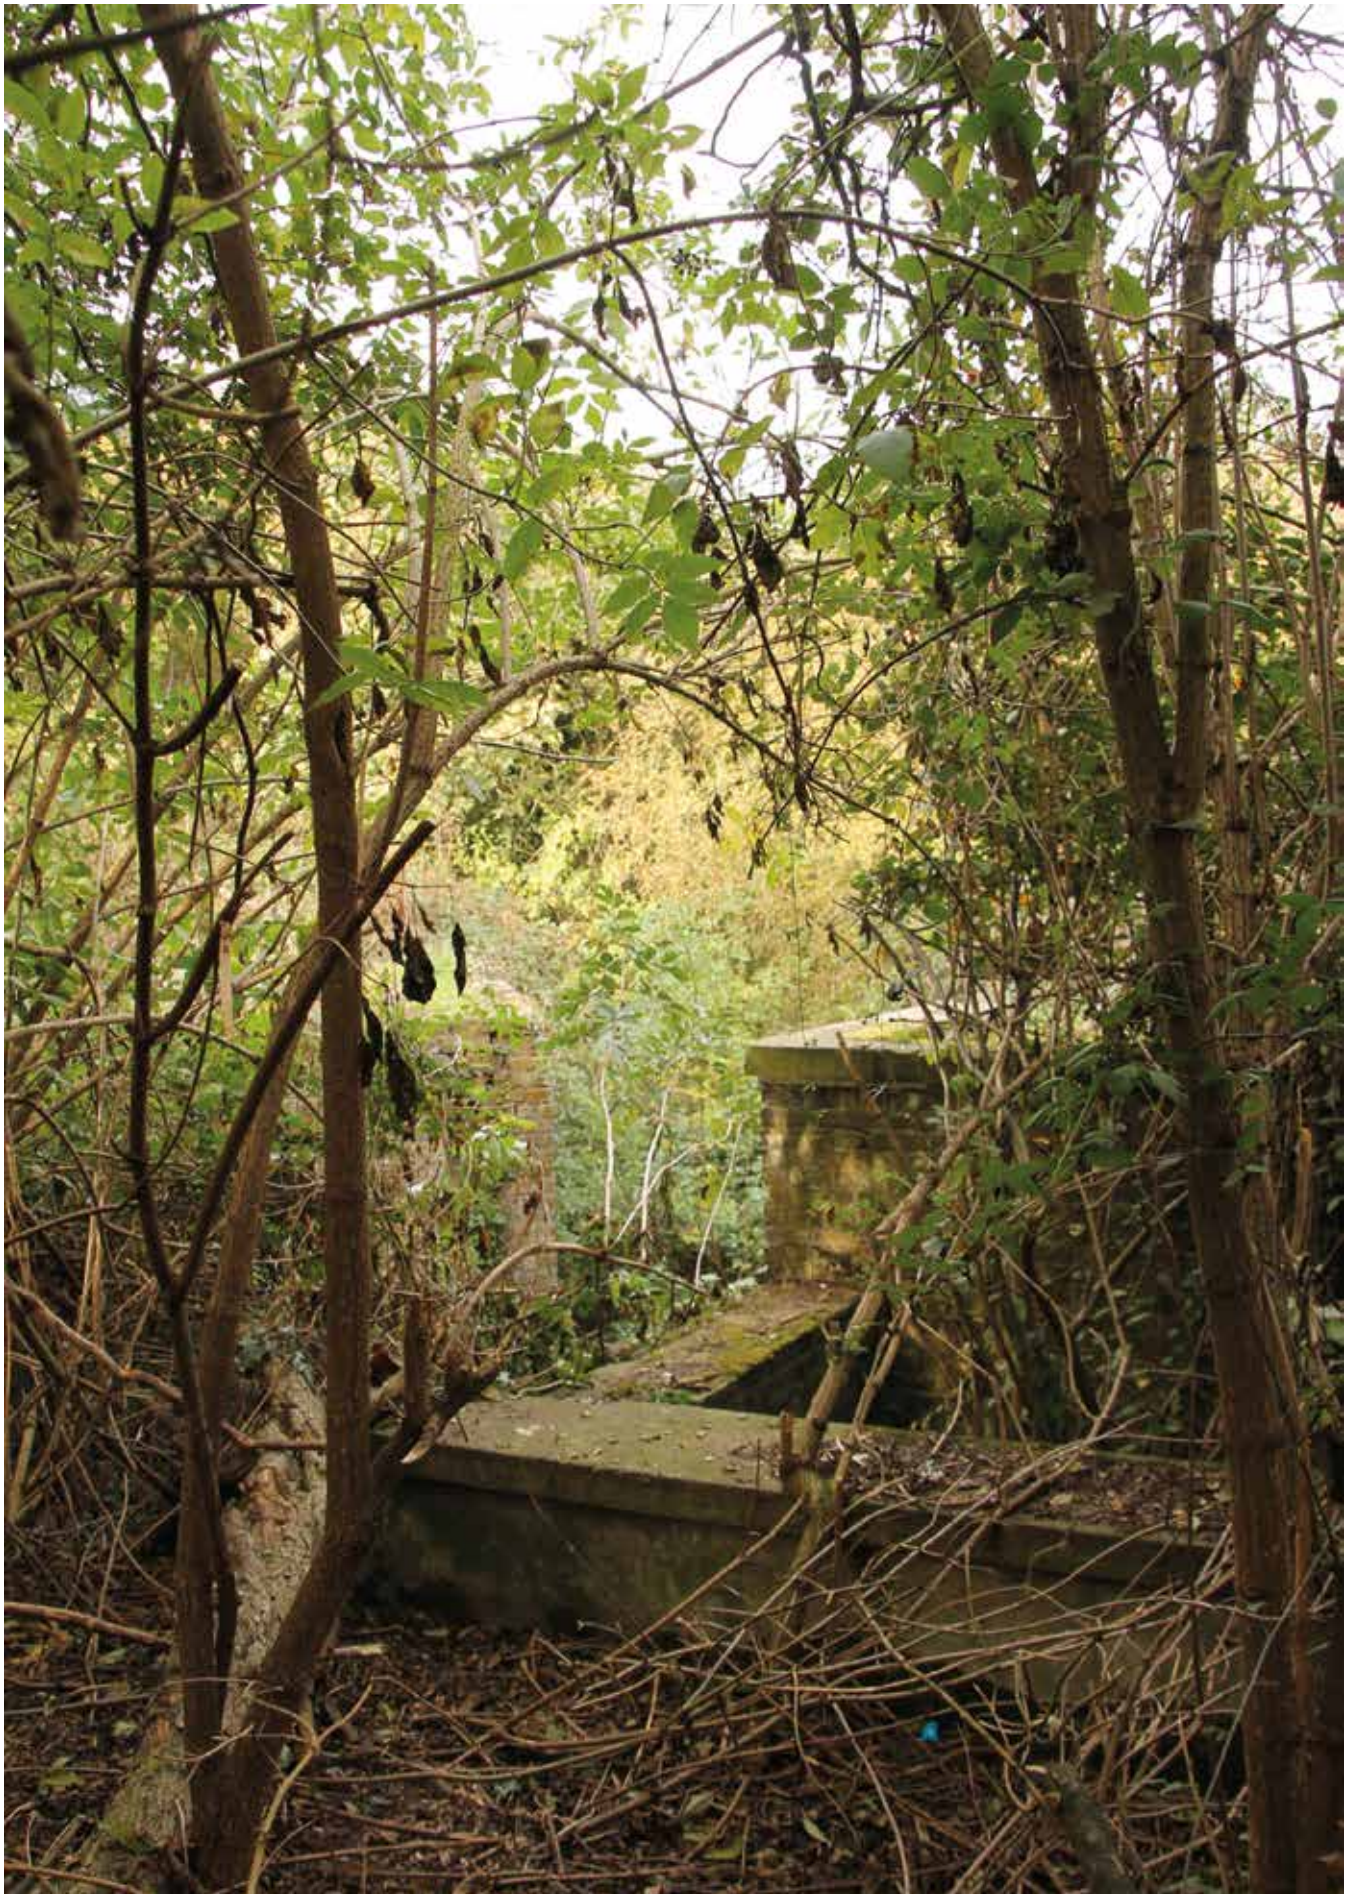
View 1: Part of the battery structure showing the undergrowth which has grown up around it.

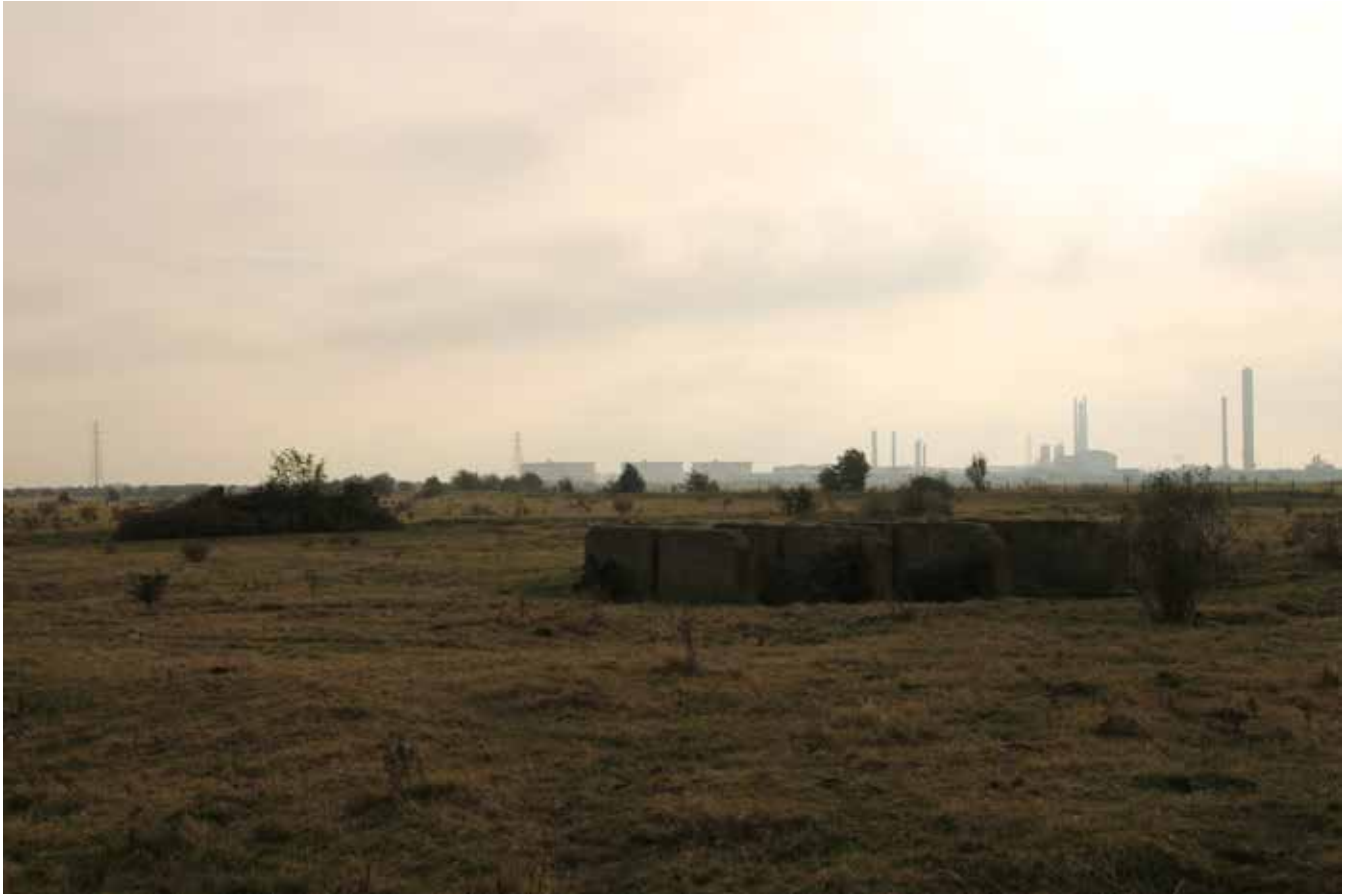
View 1: View looking south-east across the storage bays (in the foreground) and the night-shelter (on the left) towards the Shell Haven/Coryton oil refinery in the distance
